**AIRPROX REPORT No 2023243**

Date: 25 Oct 2023 Time: 0935Z Position: 5412N 00127W Location: 6 NM S Leeming

**PART A: SUMMARY OF INFORMATION REPORTED TO UKAB**

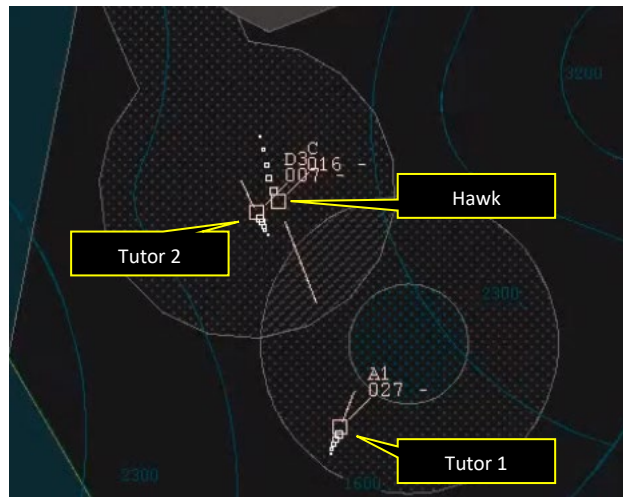
Figure 1 (0933:51). Tutor at 8NM on the instrument approach.

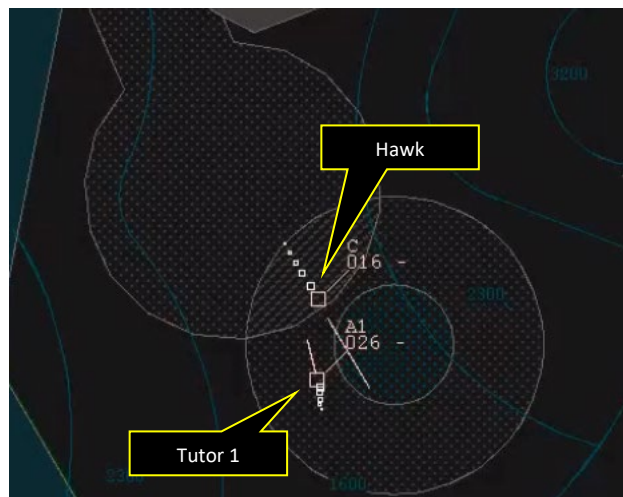
Figure 2 (0935:00). Hawk [pilot] requested position of Tutor 1.  
(Separation: 2.1NM)

At 0935:00, the Hawk pilot requested the position of Tutor 1, to which the Leeming Tower controller responded with generic Traffic Information “south west of you by a mile”. At 0935:16, the Leeming Tower controller followed up the Traffic Information by requesting whether the Hawk pilot was visual with Tutor 1. The Hawk [pilot] reported negative and that they were climbing to depart the visual circuit.

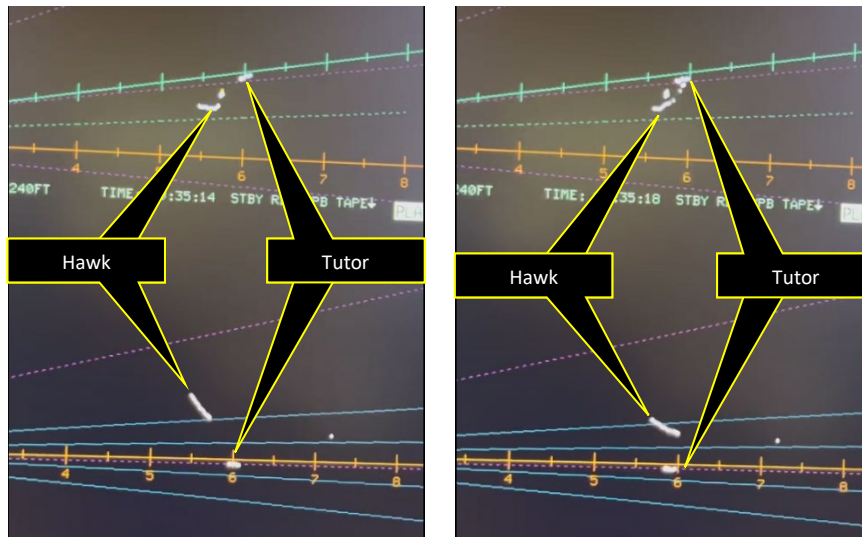
Figure 3 (0935:14) and Figure 4 (0935:18). Presentation to Leeming Talkdown controller.  
(Separation: 0935:14; 1.3NM, 0935:18; 0.7NM)

Between 0935:14 and 0938:18, the relative positions of the Hawk and Tutor 1 as presented to the Leeming Talkdown controller significantly decreased. Whilst the Tutor 1 pilot had been previously informed of the wide downwind to initial traffic, albeit incorrectly described as a Tutor and not a Hawk, there was no updated Traffic Information provided at this point.

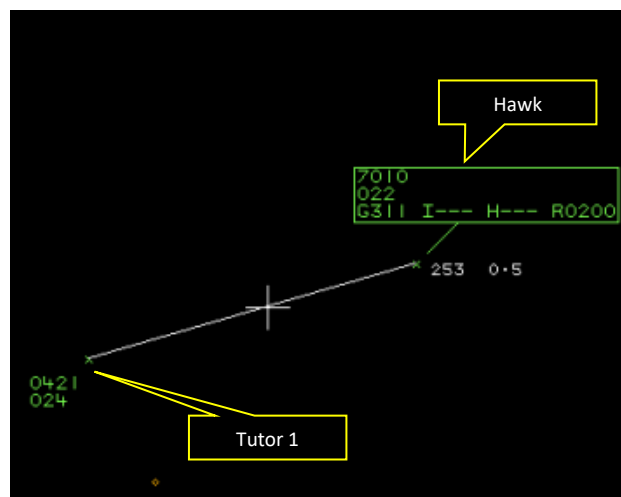
Figure 5 (0935:20). CPA.

CPA occurred at 0935:20 and was recorded as 0.5NM and 200ft separation.
