AIRPROX REPORT No 2023248

Date: 01 Nov 2023 Time: 2027Z (night) Position: 5314N 00433W Location: RAF Valley

PART A: SUMMARY OF INFORMATION REPORTED TO UKAB

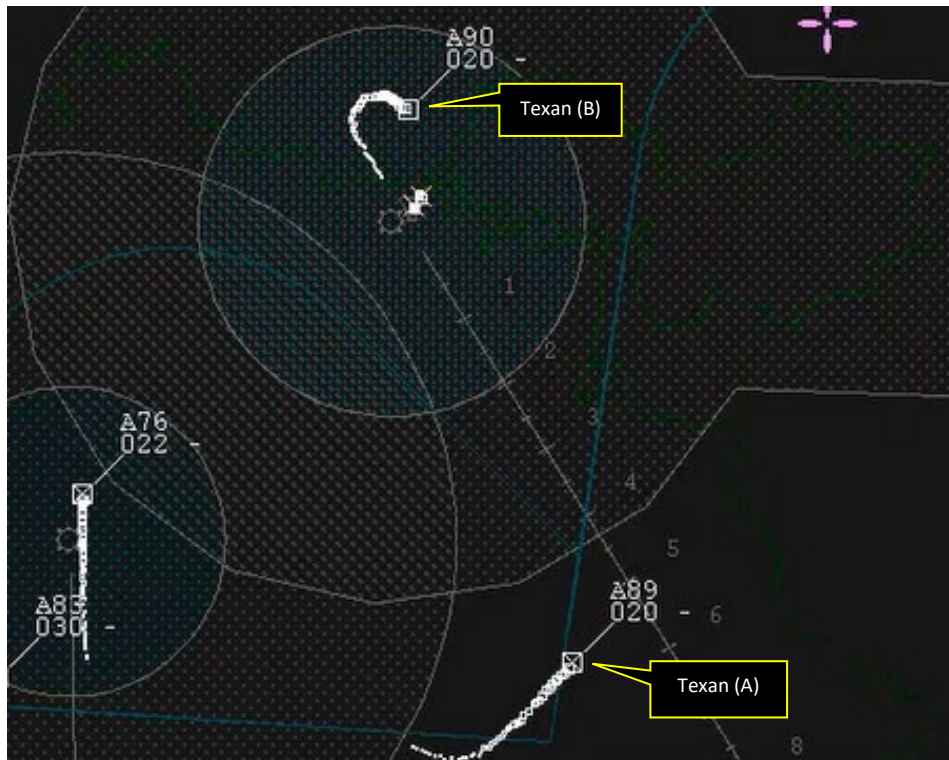
Figure 1 (2024:49). Texan (A) joined the Valley visual circuit.

At 2024:49, Texan (A) [pilot] contacted Valley Tower to join via initial, the Valley Tower controller issued a join with the following information “Runway 19RH, QFE 977hPa, One in”. Texan (B) was established early downwind at circuit height 1000ft QFE. At 2024:58, Texan (B) [pilot] reported downwind to conduct a flapless touch-and-go. At 2025:12, Texan (A) [pilot] reported at initial, to which the Valley Tower controller acknowledged through passing the circuit traffic position of “One Downwind”.

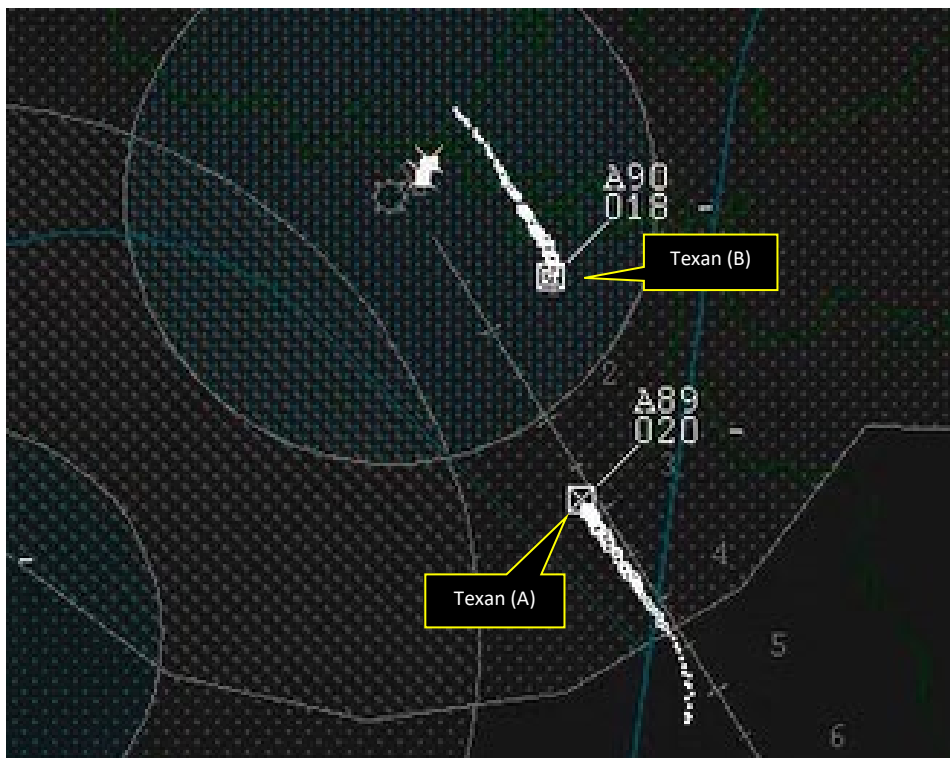
Figure 2 (2025:48). Texan (B) was cleared touch-and-go.

At 2025:48, Texan (B) was cleared touch-and-go, whilst Texan (A) was established deadside at 1000ft QFE conducting the visual join into the visual circuit.

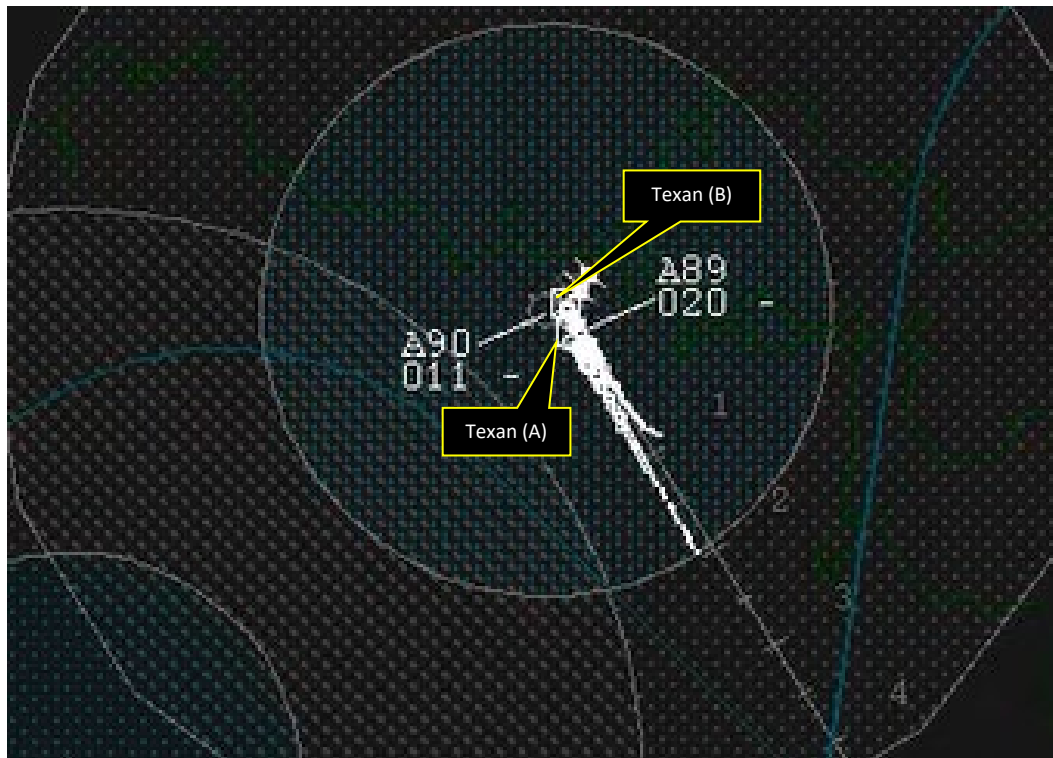
Figure 3 (2026:51). Texan (B) commenced a climb to circuit height.

At 2026:51, Texan (B), having conducted a touch-and-go, commenced a climb to circuit height. Texan (A) was abeam runway mid-point on the deadside at 1000ft QFE. At 2027:13, Texan (A) [pilot] reported “*turning*”¹ and initiated a turn across Texan (B), now also at 1000ft QFE. The Tower controller recognised the relative positions and asked Texan (A) “*Are you visual with the Texan?*”. Whilst Texan (A) [pilot] did not respond directly, at 2027:20 Texan (A) [pilot] declared “*descending below.*”

CPA could not be accurately determined due to the NATS radar recording software not displaying both aircraft consistently. It was assessed however by Texan (B) as 0NM and 300ft separation.
