AIRPROX REPORT No 2023233

Date: 03 Oct 2023 Time: 1135Z Position: 5418N 00115W Location: 4NM NNE Sutton Bank

PART A: SUMMARY OF INFORMATION REPORTED TO UKAB

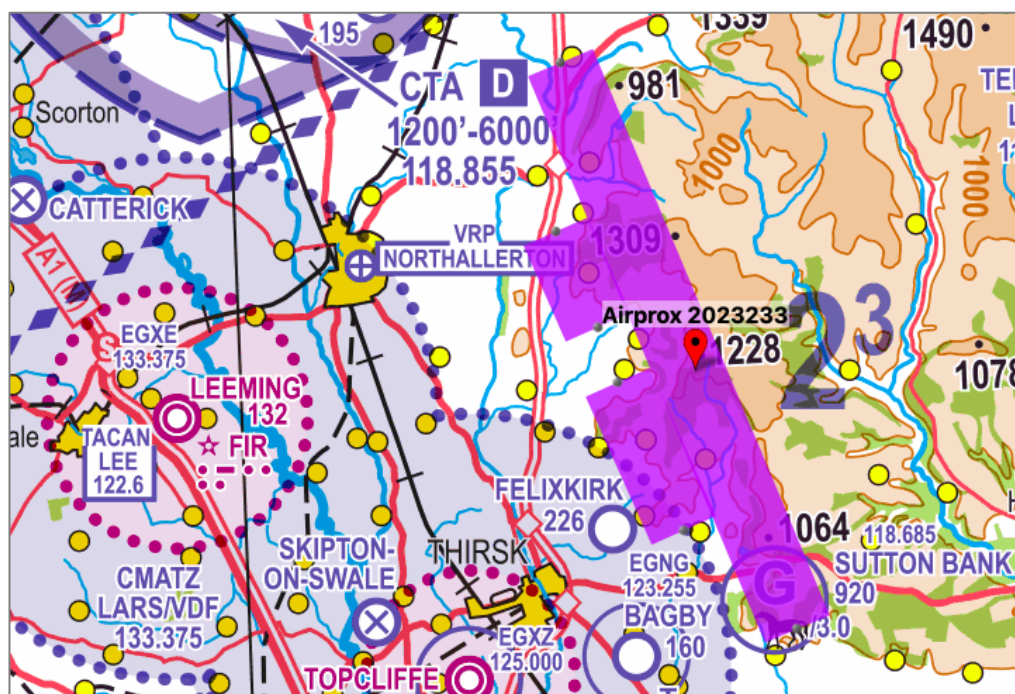
Figure 1: Ridge soaring area between Sutton Bank Airfield and Tontine interchange

When westerly winds exceed 15kt, the western edge of the North Yorks Moors between Sutton Bank Airfield (5413N 00112W) and the A19/A172 Tontine interchange (5424N 00119W) becomes very busy with gliders exploiting the resulting 'ridge lift'. At these times up to 15 gliders continuously fly along this ridge line, typically below 1500ft AGL (see Figure 1 below). ATSU's near this and other busy gliding areas may wish to install Flight Information Displays that provide instantaneous SA on aircraft carrying the EC system fitted to almost all gliders (including this Ventus).

aircraft when sharing an area of Class G airspace. In some cases, it is safer to simply avoid a known area of gliding activity due to the issues highlighted above, although recovery to Leeming from low-level to the east can make that practice troublesome.
