AIRPROX REPORT No 2023236

Date: 07 Oct 2023 Time: 1128Z Position: 5414N 00113W Location: Sutton Bank

PART A: SUMMARY OF INFORMATION REPORTED TO UKAB

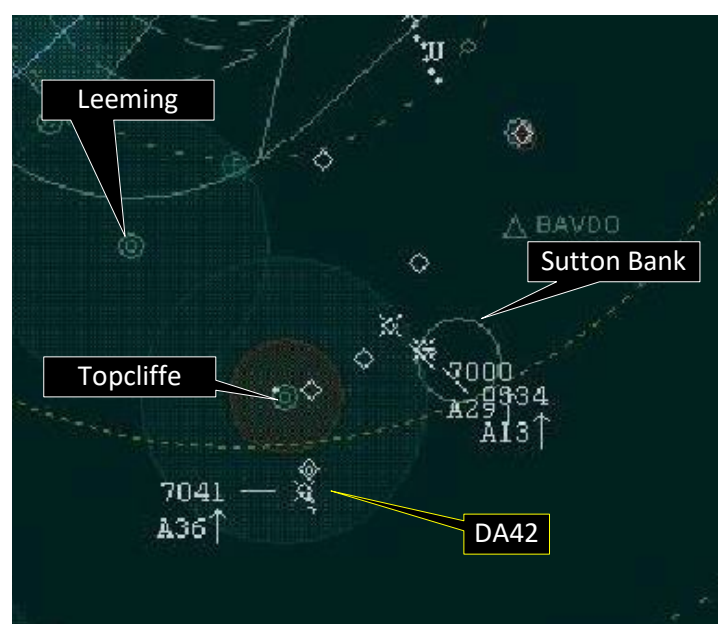
Figure 1 – Aircraft positions at 1111:45 (17min before CPA). The DA42 was observed to have been tracking northbound in a climb.

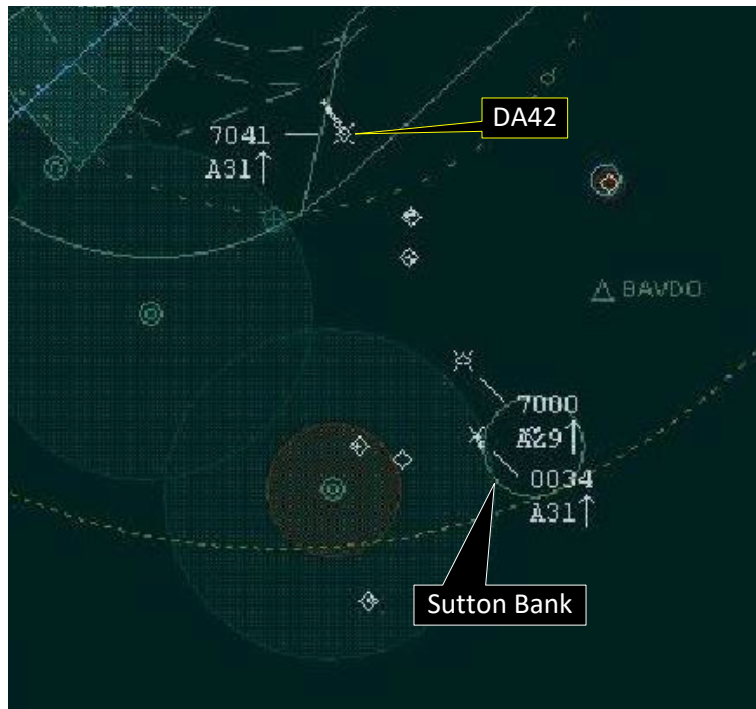
Figure 2 – Aircraft positions at 1124:10. The DA42 was observed tracking to the southeast. Traffic Information was passed to the DA42 pilot on several contacts ahead of their track.

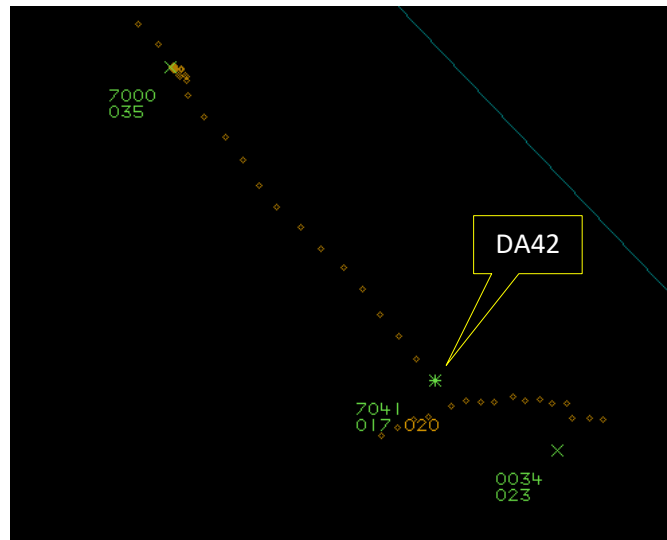
Figure 5 – CPA at 1128:04

Several primary-only returns were observed on radar in the vicinity of the DA42 but the position of the ASK21 could not be verified (Figure 5). The pilot of the ASK21 kindly supplied GPS track data for their flight. It was by combining the separate data sources that the diagram was constructed and the separation determined.

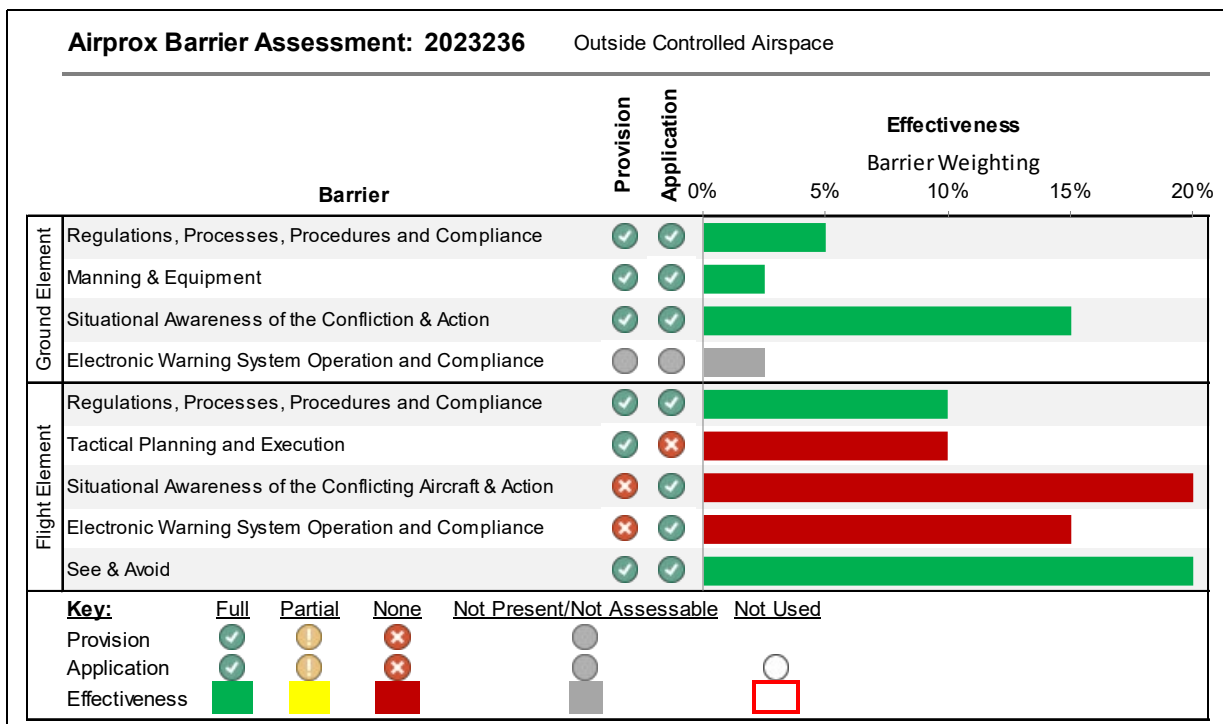
Tactical Planning and Execution was assessed as **ineffective** because the pilot of the DA42 flew through the promulgated and active airspace of the Sutton Bank gliding site.

Situational Awareness of the Conflicting Aircraft and Action were assessed as **ineffective** because the pilot of the ASK21 had not had situational awareness of the presence of the DA42.

Electronic Warning System Operation and Compliance were assessed as **ineffective** because the EC device fitted to the ASK21 would not have been expected to have detected the presence of the DA42.
