AIRPROX REPORT No 2023255

Date: 10 Nov 2023 Time: ~1338Z Position: 5236N 00102W Location: Leicester Airport

PART A: SUMMARY OF INFORMATION REPORTED TO UKAB

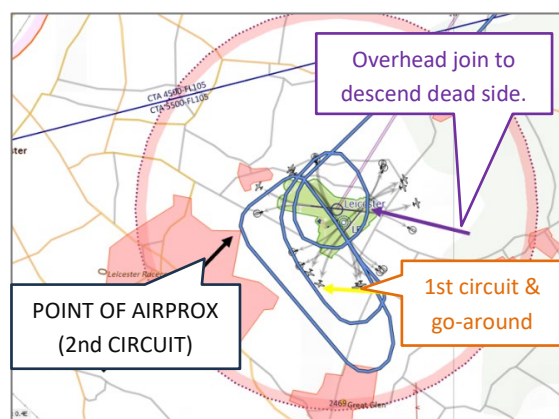
An analysis of the radar replay and ADSB tracks showed the TB200 joining the airfield from the northeast into the overhead at 1333. It performed one tight circuit and go-around, followed by a second circuit to land. A diagram of the reported Airprox position was provided by the TB200 pilot's own GPS tracking device (Figure 1).

Figure 1 – TB200 track and reported Airprox position.

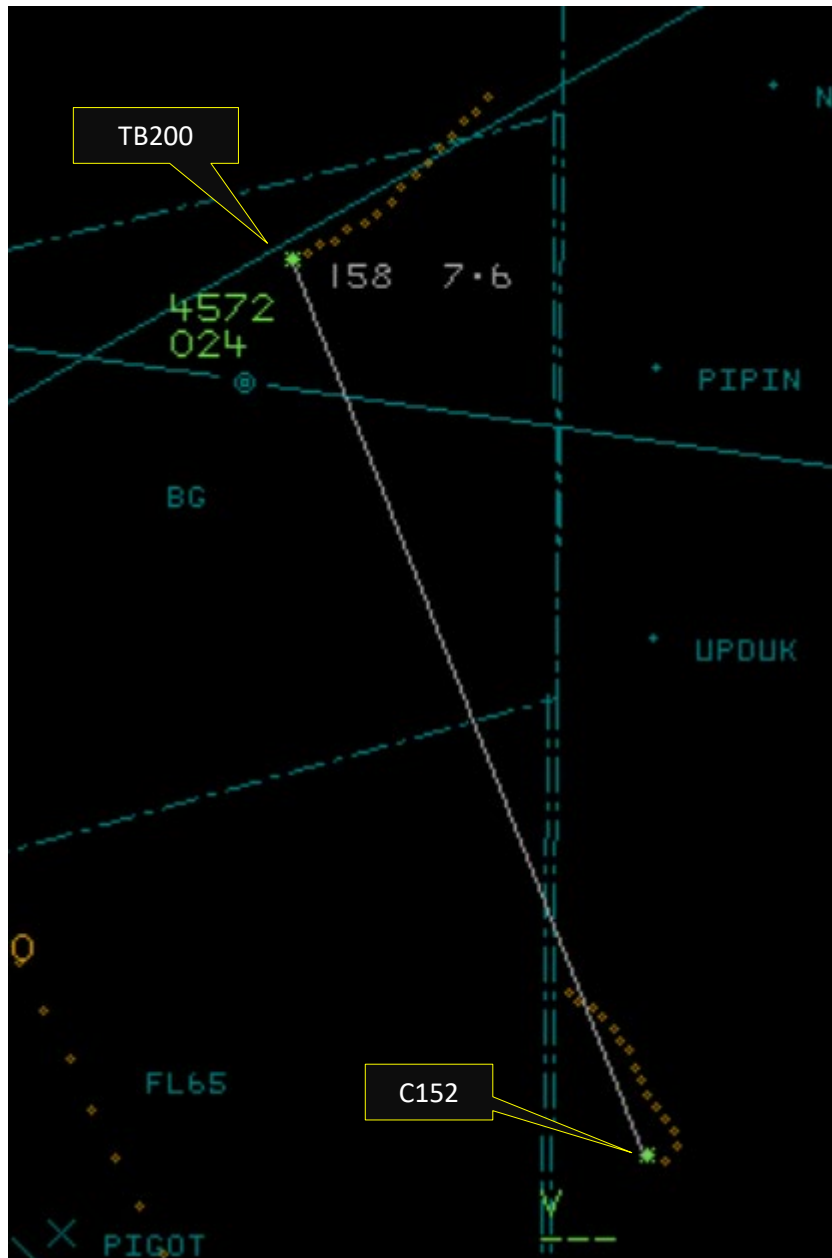
There had been one aircraft that matched the TB200 pilot's description that had later been seen parked at the airfield. That aircraft's radar returns showed that it had flown 2 circuits prior to departing the area (before to the TB200's arrival) and was operating 7NM to the southeast of the airfield during the time that the TB200 arrived and was in the circuit (Figure 2). A C172 had also arrived on a long final approach from the south and had landed prior to the TB200's arrival without entering the circuit pattern.

Figure 2 – Time 1333:10 TB200 joins from the northeast, C152 operates to the southeast.

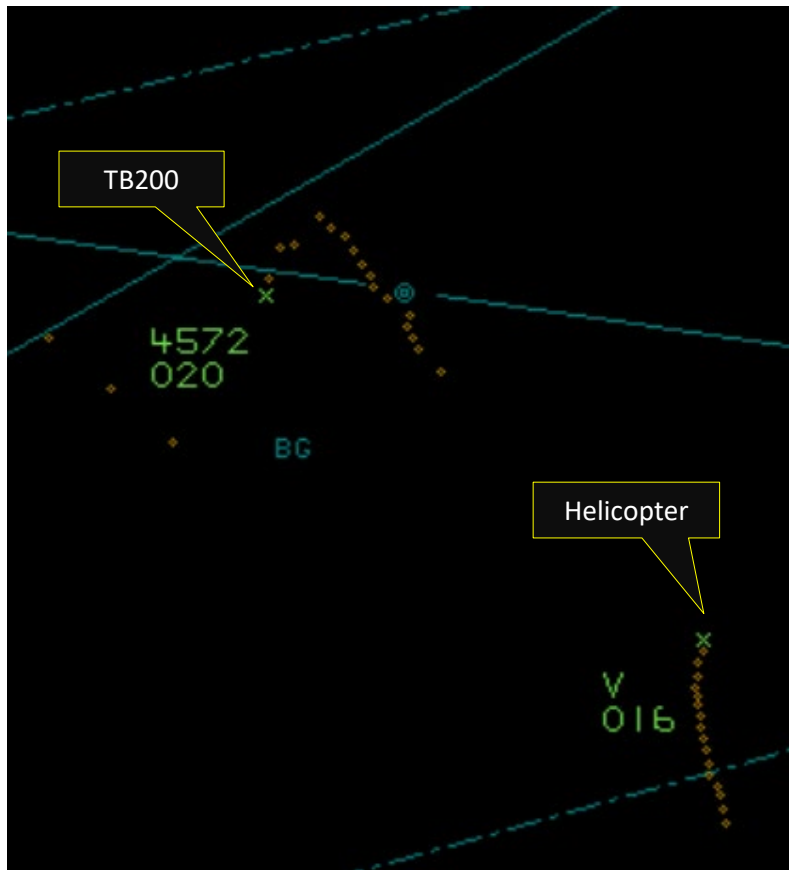
There was a helicopter arriving from the south which manoeuvred towards the rotary circuit area situated beneath the deadside of the fixed-wing circuit pattern at the time of the reported Airprox (Figure 3).

Figure 3 - Time 1338:24 TB200 at reported point of CPA

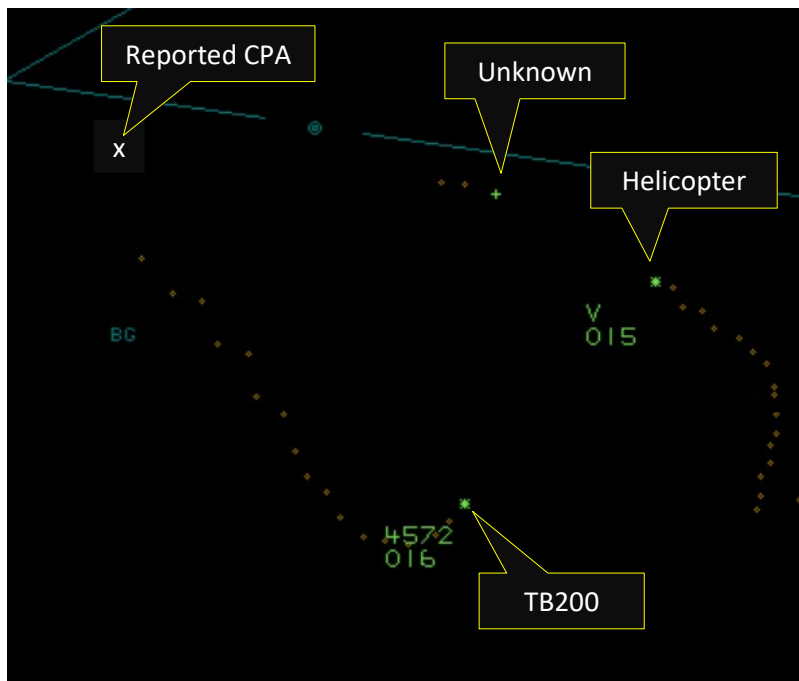
As the TB200 was on its final approach there had been one primary track to the east of the reported Airprox position which appeared briefly but could not be traced (Figure 4).

Figure 4 – Time 1339:39 TB200 on final approach post CPA
