AIRPROX REPORT No 2023258

Date: 25 Nov 2023 Time: 1359Z Position: 5329N 00253W Location: 1NM north of KIRKBY VRP

PART A: SUMMARY OF INFORMATION REPORTED TO UKAB

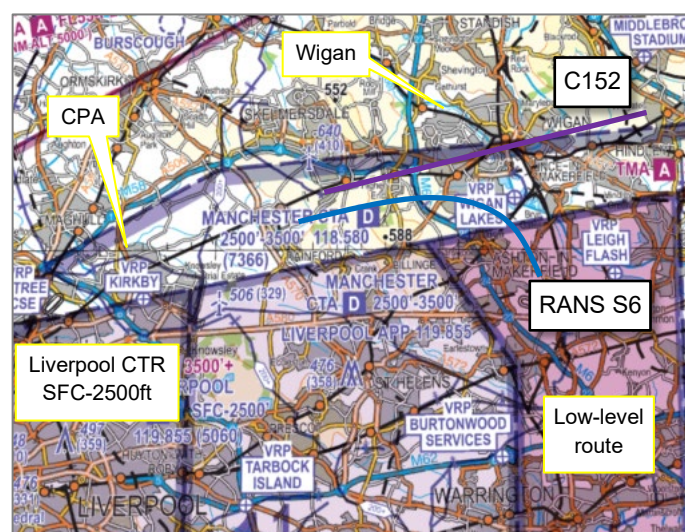
Figure 1: respective flight paths toward the relevant area

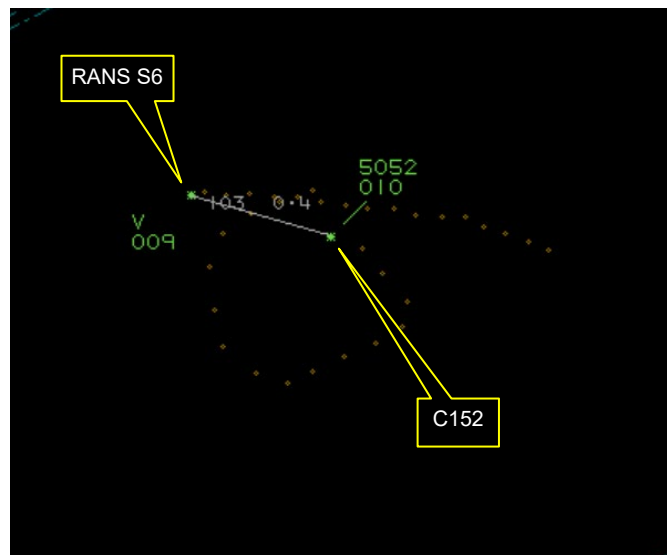
Figure 2: CPA 1359:19 100ft V/0.4NM H

The RANS S6 and C152 pilots shared an equal responsibility for collision avoidance and not to operate in such proximity to other aircraft as to create a collision hazard.² If the incident geometry is considered as converging then the C152 pilot was required to give way to the RANS S6.³
