AIRPROX REPORT No 2023260

Date: 08 Dec 2023 Time: 1241Z Position: 5205N 00209W Location: 0.5NM SW Croft Farm

PART A: SUMMARY OF INFORMATION REPORTED TO UKAB

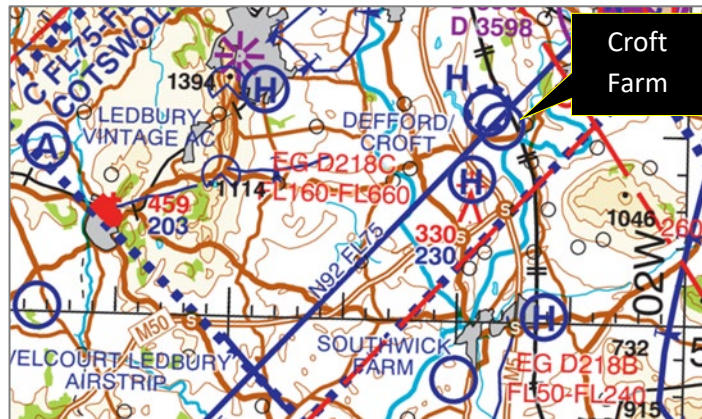
Figure 1 – the location of Croft Farm

The location of Croft Farm, as marked on a military low-flying chart, is shown in Figure 1.

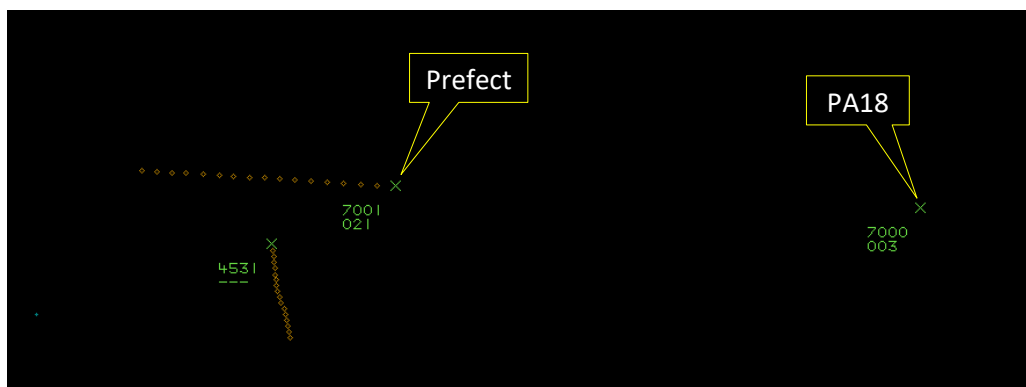
Figure 2 – 1239:11

An analysis of the NATS radar replay was undertaken and both aircraft could be identified from Mode S data. The PA18 first appeared on the radar replay at 1239:11 (Figure 2). Both aircraft were depicted on the radar replay at Flight Levels and a suitable conversion factor was used to determine their altitude. The diagram was constructed and the separation at CPA determined from the radar data.
