AIRPROX REPORT No 2023266

Date: 08 Dec 2023 Time: 1458Z Position: 5201N 00001W Location: 13NM NW Stansted

PART A: SUMMARY OF INFORMATION REPORTED TO UKAB

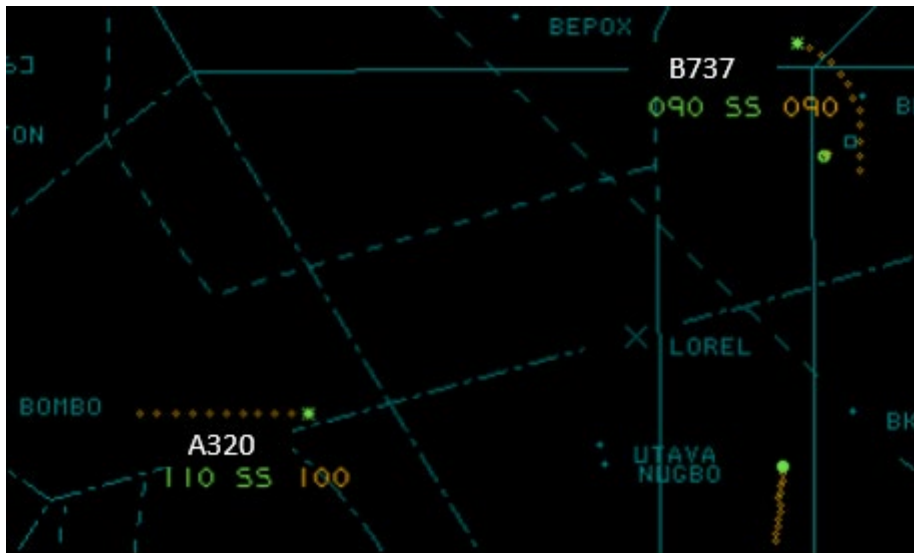
Figure 1

At 1456:07, the TC NW controller cleared [A320] to descend to FL90 (Figure 1).

[B737 C/S] was turning left onto the previously issued heading of 135°.

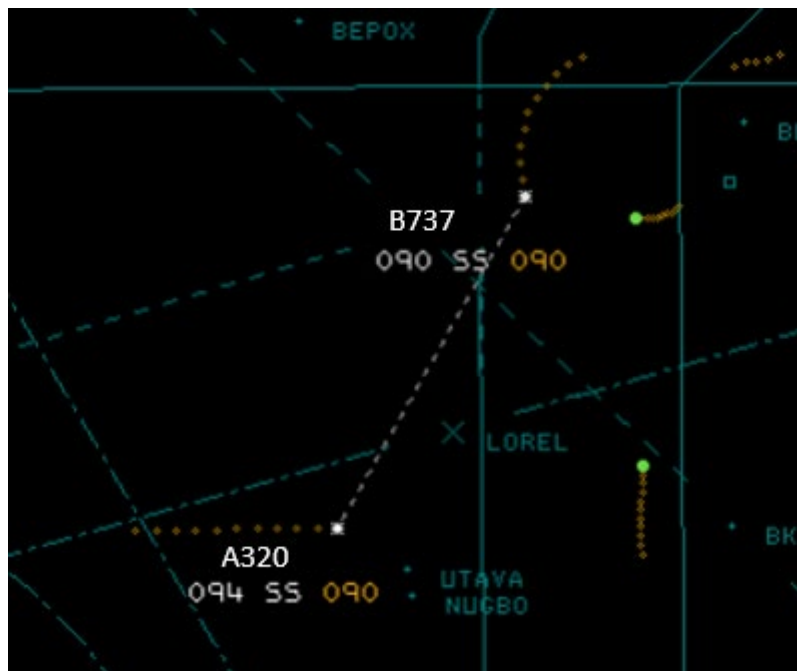
Figure 2

The Low-Level Short-Term Conflict Alert (STCA) activated at 1457:08 between the two aircraft (Figure 2) and at 1457:12 the SS INT U/T issued avoiding action to the pilot of [the B737] to turn left immediately heading 075°. Only the word, “heading” was received in response.

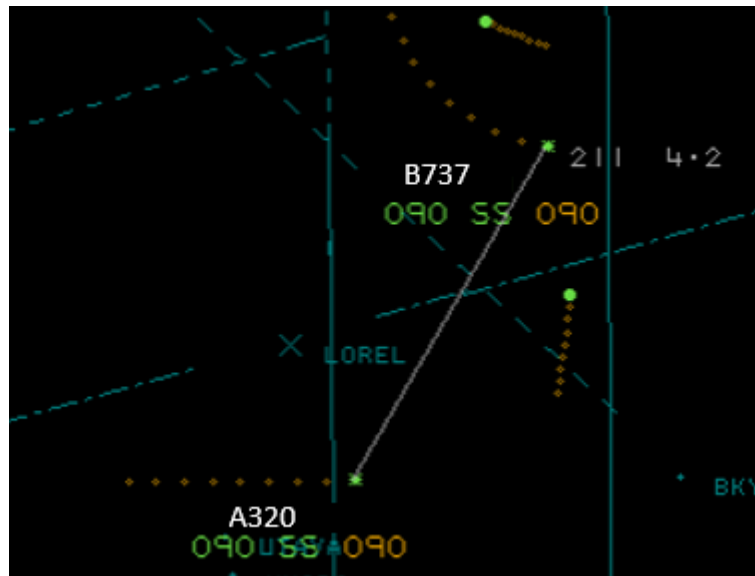
Figure 3 – CPA

The closest point of approach between [B737 C/S] and [A320 C/S] occurred at 1457:39, measured on the Multi-Track Radar as 4.2NM and 0ft, where 3NM or 1000ft were required (Figure 3). As such, there was no loss of separation associated with this event.
