AIRPROX REPORT No 2023252

Date: 17 Nov 2023 Time: ~1142Z Position: 5317N 00057W Location: Retford Gamston Airport

PART A: SUMMARY OF INFORMATION REPORTED TO UKAB

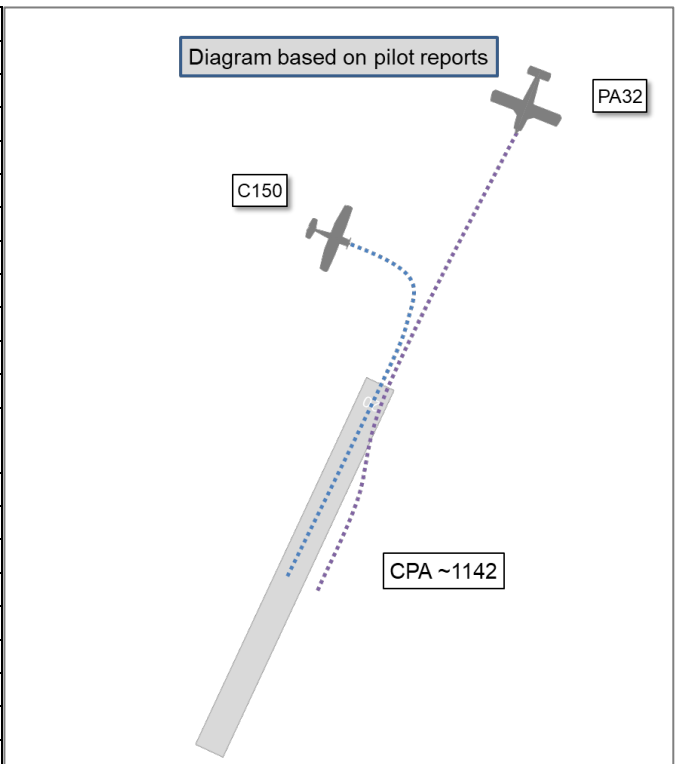
THE C150 PILOT reports, while getting airborne after a touch-and-go on RW20, at approximately 700ft and 65kt, an aircraft was seen slightly above and to the left, within 15m, headed in the same direction and straight and level. At this point they stopped the climb and maintained straight and level flight. They believed that the aircraft then vacated the circuit.

An Airprox was reported when a C150 and a PA32 flew into proximity at Retford Gamston Airport at about 1142Z on Friday 17th November 2023. Both pilots were operating under VFR in VMC, both in receipt of an AGCS from Gamston Radio.
