AIRPROX REPORT No 2024006

Date: 16 Jan 2024 Time: ~1227Z Position: 5227N 00109E Location: Tibenham

PART A: SUMMARY OF INFORMATION REPORTED TO UKAB

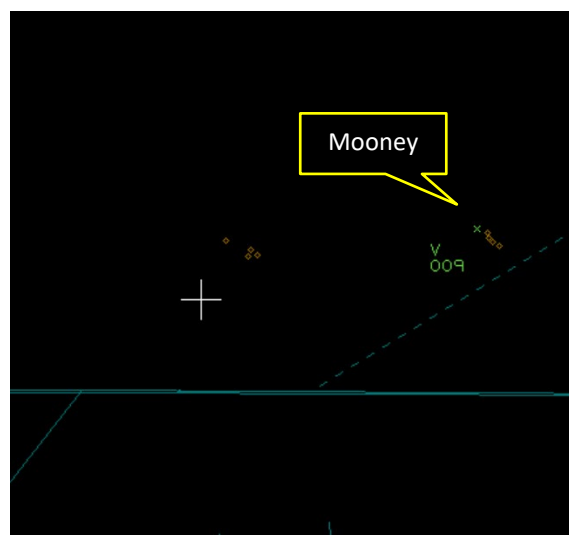
An analysis of the NATS radar replay was undertaken. At 1221 the Mooney could be identified using Mode S data, approximately 5NM from Tibenham, see Figure 1. Although a number of primary-only contacts could be seen in the Tibenham area, the T61 could not be identified. The Mooney then faded from radar.

Figure 1 -1221:13 Approximate position of Tibenham marked with the white cross

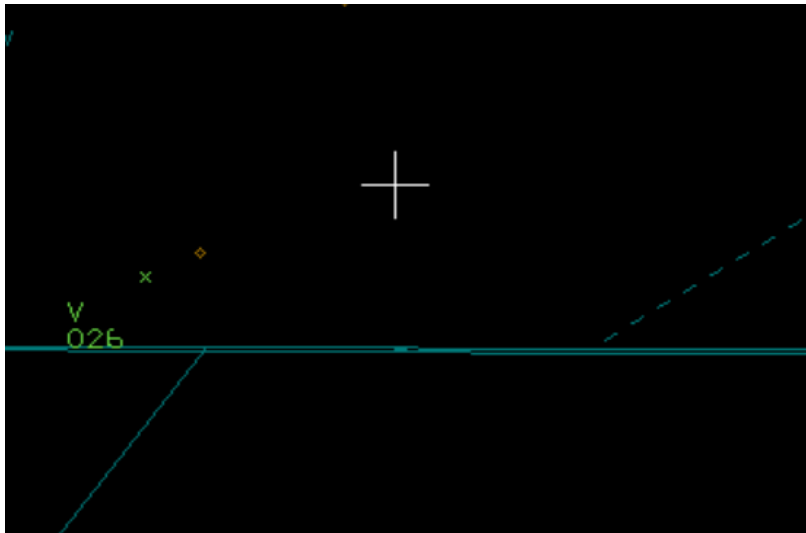
Figure 2 1227:37

At 1227:36 the Mooney reappeared on radar to the southwest of Tibenham indicating FL026 (radar QNH 1008hPa). Again, the T61 could not be seen on the radar and the exact separation could not be determined.
