**AIRPROX REPORT No 2024009**

Date: 18 Jan 2024 Time: 1435Z Position: 5220N 00120W Location: Draycote Water

**PART A: SUMMARY OF INFORMATION REPORTED TO UKAB**

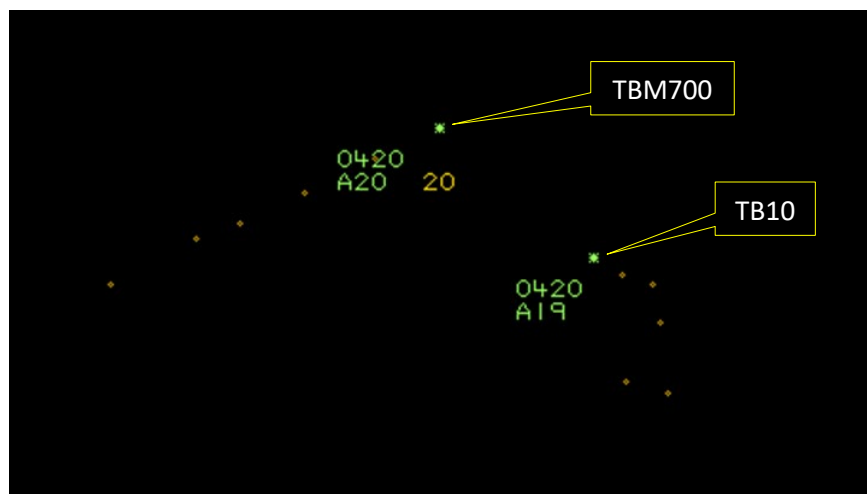
Figure 1 - 1434.32

The TBM700 pilot reported that they were in receipt of a service from Coningsby at the time of the Airprox. However, the Coventry AFISO, the Unit investigation report and the radar replay confirm that the pilot was in receipt of a Basic Service with Coventry. The pilot reported that they were flying racetracks while undertaking a practice emergency exercise involving manually lowering the landing gear. Review of the radar replay shows the aircraft approaching the airfield from the south. The aircraft passed through the RW23 climb-out lane in the descent to FL50 and then conducted a sweeping left turn to the west of the airfield before passing west-to-east at a distance of 3NM south of the airfield, where it came into [proximity] with the TB10 approaching Draycote Water (Figure 1).

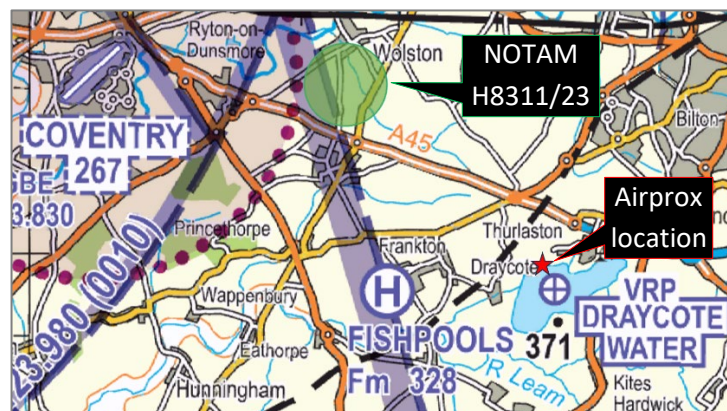
Figure 2 – NOTAM for the flying of model aircraft

The narrative report supplied by the pilot of the TB10 had made reference to an area where model aircraft may have been operating. The nearest NOTAM for the flying of model aircraft to the location of the Airprox is shown in Figure 2.

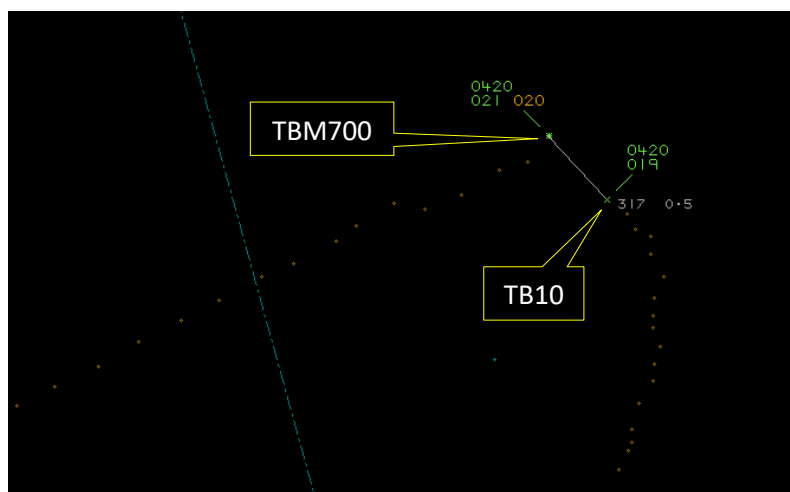
Figure 3 – CPA at 1434:35

An analysis of the NATS radar replay was undertaken and both aircraft could be positively identified from Mode S data (Figure 3). The diagram was constructed and the separation at CPA determined from the radar data.
