AIRPROX REPORT No 2024011

Date: 26 Jan 2024 Time: 1505Z Position: 5152N 00035W Location: 1.5NM WSW Dunstable Downs

PART A: SUMMARY OF INFORMATION REPORTED TO UKAB

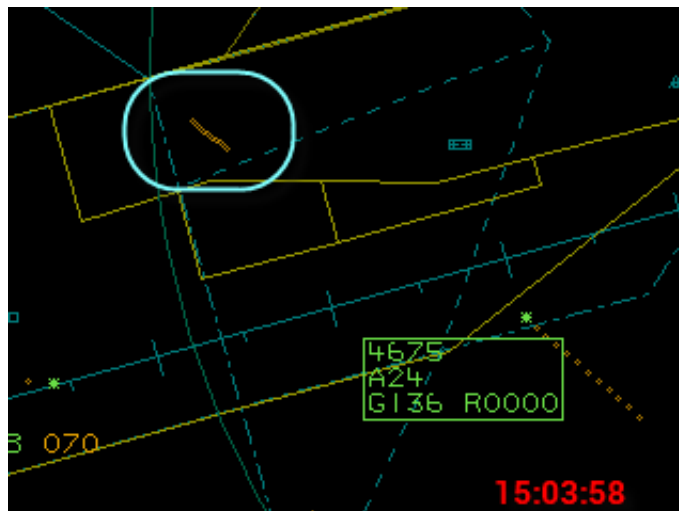
Figure 1 – The trail of a primary-only contact.

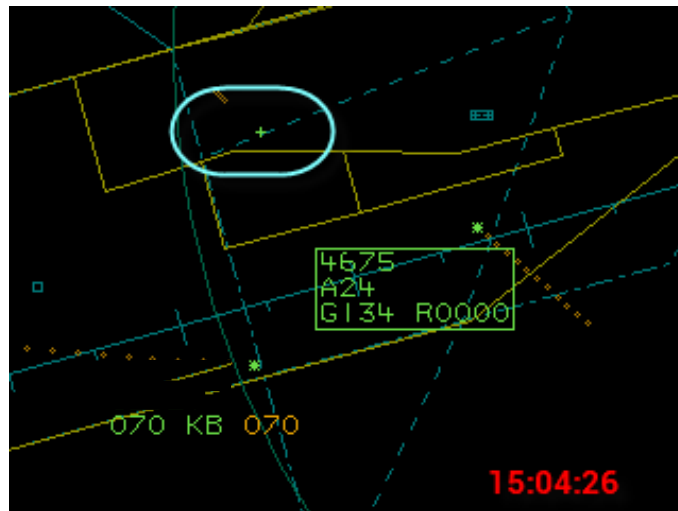
As [the S76] continued on the same track, a primary contact appeared at 1504:26, potentially related to the previous track (see Figure 2). Note: This primary target correlated to the position reported to UKAB by the pilot of [the DR400].

Figure 2 – A primary-only contact appeared.

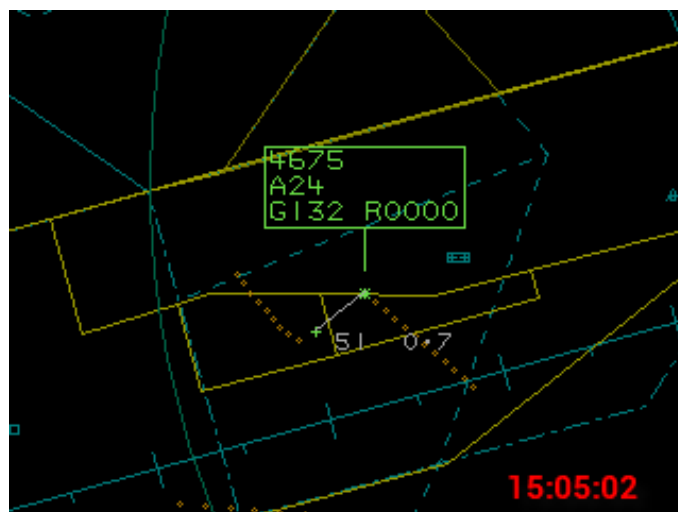
No Traffic Information was passed to the pilot of [the S76] on this primary contact, potentially due to controller workload at the time. As the returns passed abeam each other, the primary contact turned immediately left to track behind, resulting in a closest point of approach of 0.7NM laterally (see Figure 3). The pilot of [the S76] did not report an Airprox on the frequency.

Figure 3 – Possible CPA.

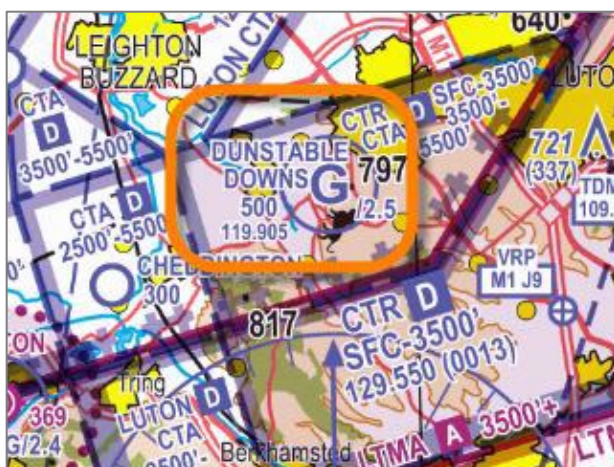
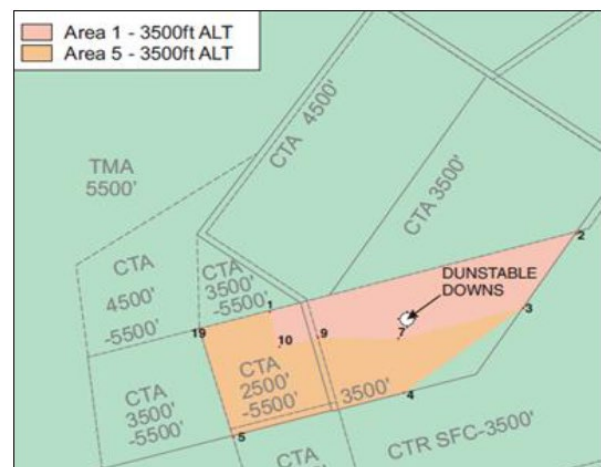
The Dunstable Downs airfield was annotated on the VFR chart as an area surrounding the airfield and not the entire gliding areas as depicted in LTC MATS Part 2 LTN (see Figure 4 and 5). As such, pilots were potentially unaware of the scope of the activity and may assume gliding/winch activity was limited to the depicted area at altitude 2500ft, whereas the entire Dunstable gliding area is active in places up to altitude 4500ft within the Luton CTA.

As part of this investigation, it was observed that VFR charts did not depict the extent of the Dunstable Downs gliding area and its varied altitude limits. Pilot awareness of glider traffic locations on a VFR transit may therefore be uncertain and limited to the area surrounding Dunstable airfield.

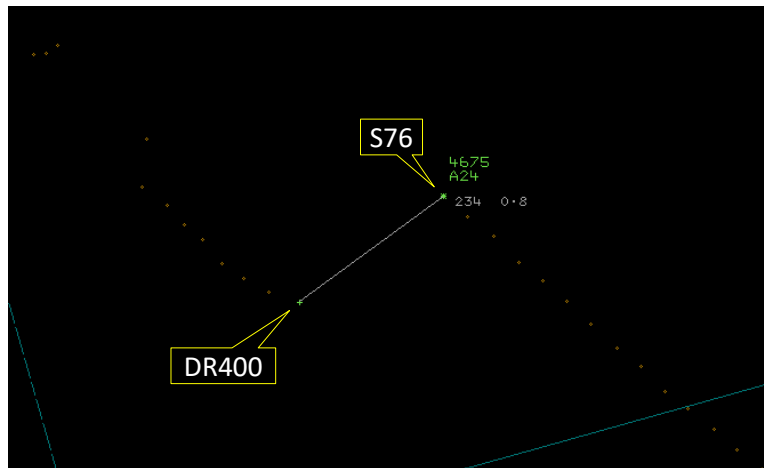
An analysis of the NATS radar replay was undertaken. The S76 could be positively identified from Mode S data. A primary-only contact was observed in the vicinity of the S76 which, by reference to the narrative report provided by the pilot of the DR400, was assessed to have been the DR400 (Figure 7). The diagram was constructed and the separation at CPA determined from the radar data.

Figure 7 – CPA at 1505:03

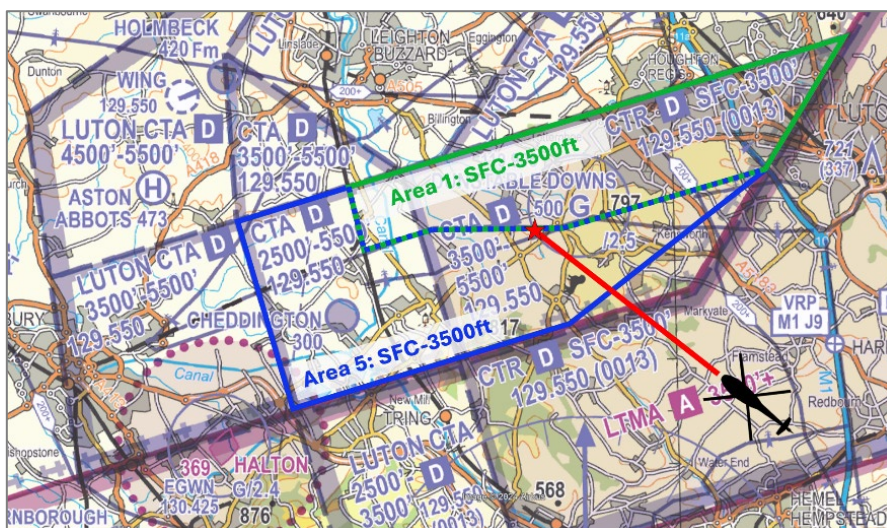
When Luton is using RW25, as on this day, gliders, tugs and tug/glider combinations operating under the LoA fly in Dunstable Gliding Areas 1 and 5 (as shown in Figure 8) at up to 3500ft AMSL without directly contacting NATS controllers. In addition, gliders are winch-launched from Dunstable Downs airfield to altitudes up to 2500ft AMSL, as notified in AIP ENR 5.5 and indicated by the '1/2.5' adjoining the airfield symbol on CAA VFR charts. Overflying this or any other glider winch site below its notified maximum winch altitude risks encountering high-tensile-strength cable connecting a launching glider to the winch on the ground.

Figure 8 - Dunstable gliding areas active at the time of the Airprox
