**AIRPROX REPORT No 2024015**

Date: 28 Jan 2024 Time: 1021Z Position: 5112N 00029W Location: Farley Green

**PART A: SUMMARY OF INFORMATION REPORTED TO UKAB**

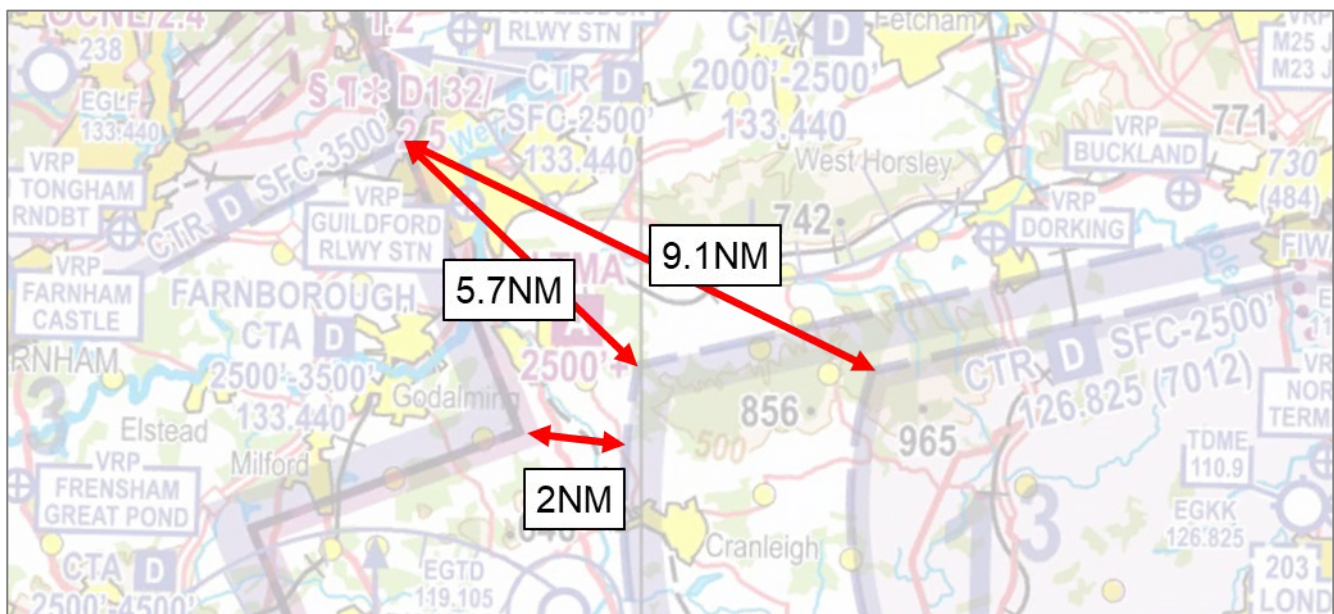
The distance between the Farnborough and Gatwick CTRs is 9.1NM, between the Farnborough CTR and Gatwick CTA base 1500ft is 5.7NM and between the Farnborough CTA4 (south of Farnborough airfield), base 2500ft, and the Gatwick CTA, base 1500ft, is 2NM.

When routing near controlled airspace (CAS), GASCo recommends that pilots plan to remain clear of the horizontal and vertical boundaries of the airspace by a suitable distance that's appropriate for them, their aircraft and the prevailing conditions. As a general rule of thumb 'Take Two' (i.e. 2 nautical miles horizontally and 200 feet vertically) would seem to be sound practical advice but in some cases it might be prudent to allow even more.
