AIRPROX REPORT No 2024019

Date: 07 Feb 2024 Time: 1055Z Position: 5202N 00102E Location: 3NM SE Elmsett

PART A: SUMMARY OF INFORMATION REPORTED TO UKAB

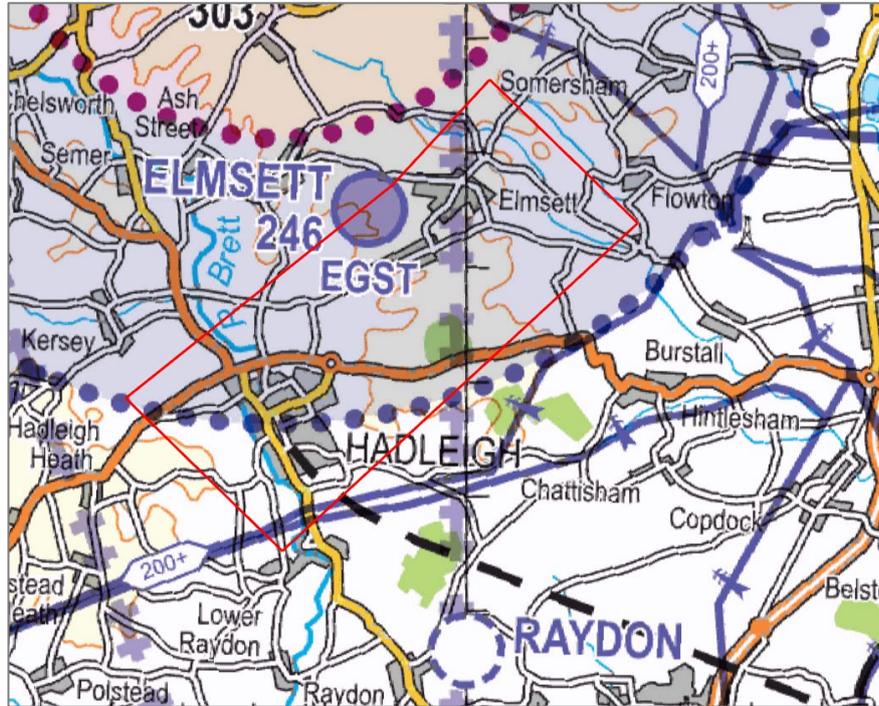
Figure 1 – Recommended Elmsett visual circuit for noise abatement

At Figure 1 is a reconstruction of a diagram (overlaid onto a VFR chart) published on the Elmsett website for the visual circuit, avoiding noise abatement areas.

The Board first looked at the actions of the EV97 pilot. They noted that the pilot reported flying downwind in the Elmsett visual circuit, but members thought that, in fact the pilot had been flying wide of the circuit as published on the Elmsett website, and that given that the circuit was already a large one for noise abatement, it meant that the EV97 pilot had increased the likelihood of coming into contact with other pilots flying just outside the Wattisham MATZ. Members briefly discussed whether the EV97 pilot could have received any form of ATS, but noted that Wattisham had not been open, and were told that they opened and closed the radar controller position depending on when they had aircraft movements, so could not be relied upon to offer an ATS. Furthermore, at more than 30NM from both Norwich and Southend, the pilot had been unlikely to receive a LARS from either unit. The Board noted that the CWS carried by the EV97 could not have detected the T61, which had not been fitted with a transponder, **(CF2)** and consequently the EV97 pilot had not received any prior situational awareness that the T61 had been in the vicinity **(CF1)**. The EV97 pilot had seen the T61, albeit late **(CF3)**, and had taken avoiding action to increase the separation.

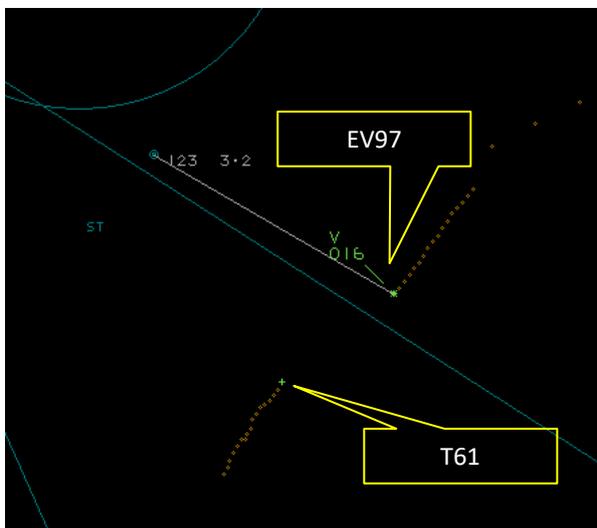
Figure 2 - 1054:35

An analysis of the NATS radar replay was undertaken. The EV97 could be seen indicating FL016 (radar QNH 1006hPa) 3.2NM southeast of Elmsett (EGST, marked on the radar screenshot as ST). The T61 could not be positively identified, but a primary track southwest of the EV97 fitted the flight profile described by the T61 pilot, Figure 2.

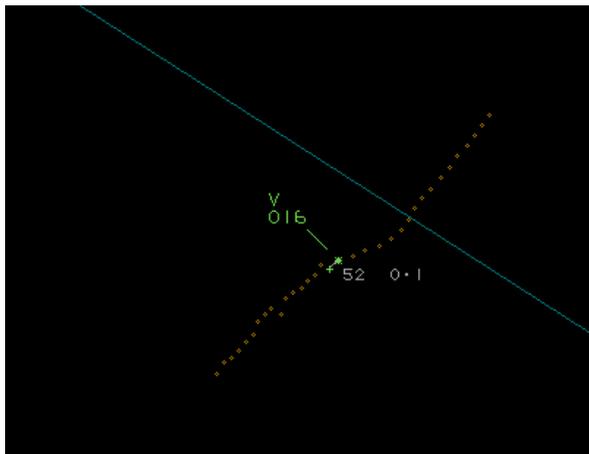
Figure 4 - 1055:15

The two aircraft continued to close with radar CPA taking place between radar sweeps, see Figures 4 and 5.
