AIRPROX REPORT No 2024013

Date: 27 Jan 2024 Time: 1522Z Position: 5259N 00254W Location: 5NM SE Borrás Quarry VRP

PART A: SUMMARY OF INFORMATION REPORTED TO UKAB

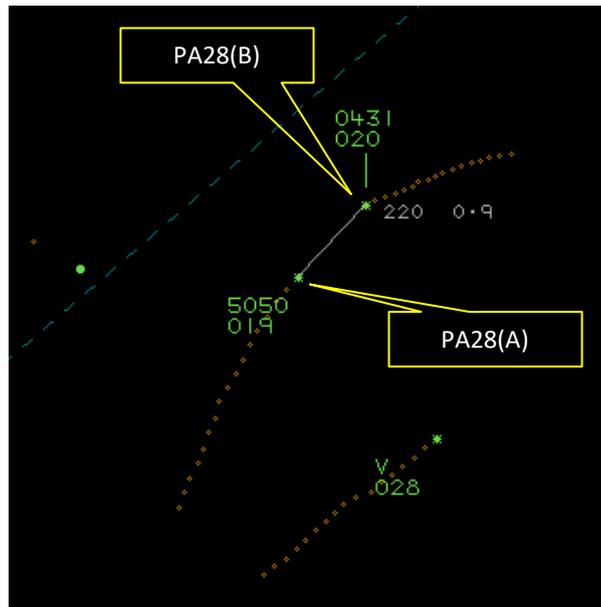
Figure 1 - 1522:12

An analysis of the NATS radar replay showed both aircraft, which were identifiable from their Mode S data. PA28(A) was indicating FL021 and initially displaying a 7000 squawk, which changed to 5050 (Liverpool conspicuity) at 1522:11. PA28(B) was displaying a 0431 squawk (Hawarden) and indicated FL020 throughout, see Figure 1. The other traffic called by Harwarden can also be seen on the screenshot, squawking 7000 (converted to V on the radar picture) and indicating FL028.

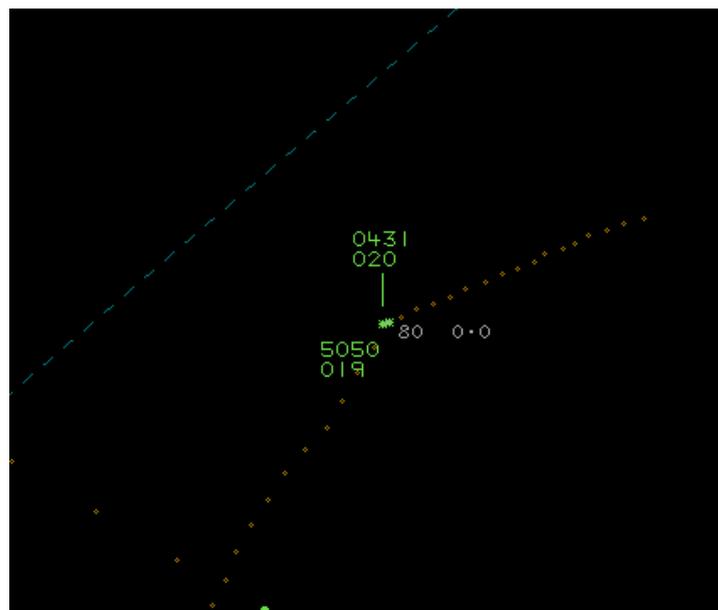
Figure 2 – CPA, 1522:27

The two PA28 aircraft continued to close, until CPA at 1522:27 (Figure 2), when radar separation indicated 100ft and <0.1NM.
