**AIRPROX REPORT No 2024047**

Date: 04 Apr 2024 Time: 1311Z Position: 5301N 00037W Location: 5NM west of RAF Cranwell

**PART A: SUMMARY OF INFORMATION REPORTED TO UKAB**

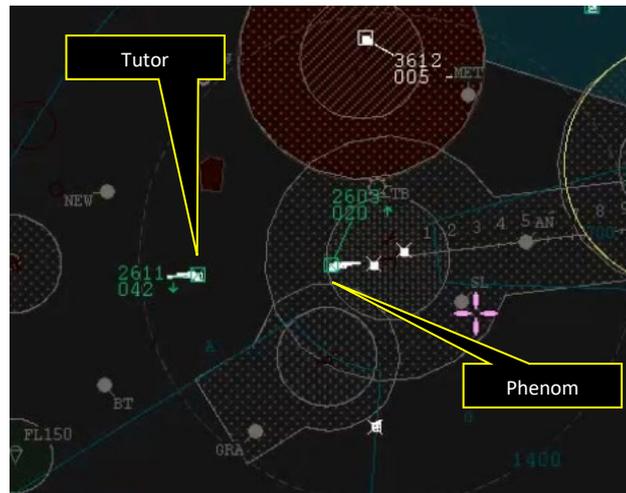
Figure 1 at 1310:19: Tutor pilot had been informed of the Phenom departure.  
(Separation: 5.6NM and 2300ft)

At **1310:19**, the Cranwell Departures controller informed the Tutor pilot of the Phenom departing RAF Cranwell “*there has been a Phenom just being released. Climbing on runway track, currently indicating 2000ft below climbing. If you can take up a south easterly track*”. The Tutor pilot acknowledged the Traffic Information and again signified their willingness to accept vectors. The Cranwell Departures controller authorised transit of the Barkston Heath ATZ but did not provide vectors based on the assumption that the previously requested southeasterly track would provide adequate lateral separation.

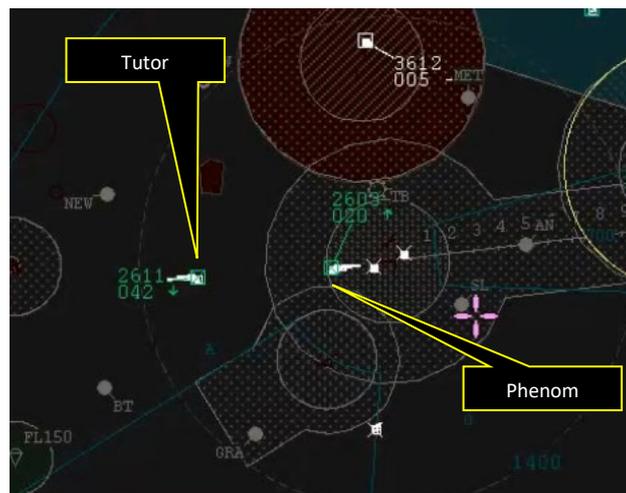
Figure 2 at 1310:36: The Phenom pilot on departure was provided with Traffic Information on the Tutor.  
(Separation: 4.2NM and 1900ft)

At **1310:36**, the Phenom pilot had contacted the Cranwell Departures controller on MID1 departure from RAF Cranwell, reporting “*level 1500ft MID1, request Traffic Service*”. The Cranwell Departures controller immediately identified the Phenom, applied a Traffic Service, restated the 1500ft Climb-out Restriction and provided Traffic Information on the Tutor “*there’s traffic 12 o’clock, 2 miles, opposite direction, Tutor recovering visually to Cranwell. Indicating 1200ft above, descending*”. The Phenom pilot had acknowledged the Traffic Information but informed the Cranwell Departures controller that they had been about to require a Deconfliction Service.

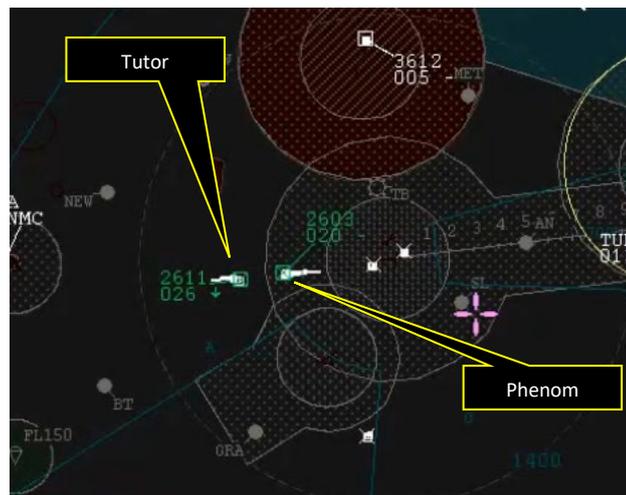
Figure 3 (1311:01): Phenom pilot requested Deconfliction Service.  
(Separation: 2.1NM and 1000ft)

At **1311:01**, the Phenom pilot had requested the anticipated Deconfliction Service. The Cranwell Departures controller subsequently applied a Deconfliction Service and provided an avoiding action turn to deconflict from the Tutor - *“Deconfliction Service, avoiding action, turn right immediately heading 360°. Previously called traffic had been left 11 o’clock, half mile, crossing right-to-left ahead, Tutor, indicating 200ft below, descending”*. The Phenom pilot acknowledged the avoiding action and initiated a turn to the north. The Tutor pilot reported visual with the Phenom and that they had been avoiding followed by transferring to Cranwell Tower.

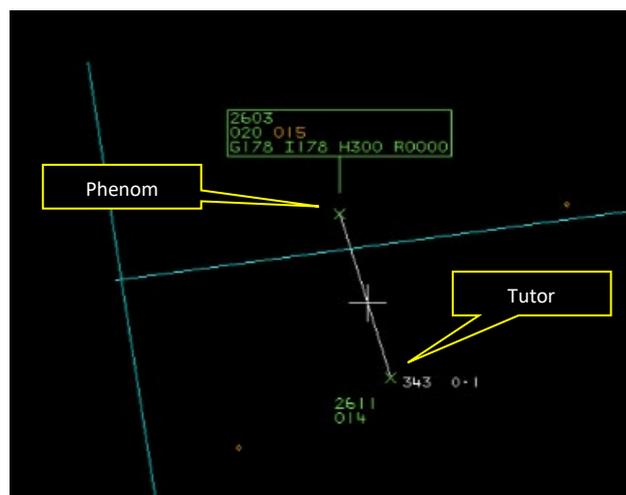
Figure 4: 1311:22 CPA.

CPA occurred at **1311:22** and was recorded as 0.1NM H and 600ft V separation.

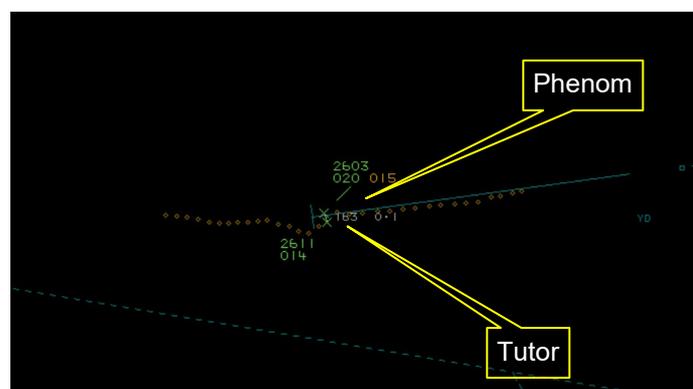
Figure 1: CPA 1311:22 600ft V/0.1NM H

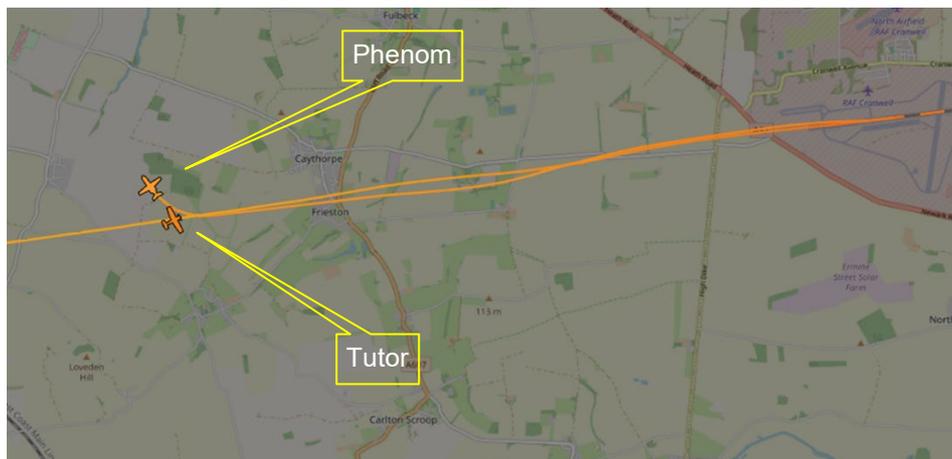
Figure 2: Post CPA - Phenom pilot's avoiding action.
