AIRPROX REPORT No 2024052

Date: 14 Apr 2024 Time: 1051Z Position: 5123N 00238W Location: 3NM E Bristol Airport

PART A: SUMMARY OF INFORMATION REPORTED TO UKAB

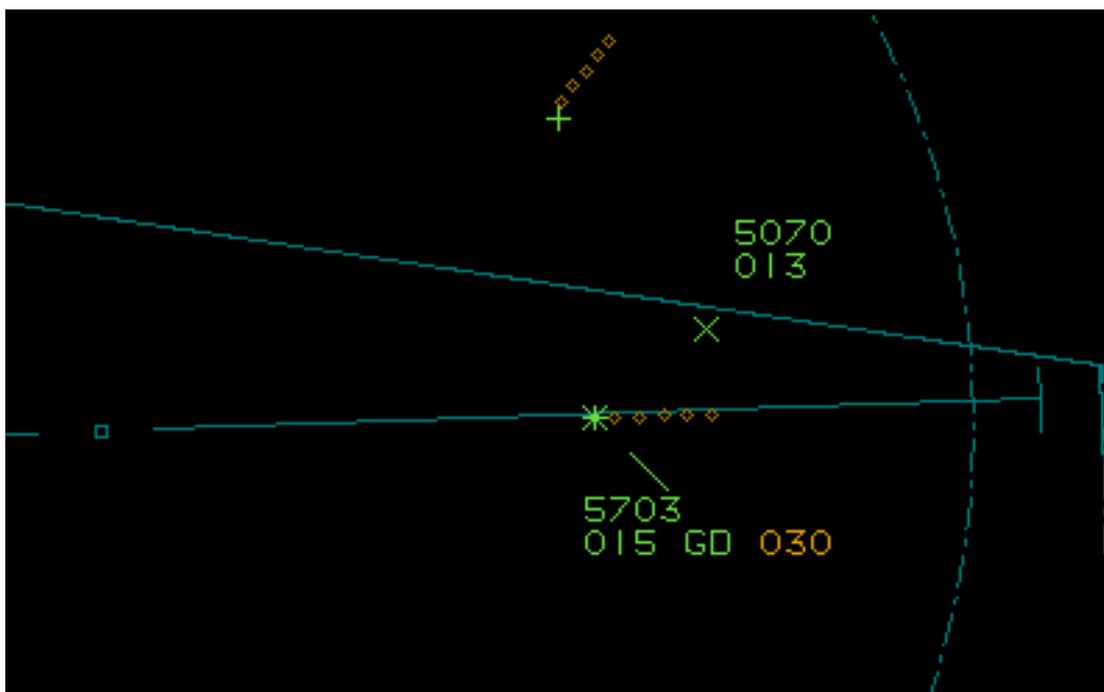
Figure 1 – 1051:30

The Sonex did not display on the NATS radar replay until 1051:30, thirteen seconds after the reported CPA, when it was on a reciprocal track to the A320 and displaced laterally by 0.5NM (Figure 1 below).

When the Sonex got airborne and started climbing and tracking east, it was on a reciprocal track to the A320, with just 0.5NM lateral displacement. There was only 27sec between the Sonex pilot reporting airborne (1050:50) and CPA occurring (1051:17). The Sonex was already within the TCAS TA envelope as it got airborne and, very soon after, entered the RA envelope. Due to the pop-up nature of the Sonex, the A320 crew will have had insufficient time to visually acquire the Sonex before having to respond to the TCAS RA.

It may be prudent for Bristol ATC to review their New Farm procedures and consider the appropriateness or otherwise of opposite direction departures and their effect on TCAS-equipped inbound traffic. Consideration could also be given to including a warning of activity at New Farm with the Bristol UK AIP entry at EGGD AD 2.20.
