AIRPROX REPORT No 2024041

Date: 30 Mar 2024 Time: 1534Z Position: 5236N 00100W Location: Leicester ATZ

PART A: SUMMARY OF INFORMATION REPORTED TO UKAB

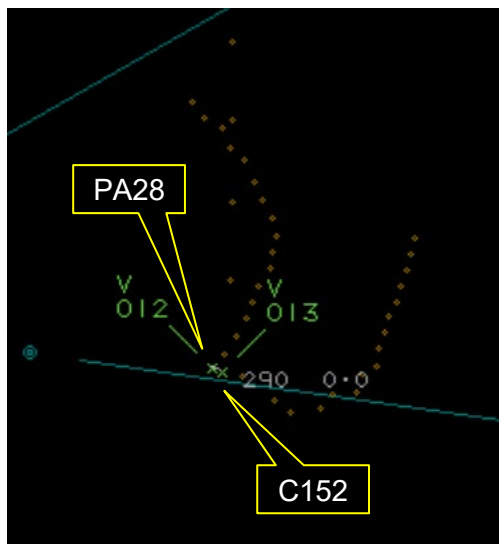
Figure 1: CPA 1534:11 - 100ft V/<0.1NM H

Both pilots report that the PA28 passed over the C152 at CPA but, with the vertical separation recorded as 100ft, radar tolerances have shown the situation to be reversed (Figure 1 above).

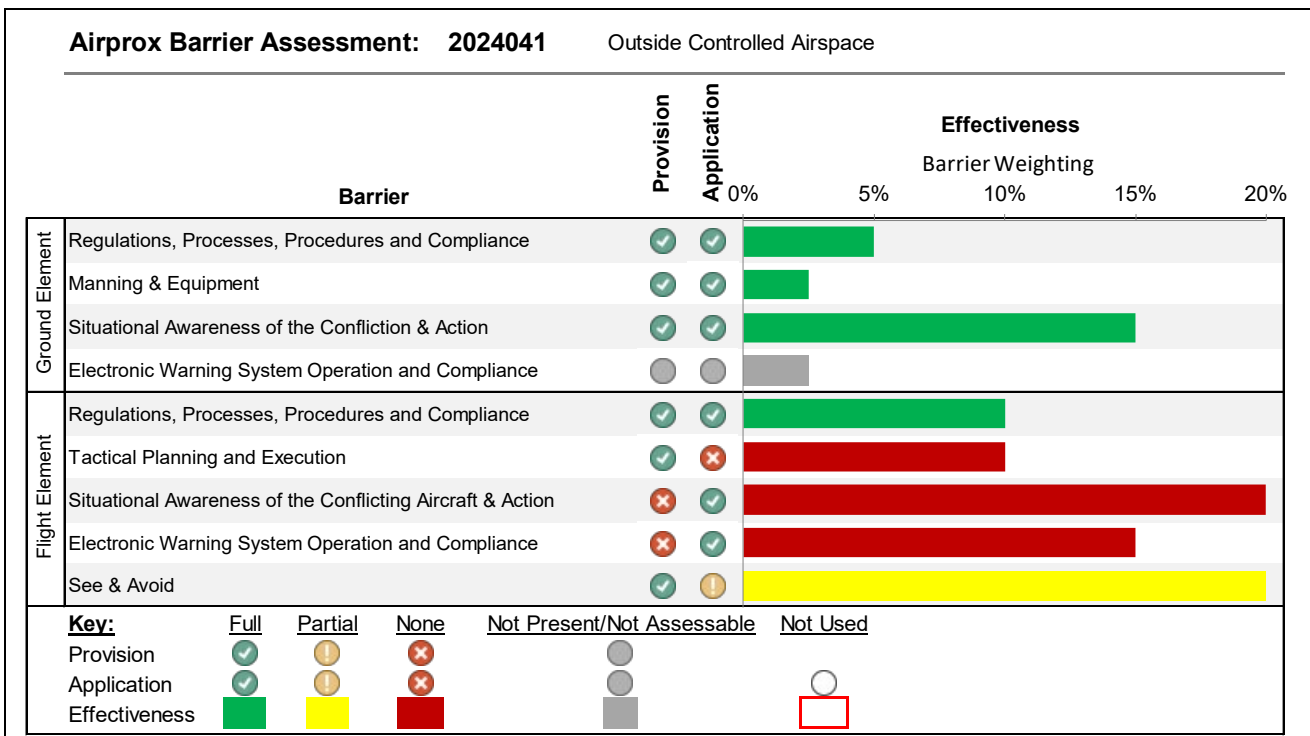
Tactical Planning and Execution was assessed as **ineffective** because the PA28 pilot had not fully prepared for an arrival at Leicester, had not joined the circuit in the preferred manner and had not conformed with the pattern of traffic formed by the C152.

Situational Awareness of the Conflicting Aircraft and Action were assessed as **ineffective** because the C152 pilot had only generic situational awareness of the joining PA28 and the PA28 pilot had no situational awareness of the presence of the C152.

Electronic Warning System Operation and Compliance were assessed as **ineffective** because the equipment carried by the PA28 had not been able to detect the electronic emissions from the C152.

See and Avoid were assessed as **partially effective** because the PA28 pilot had not seen the C152 prior to CPA.
