AIRPROX REPORT No 2024026

Date: 27 Feb 2024 Time: 1602Z Position: 5109N 00146W Location: Boscombe Down (406ft)

PART A: SUMMARY OF INFORMATION REPORTED TO UKAB

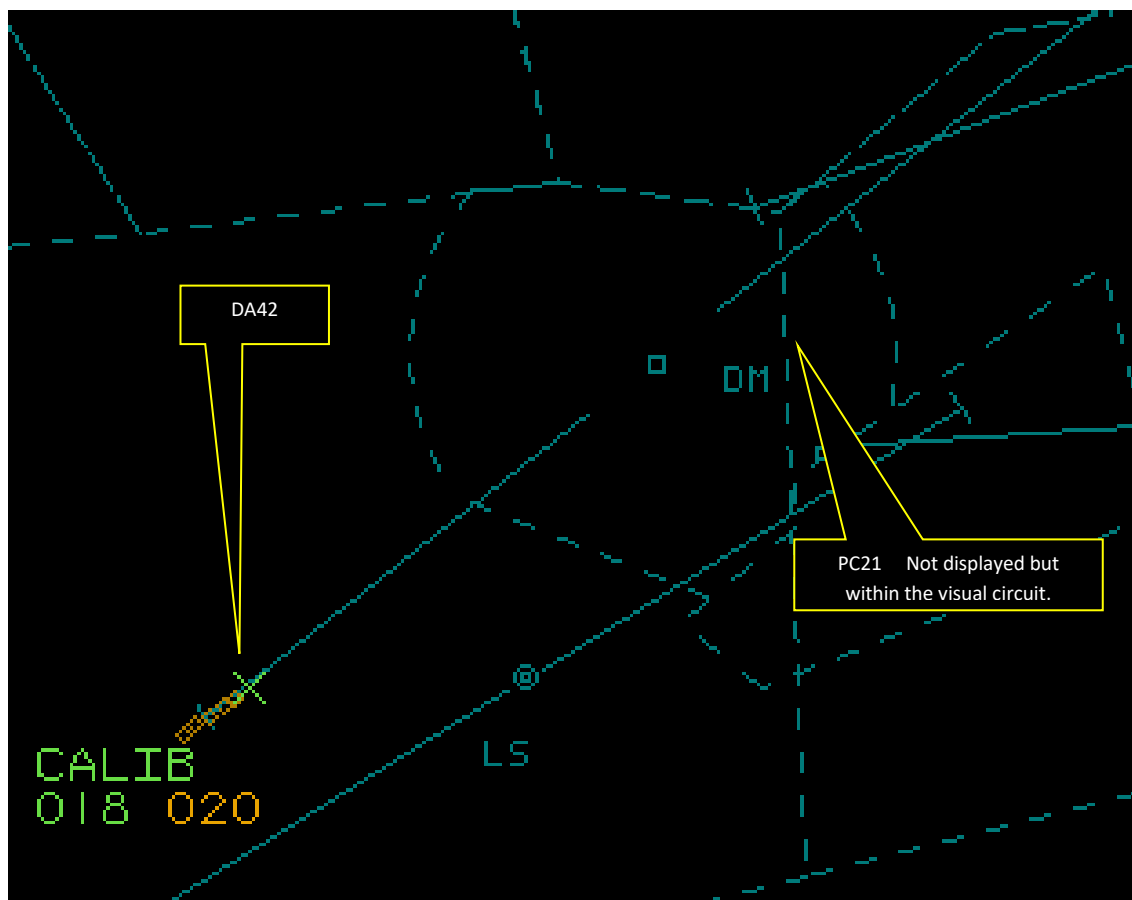
During the period of these phone calls, and unaware of the discussions regarding a change of intentions for the DA42, the Boscombe Down Approach controller provided the DA42 pilot with own navigation on two occasions, at 1554:35 and at 1555:28. However the DA42 pilot confirmed their intentions at 1557:35 with “*we are holding current position at two thousand*”. Whilst unable to identify a precise timing, the DA42 can be confirmed as established on an inbound profile to RW05 at 1559:15.

Figure 1 (1600:17): DA42 commences RW05 approach.
(DA42 5.3NM from Boscombe Down overhead)

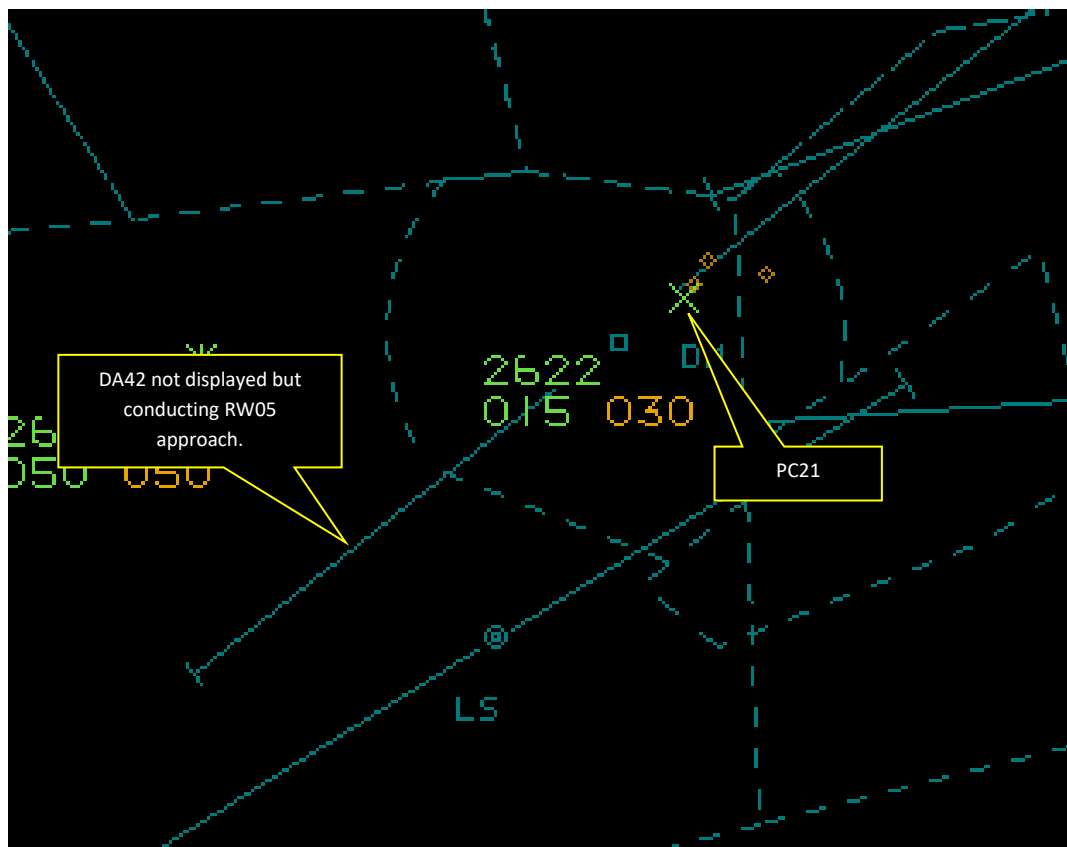
Figure 2 (1601:24): PC21 instructed to climb to 3000ft QFE.

The PC21 pilot acknowledged the broadcast call and requested confirmation that the DA42 was climbing to 2000ft QFE. The Boscombe Down Aerodrome controller confirmed the DA42’s height and then, at 1601:24, instructed the PC21 pilot to climb to 3000ft QFE, which the PC21 pilot acknowledged. The decision to climb the PC21 was based upon an assumption that whilst the DA42 was potentially approaching the out of use runway, the most suitable course of action was to climb the PC21 out of the visual circuit environment.

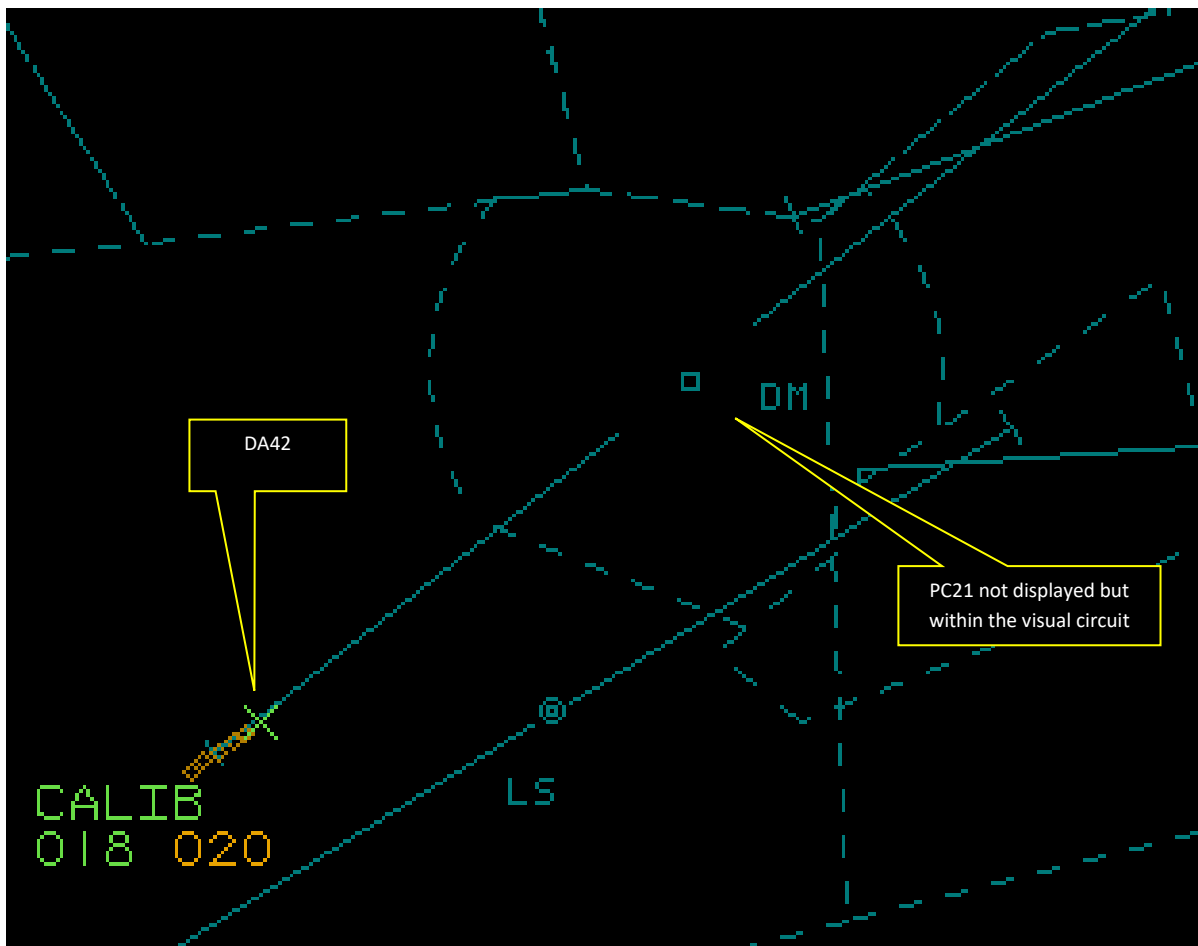
Figure 3 (1601:44): PC21 instructed to maintain circuit height.

At 1601:29, the Boscombe Down Supervisor called the Boscombe Down Aerodrome controller but was still talking in person with the Boscombe Down Approach controller. Therefore, the Boscombe Down Supervisor's instruction regarding the DA42 of *"Get him climbing, once he's level 2000ft then turn him outbound"* was heard by both the Boscombe Down Aerodrome and Approach controllers but only meant for the Boscombe Down Approach controller. This caused the Boscombe Down Aerodrome controller to confirm their in-action plan of climbing the PC21 to 3000ft with the Boscombe Down Supervisor. Aware of the head-to-head nature, the Boscombe Down Supervisor corrected the Boscombe Down Aerodrome controller, who subsequently instructed the PC21 pilot to maintain circuit height at 1601:44.

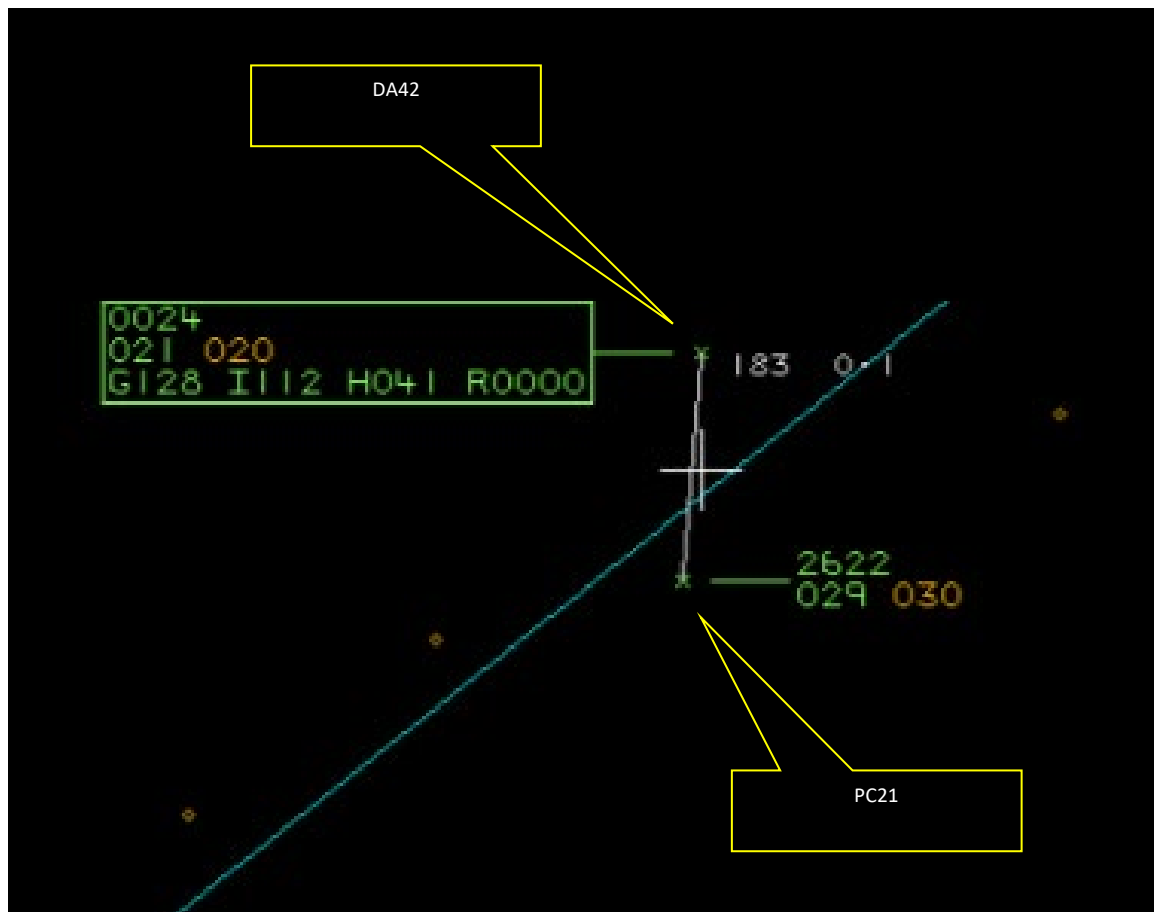
Figure 4 (1602:26). CPA.

CPA occurred at 1602:06 and was recorded as 0.1NM horizontal and 800ft vertical separation.
