AIRPROX REPORT No 2024036

Date: 24 Feb 2024 Time: 1227Z Position: 5255N 00255W Location: 1.5NM NW Ellesmere Lake

PART A: SUMMARY OF INFORMATION REPORTED TO UKAB

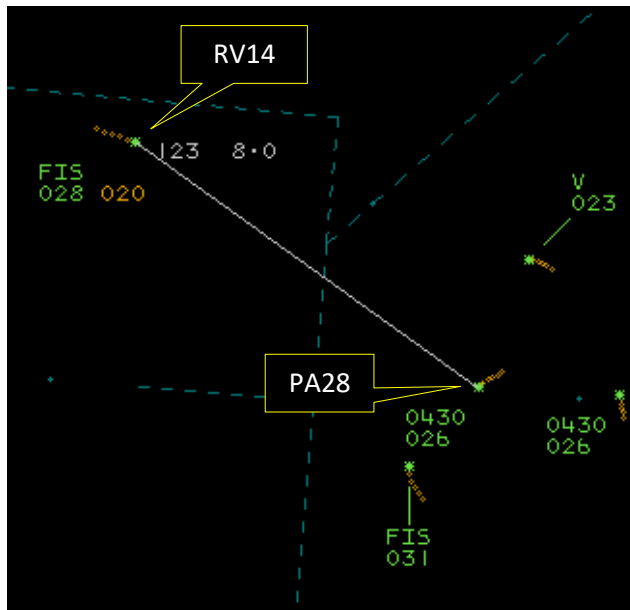
Figure 1 – 1224:00

By 1224:00 the RV14 pilot had changed track to the east and the aircraft were 8NM apart and still not a factor to each other (Figure 1).

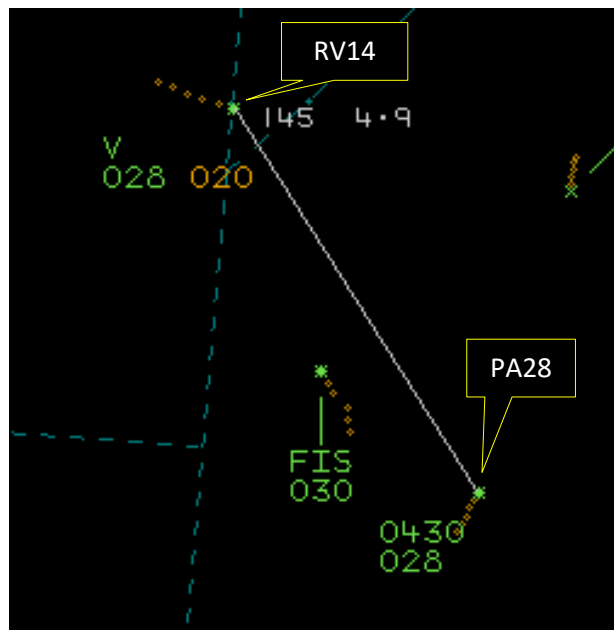
Figure 2 – 1225:30

At 1225:30 the PA28 pilot had turned onto a northeasterly track and there was 4.9NM between the two aircraft, with them indicating co-altitude (Figure 2).

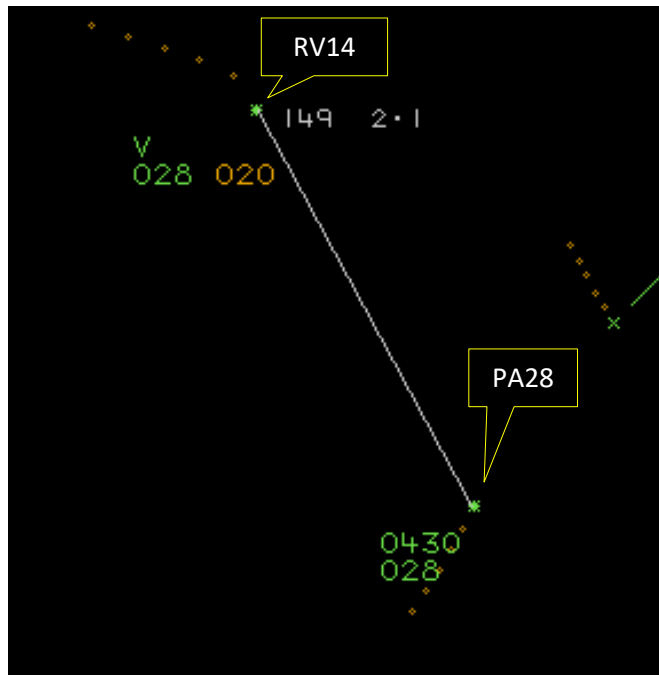
Figure 3 – 1226:30

By 1226:30 there was 2.1NM between the two aircraft, with them indicating co-altitude (Figure 3).

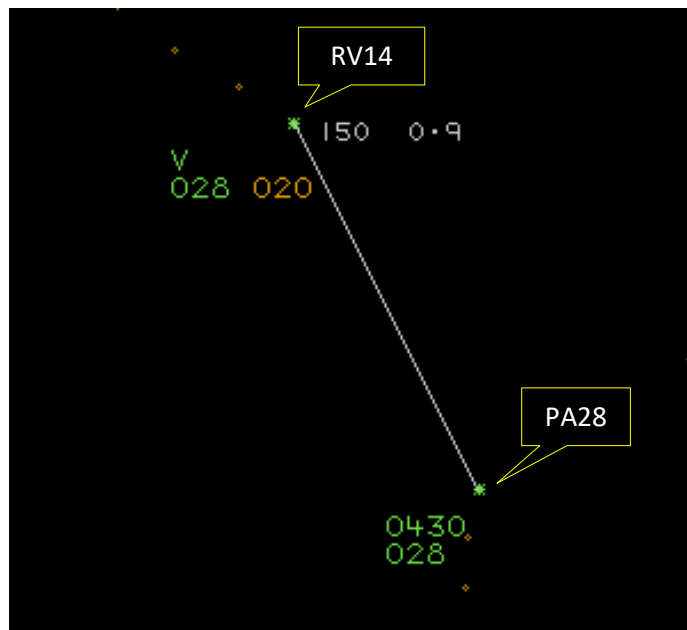
Figure 4 – 1226:50

At 1226:50 the pilot requested that the service be upgraded to a Traffic Service, and the pilot was instructed to squawk 0431 (Figure 4).

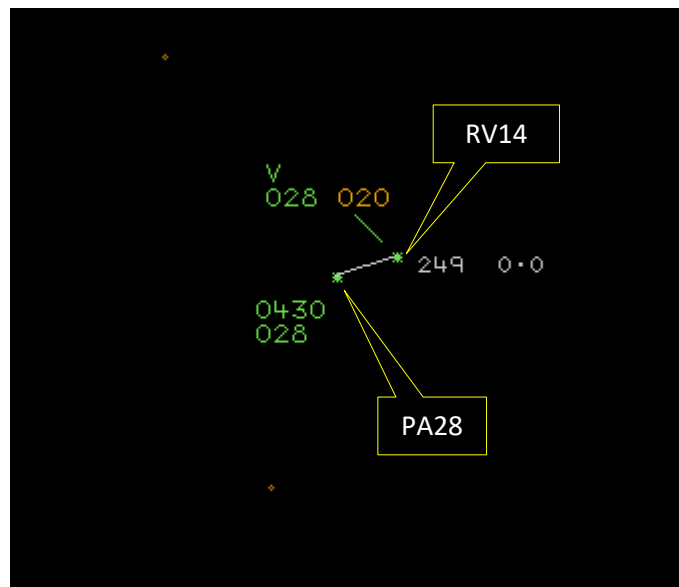
Figure 5 -1227:05 CPA

At 1227:05 CPA occurred with the lateral distance between the two aircraft displayed as 0.0NM and indicating co altitude. Of note is that the squawk had not yet changed to the allocated discrete squawk of 0431 i.e., the aircraft had not yet been identified and the service had not yet been upgraded to a Traffic Service (Figure 5).

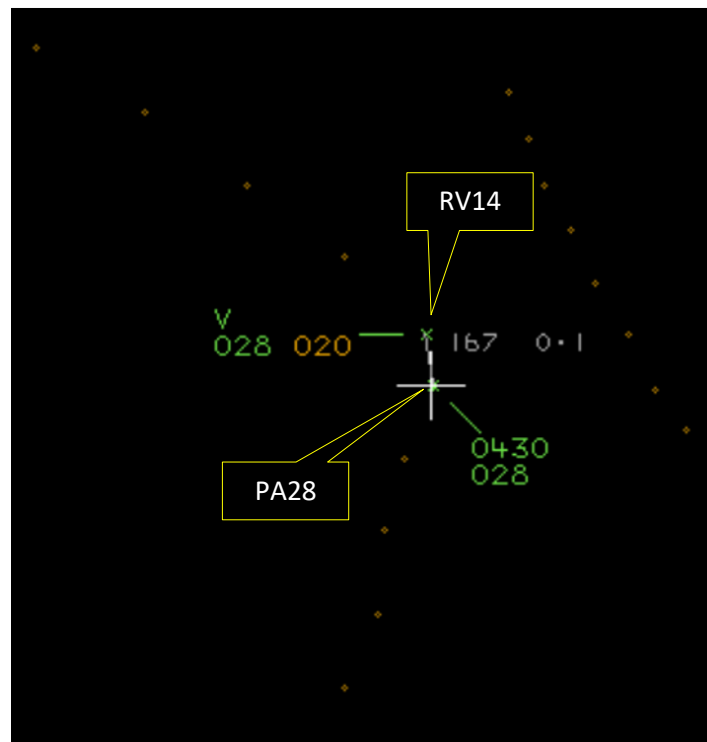
Figure 6 – CPA – 1227:08.

Both aircraft were positively identified on radar using Mode S data. The RV14 on track to their destination via Lake Ellesmere VRP and the PA28 on an instructional flight heading approximately north-northeast back to their base on a converging track (Figure 6). The separation displayed in ATSI’s CPA screenshot above could not be replicated.
