**AIRPROX REPORT No 2024016**

Date: 30 Jan 2024 Time: 1406Z Position: 5155N 00209W Location: Gloucestershire Airport ATZ

**PART A: SUMMARY OF INFORMATION REPORTED TO UKAB**

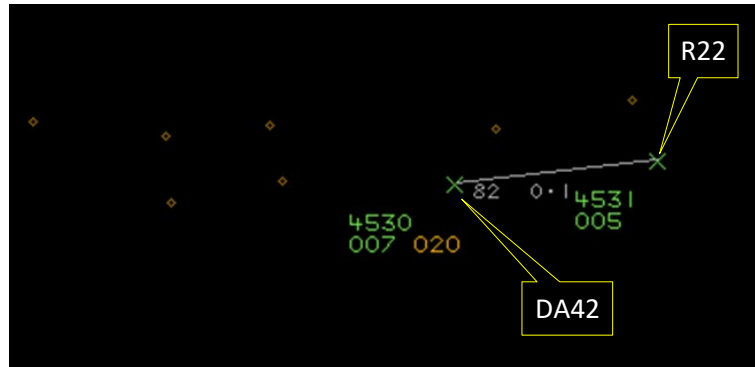
Figure 1 – 1405:42

The screenshots below are taken from the NATS radar replay system and the levels displayed are Flight Levels. The QNH entered into the radar display processor was 1030hPa, a difference of 459ft when converted to altitudes. The published aerodrome elevation at Gloucestershire Airport is 101ft and the RW27 threshold elevation is 87ft. The Gloucester MATS Part 2 states that helicopters operating in the RW27 helicopter circuit will be provided with the threshold QFE.

The published fixed-wing circuit height is 1000ft QFE and the published helicopter circuit height is not above 750ft QFE. Flight Level-to-height calculations indicate that the helicopter circuit height was exceeded by the R22 pilot.

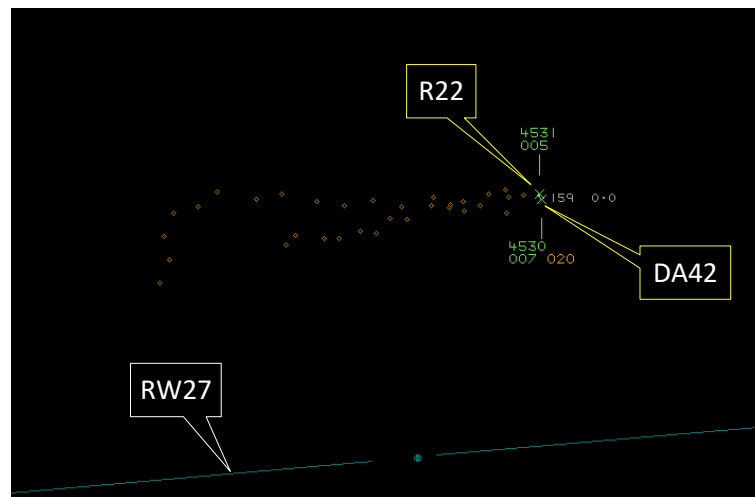
Figure 4 – CPA at 1450:51

An analysis of the NATS radar replay was undertaken and both aircraft could be positively identified from Mode S data (Figure 4). Both aircraft were depicted on the radar replay as having flown at Flight Levels. A suitable correction was used to determine the aircraft altitudes (based upon a QNH of 1030hPa from the METAR observed at Gloucestershire Airport 14min after CPA). The diagram was constructed and separation at CPA determined from the radar data.

By taking the Flight Level data from the radar replay and the pressure from the nearest METAR observation, members calculated that the pilot of the R22 had exceeded the vertical limit of the helicopter circuit by approximately 100ft. It was therefore agreed that the pilot of the R22 had not complied with the published procedure (**CF4**). Members also agreed that, in the execution of their circuit, they had not remained below the maximum permitted height (**CF5**).
