AIRPROX REPORT No 2024018

Date: 01 Feb 2024 Time: 1406Z Position: 5257N 00034W Location: Barkston Heath ATZ

PART A: SUMMARY OF INFORMATION REPORTED TO UKAB

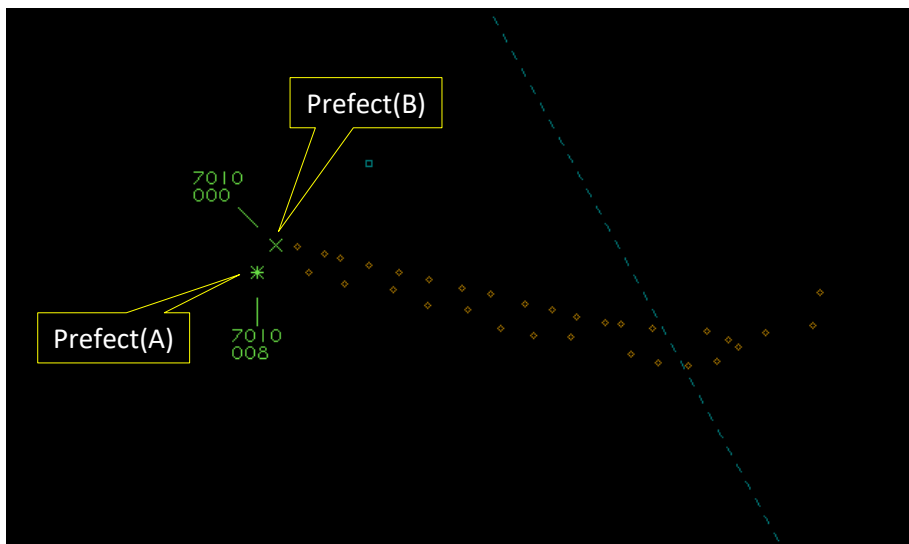
Figure 1 – CPA at 1405:47

From [the Barkston Tower controller's] perspective, the aircraft had a small amount of lateral separation and approximately 400-500ft of vertical separation.

An analysis of the NATS radar replay was undertaken and both aircraft could be positively identified from Mode S data (Figure 1). The diagram was constructed and the separation at CPA determined from the radar data.
