**AIRPROX REPORT No 2024023**

Date: 12 Feb 2024 Time: 1659Z Position: 5120N 00055W Location: 2.5NM west of Blackbushe

**PART A: SUMMARY OF INFORMATION REPORTED TO UKAB**

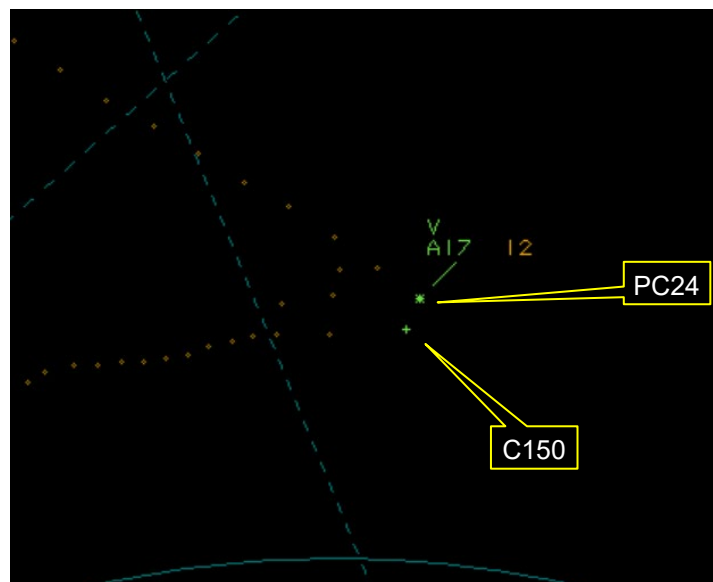
CPA – NK V/<0.1NM H 1659:23

The C150 and PC24 pilots shared an equal responsibility for collision avoidance and not to operate in such proximity to other aircraft as to create a collision hazard.<sup>1</sup> If the incident geometry is considered as converging then the PC24 pilot was required to give way to the C150.<sup>2</sup>
