**AIRPROX REPORT No 2024079**

Date: 06 May 2024 Time: ~1509Z Position: 5249N 00212W Location: IVO Seighford Airfield

**PART A: SUMMARY OF INFORMATION REPORTED TO UKAB**

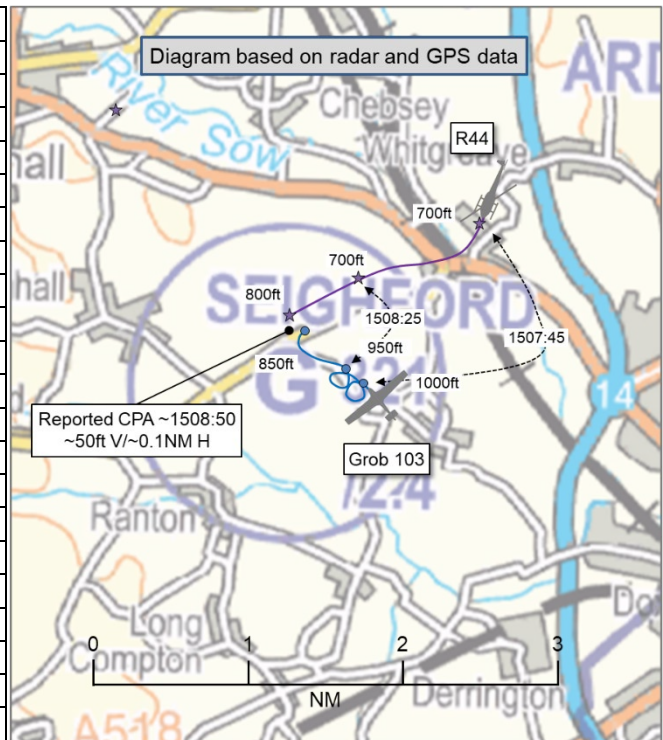
| Recorded | Aircraft 1 | Aircraft 2 |
|---|---|---|
| Reported | 200ft V/100m H | 500ft V/>1.0NM H |
| Recorded | ~50ft V/~0.1NM H | |

The Grob 103 had not been carrying a transponder and appeared on radar only momentarily as a primary contact ahead of the reported CPA. The diagram on page 1 was constructed using radar data for the R44 and GPS-derived data for the Grob 103.

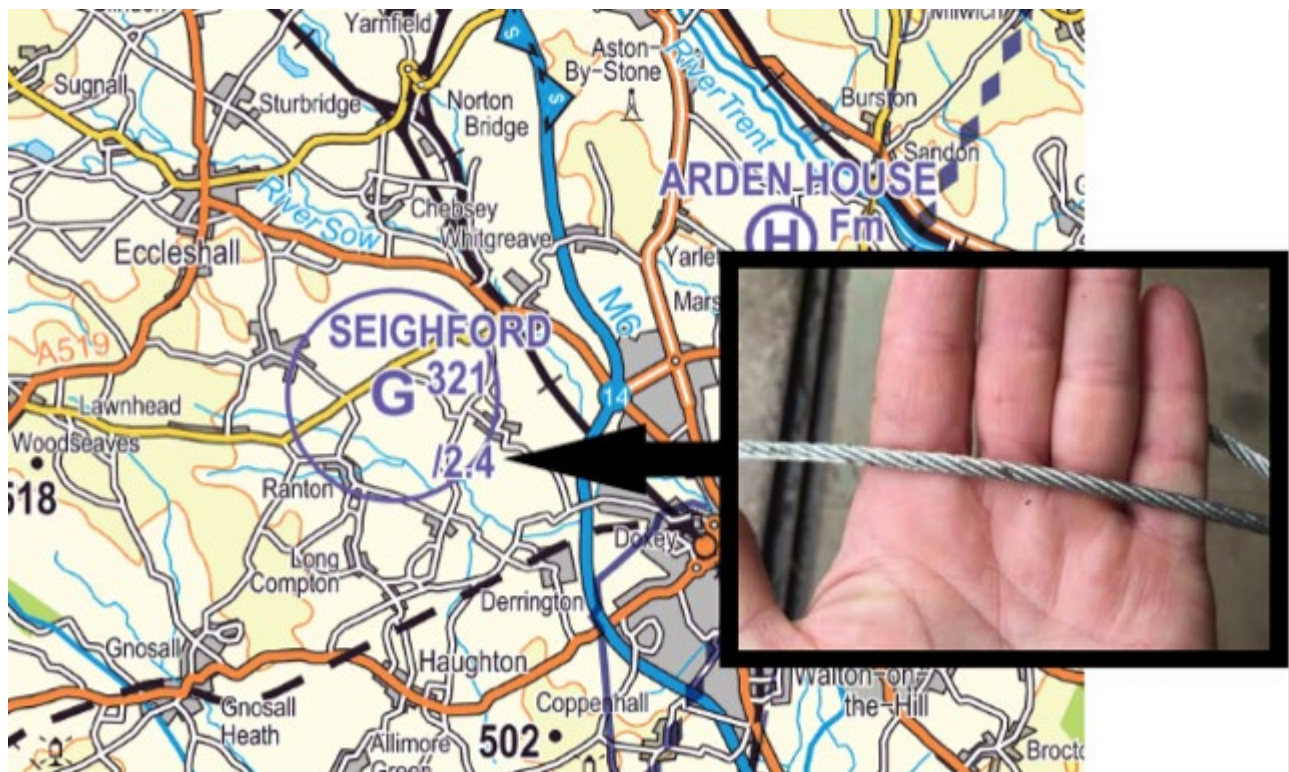
Figure 2: UK 1:250,000 Chart

UK glider launch sites (including Seighford) are listed in UK AIP ENR 5.5 and labelled on the CAA 1:500,000 and 1:250,000 charts with a "G" symbol, as shown in Figure 2. A greater density of gliders may be expected nearby at any time during daylight hours, and at any altitude up to cloudbase. Where winch launching is used, the maximum winch launch altitude is listed in the AIP and marked on the chart; this is 2400ft AMSL at Seighford, as indicated by the black arrow. Overflying a winch site below this altitude during daylight hours risks encountering high tensile strength cable (as pictured) connecting a launching glider to the winch on the ground.

Despite having access to a widely-used moving map navigation application (running on their mobile phone), the R44 pilot does not report seeing a warning as they flew through the circuit of an active gliding site below its notified maximum winch launch altitude. It would be useful to understand why.

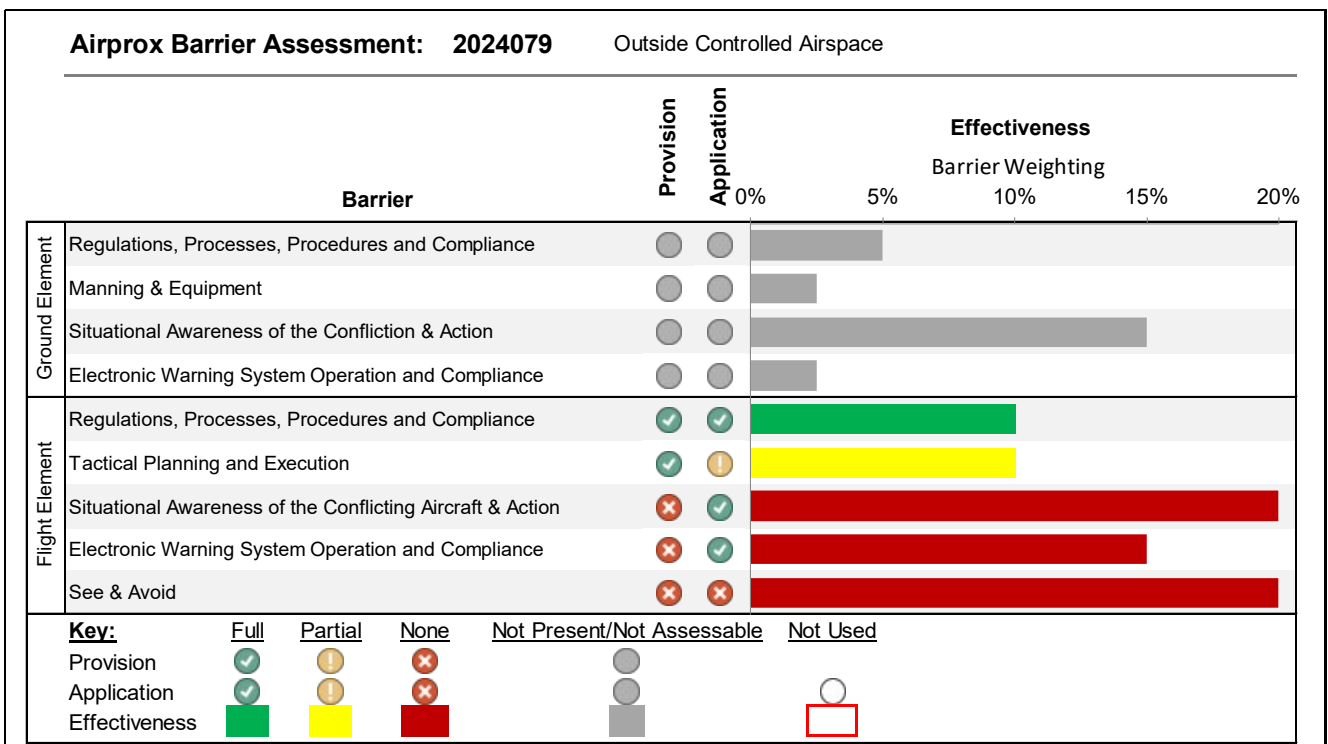
**Tactical Planning and Execution** was assessed as **partially effective** because the R44 pilot’s pre-flight briefing had led to them flying through a promulgated and active glider site at an altitude that increased the likelihood of an encounter with a glider.

**Situational Awareness of the Conflicting Aircraft and Action** were assessed as **ineffective** because neither the Grob 103 pilot nor the R44 pilot had any situational awareness of the presence of the other aircraft.

**Electronic Warning System Operation and Compliance** were assessed as **ineffective** because the equipment carried by the Grob 103 had not been able to detect any emissions from the R44.

**See and Avoid** were assessed as **ineffective** because neither pilot had effectively gained visual contact with the other aircraft before CPA.
