AIRPROX REPORT No 2024075

Date: 04 May 2024 Time: 1042Z Position: 5228N 00020W Location: 3NM W of Peterborough/Conington

PART A: SUMMARY OF INFORMATION REPORTED TO UKAB

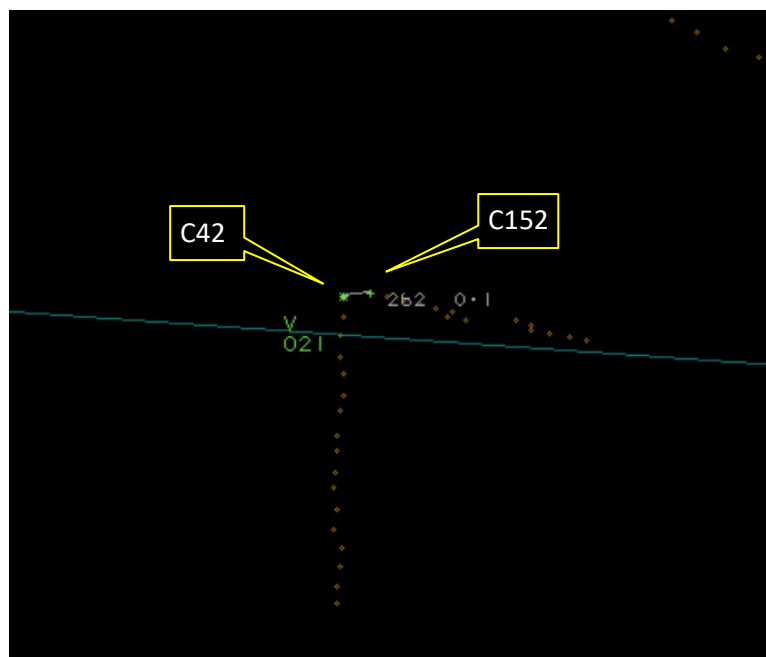
Figure 1: CPA minus 2sec (1041:50). The C152 Primary return disappeared at 1041:52.
