AIRPROX REPORT No 2024069

Date: 30 Apr 2024 Time: 0930Z Position: 5135N 00031W Location: Denham ATZ

PART A: SUMMARY OF INFORMATION REPORTED TO UKAB

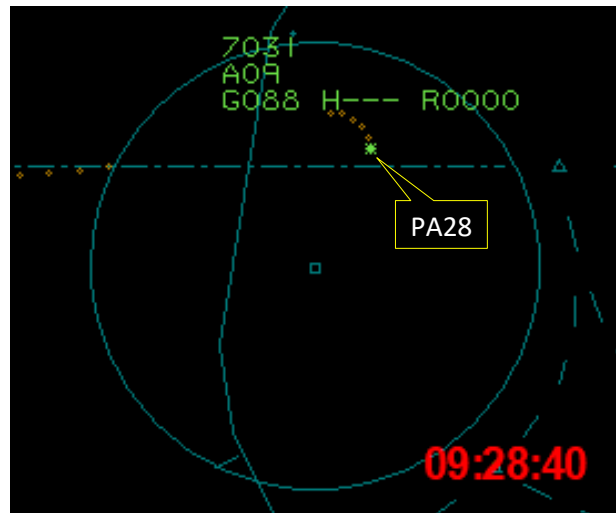
Figure 1 – 0928:40

The LL SVFR controller cleared the pilot of [the PA28] to transit the zone as per their route request, not above altitude 1200ft VFR at 0928:40, which was read-back correctly by the pilot (Figure 1).

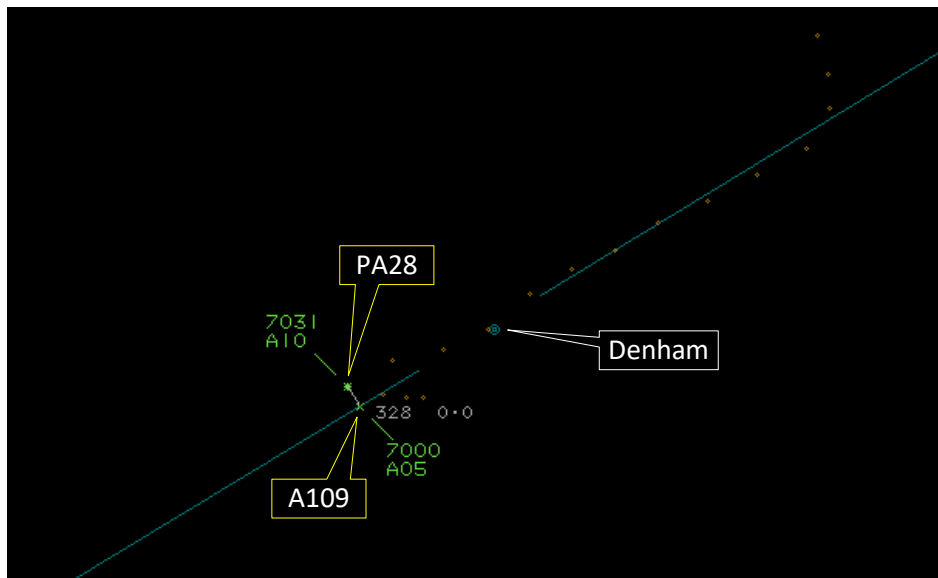
Figure 2 – CPA at 0929:56

[The pilot of the] AW109 departed Denham displaying Mode A 7000 (VFR conspicuity) and was first displayed on the NODE multi-track radar at 0929:50. The Closest Point of Approach was recorded as 0.0NM and 500ft (Figure 2).

The conflict was not observed by the LL SVFR sector team at the time of the event and they were not responsible for effecting any separation with the pending departure of [the A109]. The pilot of [the PA28] was subsequently issued a Radar Control Service at 0930:07.
