AIRPROX REPORT No 2024068

Date: 26 Apr 2024 Time: 1126Z Position: 5136N 00009E Location: 3NM south of Stapleford

PART A: SUMMARY OF INFORMATION REPORTED TO UKAB

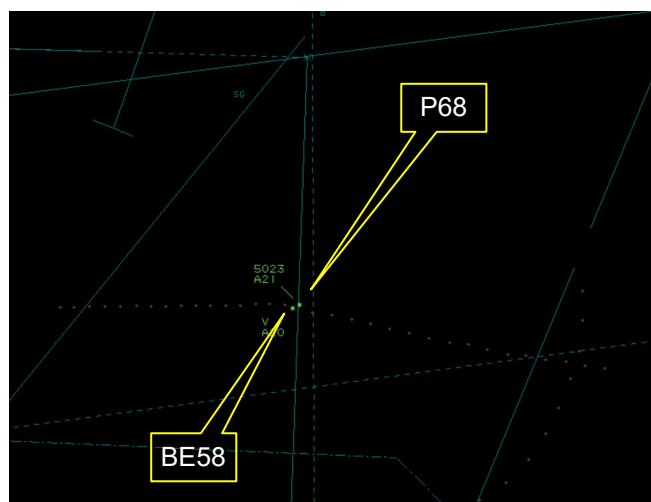
The radar displayed the Mode C of the BE58 which had then climbed to altitude 2100ft at 1125:51 with 0.7NM lateral distance from the P68. The Mode C of the P68 displayed descent to altitude 2100ft with 0.3NM lateral distance at 1125:59. Radar replay had not indicated any lateral or vertical manoeuvre to avoid. The BE58 displayed a slight left turn and subsequent descent to 2000ft. The pilot of the P68 had not reported the conflict on the frequency.

Figure 1: CPA + 1sec – CPA at 1126:05 100ft V/ <0.1 NM
