AIRPROX REPORT No 2024067

Date: 20 Apr 2024 Time: ~1148Z Position: 5346N 00106W Location: Thorpe Wood, Selby

PART A: SUMMARY OF INFORMATION REPORTED TO UKAB

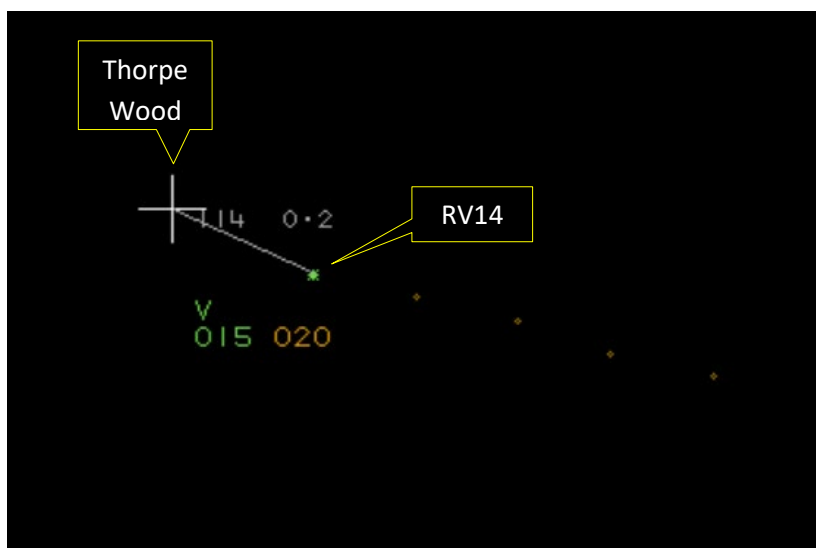
An analysis of the NATS radar replay was undertaken, and the RV14 was positively identified using Mode S data, passing over the reporting point at a similar height and time stated in the ASW20 pilot's narrative (Figure 1).

Figure 1 – Time 1148:11 the RV14 at 0.2NM from Thorpe Wood (the reported point of CPA)

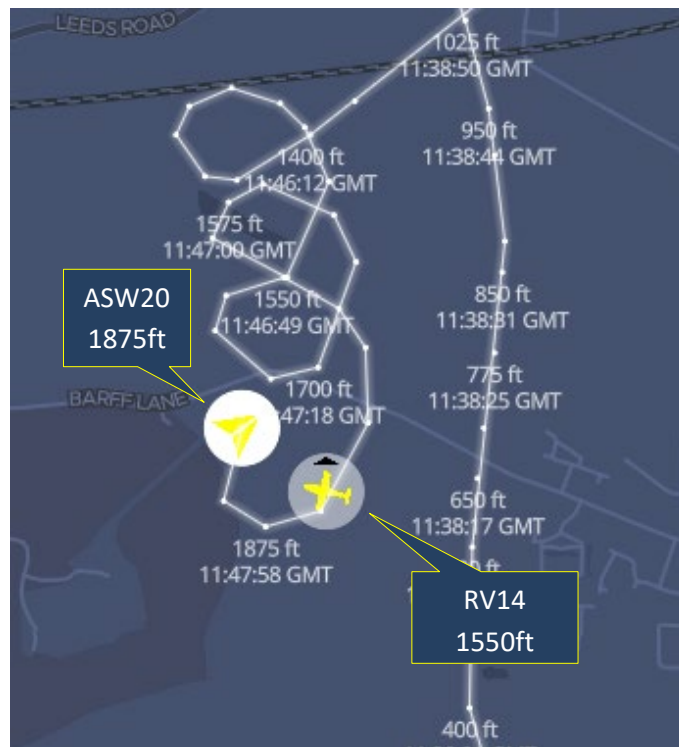
Both aircraft were identified by ADS-B, but the ASW20 did not appear on the radar replay. The track and altitude of the RV14 displayed on radar replay were coincident with the ADS-B output (Figure 2).

Figure 2 – Time ~1148:11 CPA

Thorpe Wood, Selby is 1NM to the east of Sherburn-in-Elmet's ATZ on the approach to RW28. The aircraft altitudes in Figures 1 and 2 are based on 1013hPa. The point of CPA was calculated as around 1148:11 as the ASW20 was manoeuvring clockwise through the northerly position of its next orbit.
