AIRPROX REPORT No 2024065

Date: 26 Apr 2024 Time: 1023Z Position: 5211N 00002W Location: 3NM E Gransden Lodge

PART A: SUMMARY OF INFORMATION REPORTED TO UKAB

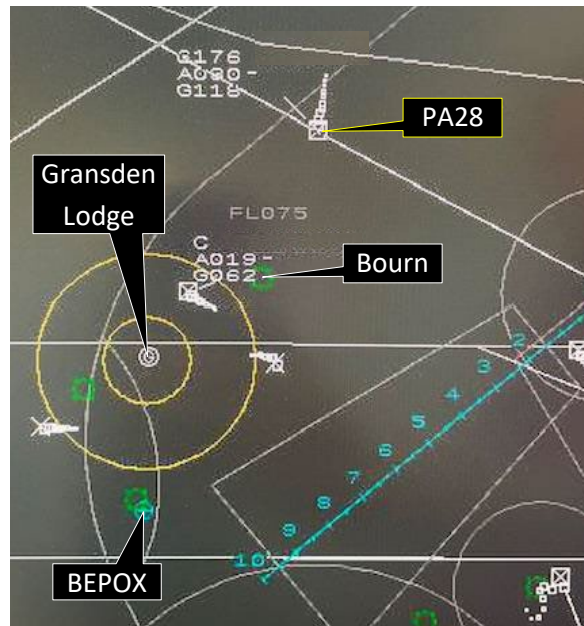
Figure 1 – The position of the PA28 at 1020:43

[The pilot of the PA28] was approximately 8NM NW of Cambridge and reported general handling complete, ready for their instrument approach. They were upgraded to a Procedural Service, given a change of squawk to 6177 and given a direct track to BEPOX. The pilot was reminded that Gransden Lodge was notified as active with ten gliders and was asked to "keep a lookout".

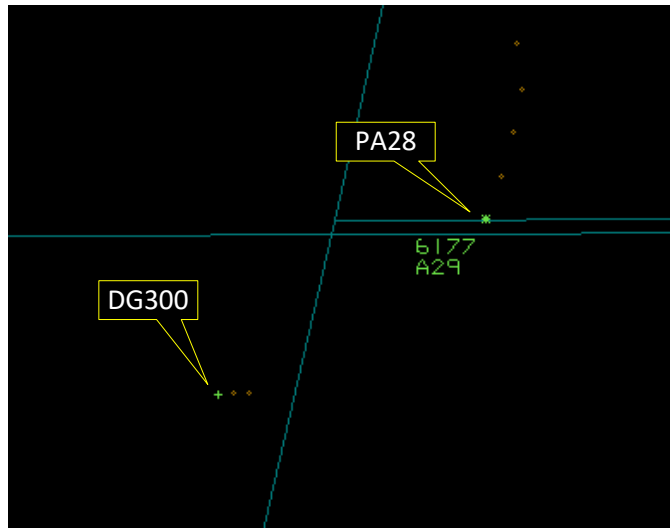
An analysis of the NATS radar replay was undertaken and the PA28 could be positively identified from Mode S data. The DG300 could not be positively identified. However, a primary-only contact was briefly observed on radar at a position that, by reference to GPS track data kindly supplied by the DG300 pilot, was assessed to have been the DG300 (Figure 3).

Figure 3 - 1023:10. A primary-only contact (assessed to have been the DG300) appeared for a few seconds.

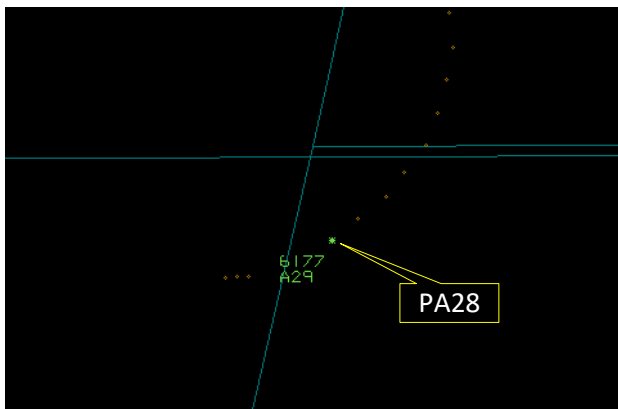
Figure 4 – 1023:26

The diagram was constructed and the separation at CPA determined by combining the data sources. The moment of CPA was assessed to have occurred between the radar sweeps at 1023:26 and 1023:30 (See Figures 4 and 5). The altitude of the PA28 was observed to have changed between those sweeps and, consequently, the altitude of the PA28 has been shown as an approximation in the diagram.
