**AIRPROX REPORT No 2024059**

Date: 21 Apr 2024 Time: 1129Z Position: 5217N 00052W Location: 2.5NM W of Sywell

**PART A: SUMMARY OF INFORMATION REPORTED TO UKAB**

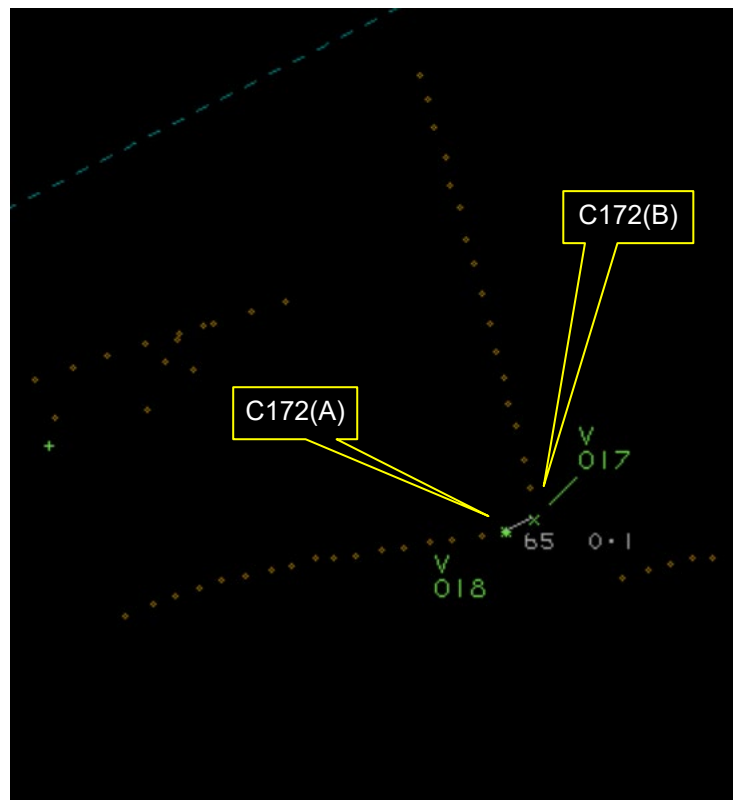
Figure 1: CPA 1129:02 100ft V/<0.1NM H

The C172(A) and C172(B) pilots shared an equal responsibility for collision avoidance and not to operate in such proximity to other aircraft as to create a collision hazard.<sup>1</sup> If the incident geometry is considered as converging then the C172(B) pilot was required to give way to the C172(A).<sup>2 3</sup>
