AIRPROX REPORT No 2024054

Date: 13 Apr 2024 Time: 1422Z Position: 5152N 00118W Location: Oxford Kidlington ATZ

PART A: SUMMARY OF INFORMATION REPORTED TO UKAB

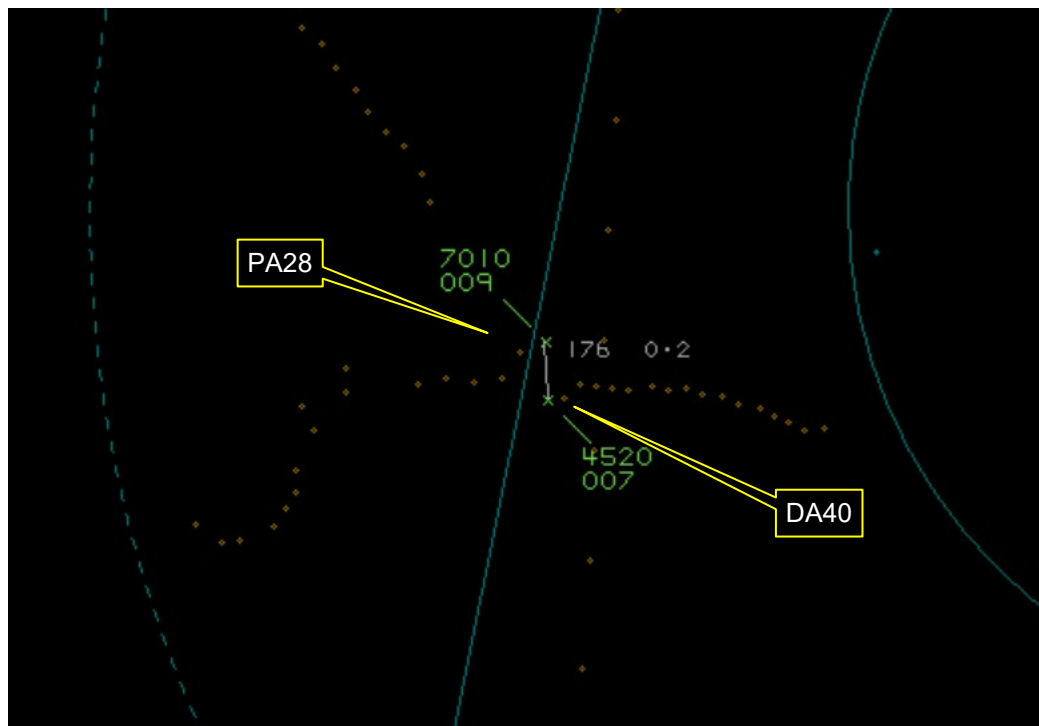
Misidentification of aircraft in the circuit by the instructor pilot on board the PA28.

The Oxford investigation report appears to highlight a mis-identification of the DA40 by the PA28 pilot. The RT had been standard, and the controller had been within their right to assume that when the PA28 pilot had reported visual with the traffic they were given (on left base), that the pilot had correctly identified it. There may be a discussion as to whether technically the PA28 had been number 3, which might have highlighted that there were two ahead, one of which being the misidentified aircraft on short final. The unit itself is unable to determine if that aircraft had effectively completed its approach by this time meaning there would have been only 2 remaining in the circuit at the time of the incident. That being said, the PA28 pilot had been told that the one ahead was on left-base and not final.

Figure 1: CPA 1421:50 200ft V/0.2NM H

Event to be utilised for unit training (pending approval from those involved).
