## **AIRPROX REPORT No 2024048**

Date: 08 Apr 2024 Time: 1044Z Position: 5712N 00209W Location: Aberdeen

# PART A: SUMMARY OF INFORMATION REPORTED TO UKAB

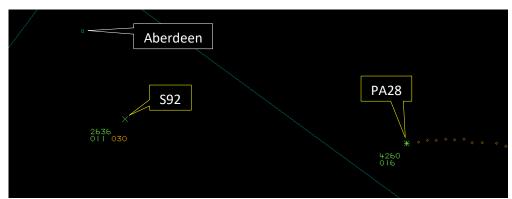
Figure 1 – Aircraft positions at 1043:04

An analysis of the NATS radar replay was undertaken and both aircraft could be positively identified from Mode S data. The S92 first appeared on the radar replay at 1043:04 (Figure 1).

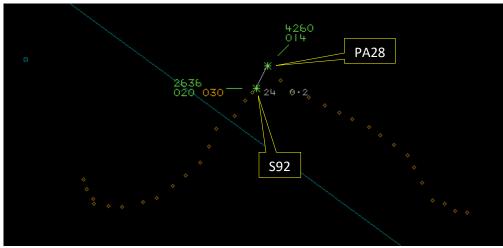
Figure 2 – CPA at 1044:08

The diagram was constructed and the separation at CPA determined from the radar data (Figure 2).

The S92 and PA28 pilots shared an equal responsibility for collision avoidance and not to operate in such proximity to other aircraft as to create a collision hazard.<sup>1</sup>

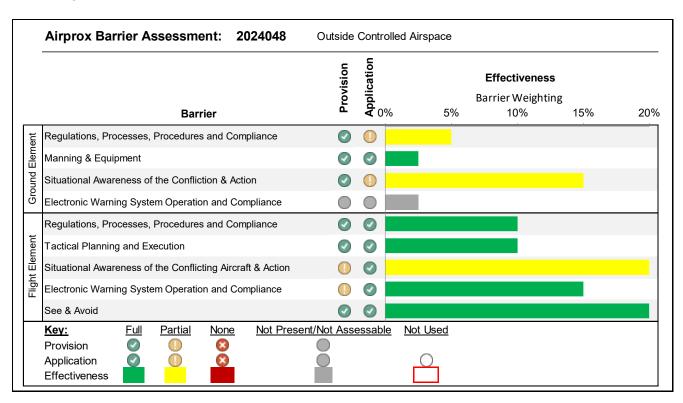
In assessing the effectiveness of the safety barriers associated with this incident, the Board concluded that the key factors had been that:

**Regulations, Processes, Procedures and Compliance** were assessed as **partially effective** because the Aberdeen Tower controller had not complied with the requirement to have passed Traffic Information on the S92 to the pilot of the PA28.

**Situational Awareness of the Confliction and Action** were assessed as **partially effective** because the instructions passed by the Aberdeen Tower controller had contributed to the reduction in the separation between the S92 and PA28.

Situational Awareness of the Conflicting Aircraft and Action were assessed as partially effective because the pilot of the PA28 had only generic situational awareness of the presence of the S92.
