AIRPROX REPORT No 2024109

Date: 02 Jun 2024 Time: 1234Z Position: 5131N 00409W Location: 6NM SSW of Swansea Airport

PART A: SUMMARY OF INFORMATION REPORTED TO UKAB

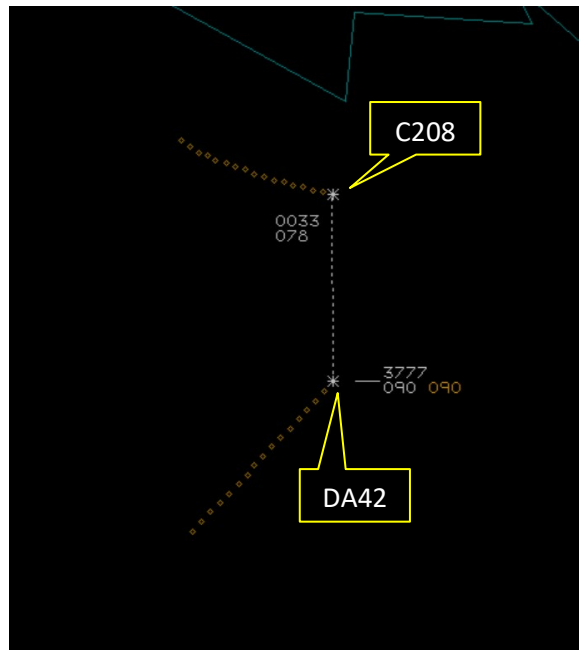
An analysis of the NATS radar replay was undertaken. The DA42 was positively identified using Mode S data throughout. The C208 was also identified with aircraft data from 1226:31. The first STCA between the DA42 and the C208 occurred at 1232:47 (Figure 1), which became a warning at 1233:31.

Figure 1 – Time 1232:47 separation on first radar screen alert 2.4NM.

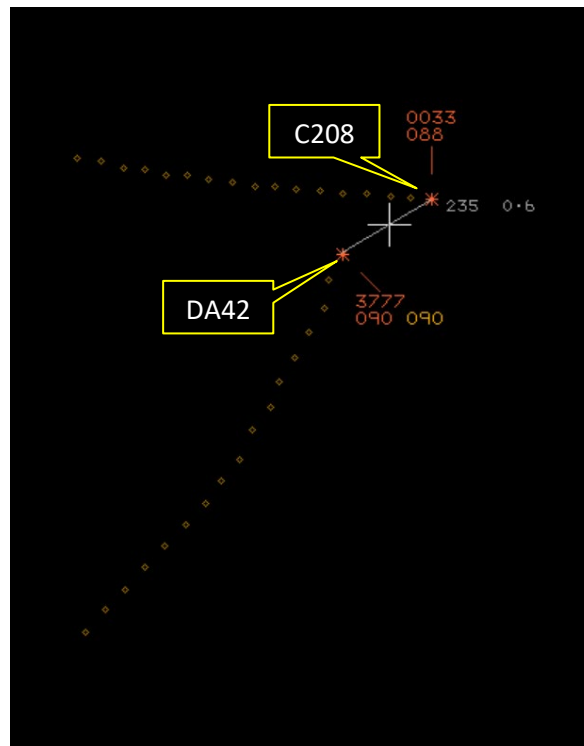
The DA42 manoeuvred left and behind the C208 and the CPA was determined as occurring at 1233:43 with 200ft vertical and 0.6NM horizontal separation (Figure 2).

Figure 1 – Time 1233:43 separation at CPA was 200ft and 0.6NM.
