AIRPROX REPORT No 2024111

Date: 05 Jun 2024 Time: 0733Z Position: 5203N 00036W Location: Cranfield

PART A: SUMMARY OF INFORMATION REPORTED TO UKAB

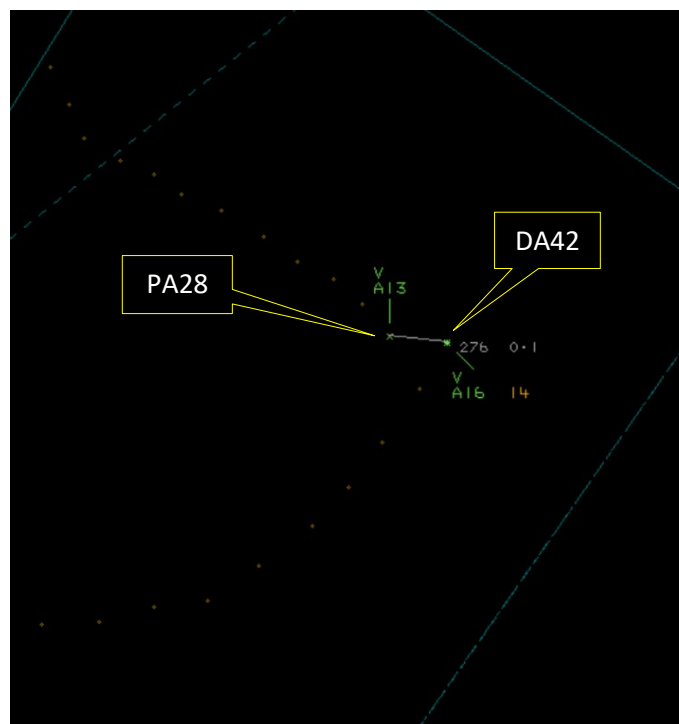
An analysis of the NATS radar replay was made and both aircraft were positively identified using Mode S data. CPA was determined to have been at 0733:02 (Figure 1).

Figure 1 -Time 0733:02 separation at CPA 300ft and 0.1NM
