AIRPROX REPORT No 2024112

Date: 04 Jun 2024 Time: 1020Z Position: 5154N 00210W Location: Gloucestershire Airport

PART A: SUMMARY OF INFORMATION REPORTED TO UKAB

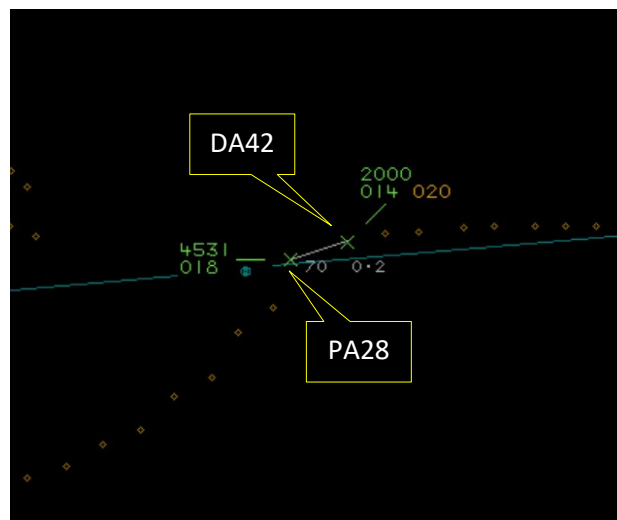
The DA42 pilot was performing an instrument approach with a go-around and practise EFATO on RW27, while the PA28 pilot approached from the southwest towards the RW27 threshold (Figure 1).

Figure 1 - Time 1019:42 separation 400ft and 0.2NM

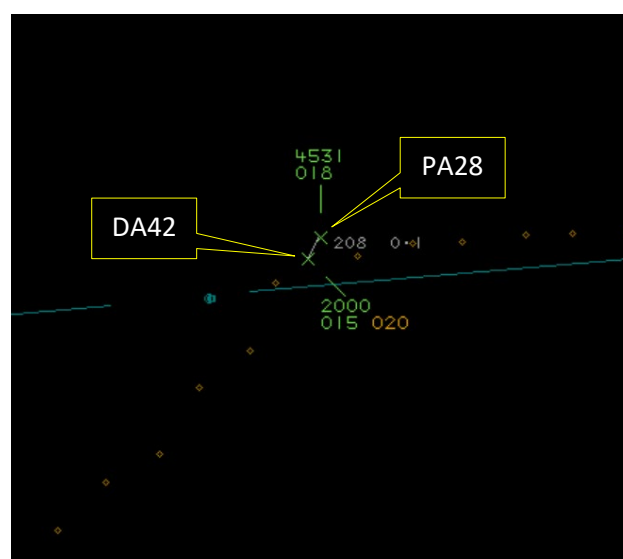
The next radar sweep was at 1019:46 after the PA28 had passed the DA42, diverging, with 300ft vertical and 0.1NM horizontal separation (Figure 2).

Figure 2 - Time 1019:46 separation 300ft and 0.1NM

CPA was assessed to have been at 1019:44 with approximately 350ft vertical and less than 0.1NM horizontal separation, after which the PA28 commenced a right-hand turn to the deadside for a standard overhead join for RW27 right-hand (Figure 3).
