AIRPROX REPORT No 2024089

Date: 10 May 2024 Time: ~1644Z Position: 5409N 00114W Location: 6NM ESE of Topcliffe

PART A: SUMMARY OF INFORMATION REPORTED TO UKAB

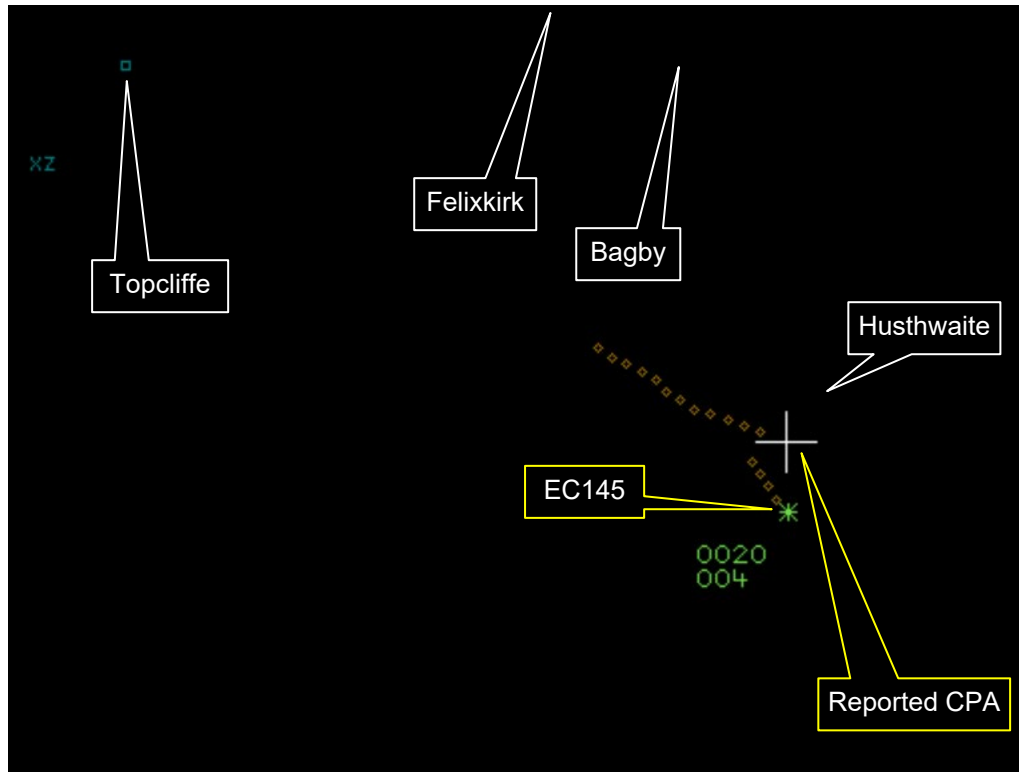
Figure 1: Reported CPA ~1644:10

The EC145 was tracked via radar and identified through Mode S data. The Biplane did not appear on radar or other proprietary aircraft tracking systems and could not be traced. Figure 1 shows the EC145 track – a distinctive right turn was recorded at or around the point at which the pilot reported sighting the Biplane. Also shown are the relative positions of the clutch of airfields commented on in the same report.
