**AIRPROX REPORT No 2024093**

Date: 20 May 2024 Time: 1620Z Position: 5412N 00113W Location: 1.5NM S Sutton Bank

**PART A: SUMMARY OF INFORMATION REPORTED TO UKAB**

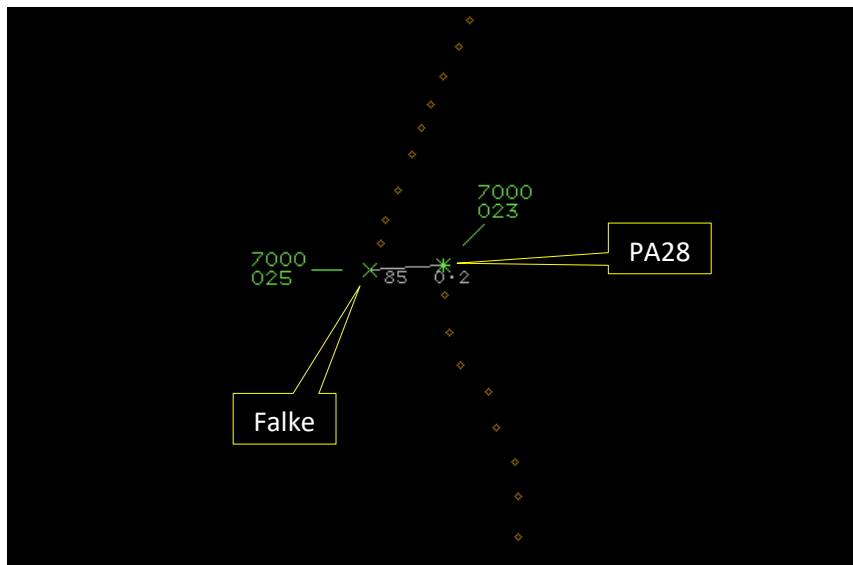
Figure 1 – CPA at 1620:27

An analysis of the NATS radar replay was undertaken. The PA28 was positively identified from Mode S data. The Falke was identified by reference to the pilot's report (Figure 1). Both aircraft were depicted on the radar replay as having been at Flight Levels. The pilot of the Falke kindly supplied GPS track data for their flight. The diagram was constructed and the separation at CPA determined by combining the data sources.

Concluding the discussion, members agreed that, although the radar replay had indicated that the horizontal separation at CPA had been 0.2NM, the actual separation may have been notably less given the accepted limitations of the radar system. Indeed, members noted that the pilot of the Falke had estimated the separation to have been 50m. Although the exact measurement of horizontal separation at CPA could not be resolved by members as having been 50m or 0.2NM, members agreed that safety margins had reduced much below the norm and were satisfied that there had been a risk of collision (CF6). It was further agreed that it had been the emergency action taken by the Instructor in the Falke that had increased separation at the last minute. As such, the Board assigned Risk Category B to this event.

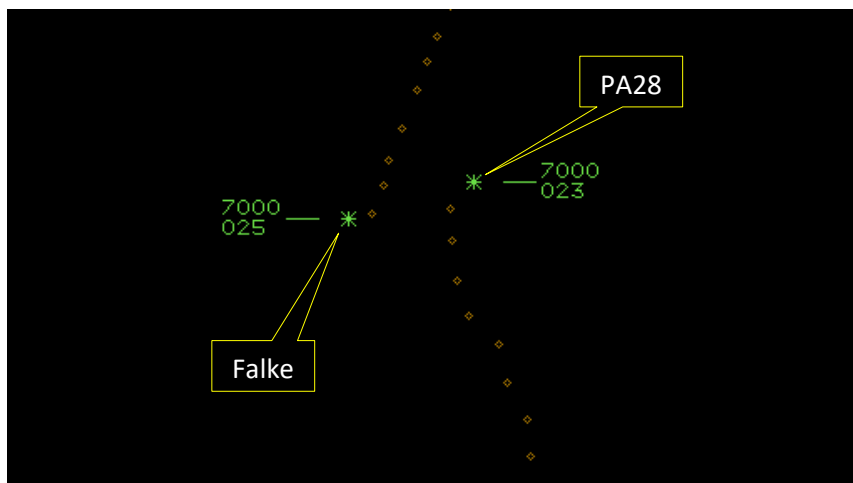
Figure 2 – After CPA

Both pilots appeared to have altered course to the right, as shown on the radar replay after CPA (Figure 2).

Turning their attention to the actions of the pilot of the PA28, members noted from their narrative report that they had recalled the southbound leg of their journey through the area rather than the northbound leg which had occurred approximately an hour later. Members surmised that the PA28 pilot had either not been aware of the encounter with Falke on their northbound leg, or that they had not considered the encounter with the Falke as having been particularly noteworthy. Members noted from the radar replay that the track of the PA28 appeared to have deviated to the right at the moment that the Falke

had passed left-abeam the PA28 at the moment of CPA. Therefore, members agreed that the pilot of the PA28 had not sighted the Falke until CPA and agreed that that effectively constituted a non-sighting (CF5).
