**AIRPROX REPORT No 2024094**

Date: 19 May 2024 Time: 1607Z Position: 5535N 00521W Location: Dougarie Point, Isle of Arran

**PART A: SUMMARY OF INFORMATION REPORTED TO UKAB**

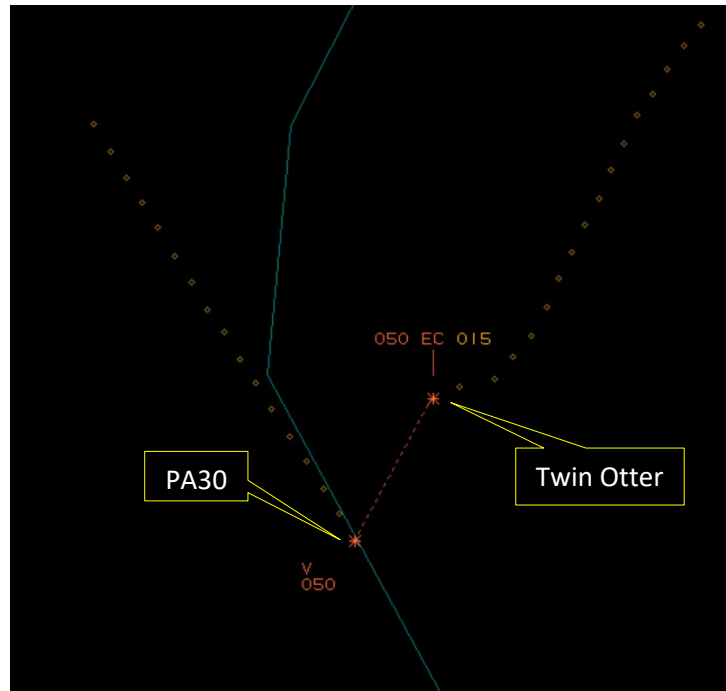
An analysis was made of the radar replay and both aircraft were positively identified using Mode S data. The radar was set with the LON QNH at 1013hPa and the time of CPA was determined as 1606:42 (Figure1).

Figure 1- Time 1606:42 separation 0ft and 1.0NM at CPA
