AIRPROX REPORT No 2024099

Date: 24 May 2024 Time: 1122Z Position: 5157N 00117W Location: 5NM N Weston-on-the-Green

PART A: SUMMARY OF INFORMATION REPORTED TO UKAB

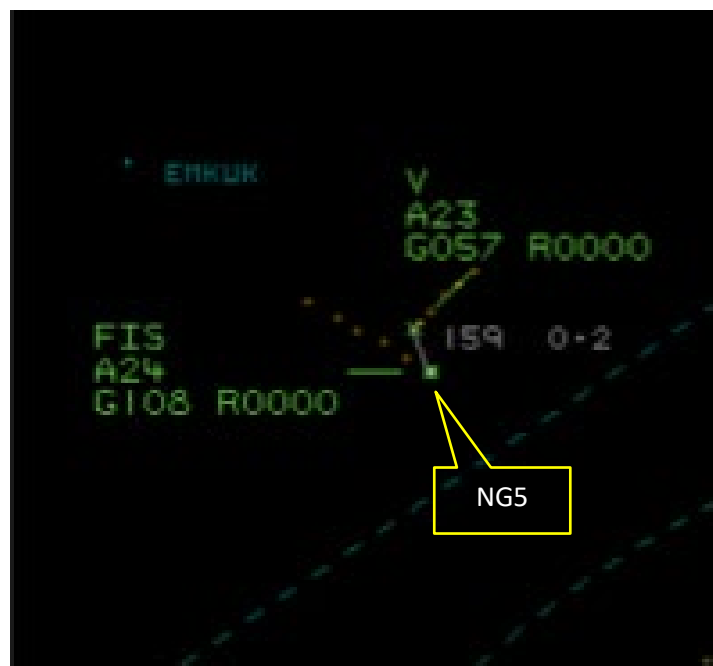
Figure 1

At 1121:26, 7.6NM north of Oxford Airport, an aircraft squawking 7000 (identified using Mode-S data as [uninvolved C/S]) passed 0.2NM behind [NG5 C/S] (FIS in the image) at the same level, as shown in Figure 1. This aircraft was a red and white Slingsby T61F Venture, low-wing, and was not in receipt of a Service from the London FISO. Neither aircraft was observed on radar to have made an avoidance manoeuvre.

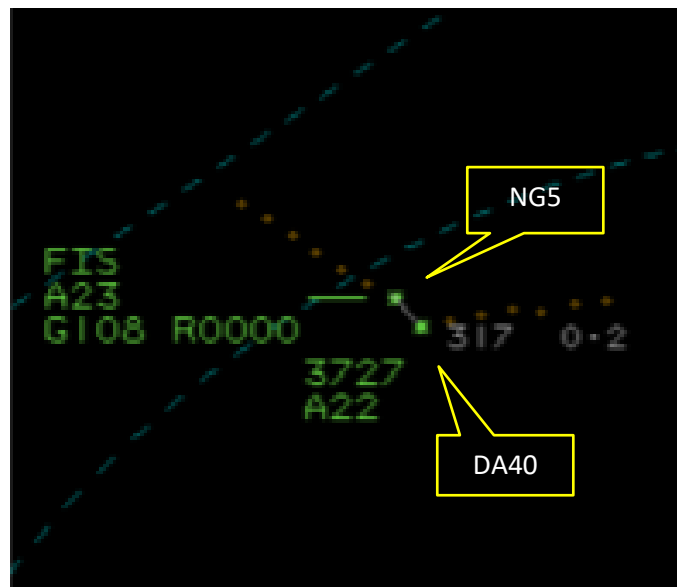
Figure 2

Shortly after this, at 1122:18 another aircraft, squawking 3727 (Brize Norton frequency monitoring code) crossed left-to-right 0.2NM ahead of [NG5 C/S] and 100ft below, 6.9NM NNE of Oxford Airport, as shown in Figure 2. This equated to a distance of around 5NM north of Weston-on-the-Green. The other aircraft was identified by Mode S as [DA40 C/S], a Diamond DA40, high t-tail prop, in white and blue. Neither aircraft was observed on radar to have made an avoidance manoeuvre.

It is assessed that, as the other aircraft involved was described as having a t-tail by the NG5 pilot and given the location, the conflict with the [DA40 C/S] was most probable to be the one referred to by the NG5 pilot.

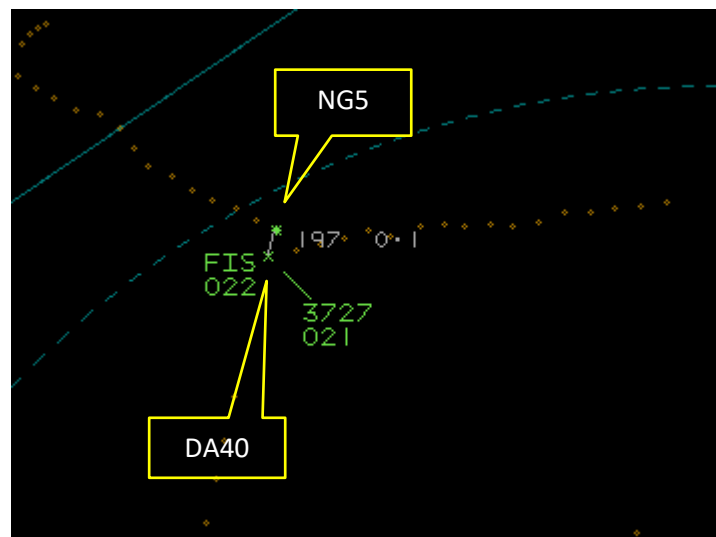
Figure 3 - 1122:23

An analysis of the NATS radar replay was undertaken and both aircraft could be identified using Mode S information. Allowing the radar to run on one further sweep beyond that in the NATS ATC

investigation radar screenshot at Figure 2, put the two aircraft at 100ft and 0.1NM apart, although by this time the DA40 had crossed ahead of the NG5.

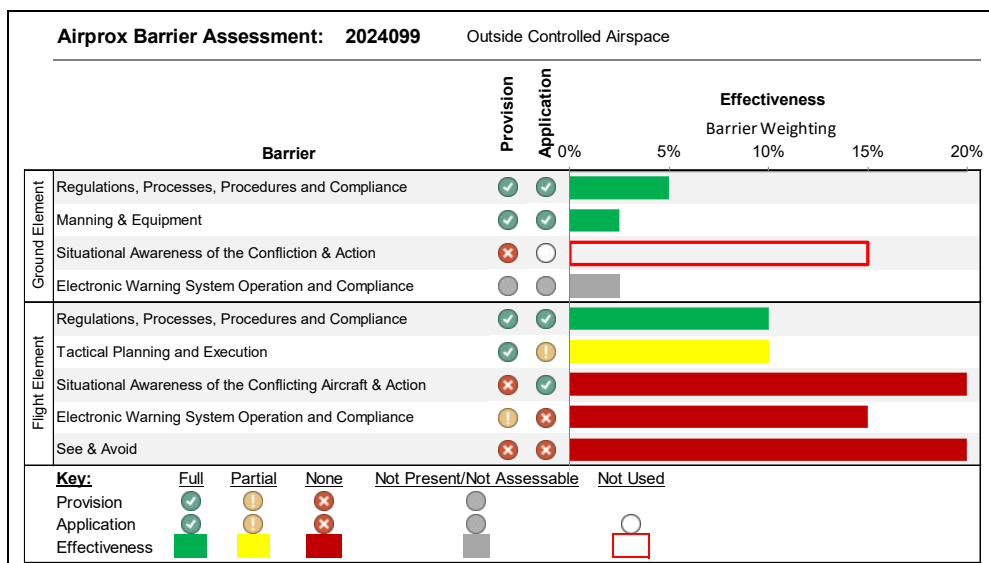
Situational Awareness of the Confliction and Action were assessed as **not used** because the London Information FISO was not required to monitor the Basic Service traffic and operates without surveillance equipment.

Tactical Planning and Execution was assessed as **partially effective** because the DA40 pilot could have called Brize Radar for an ATS, rather than just monitor the frequency. Likewise, the NG5 pilot could also have requested a radar service from Brize Radar, which may have provided Traffic Information. Alternatively, with their relative position from the Oxford feathers and within 10NM of the airfield, both pilots could have called Oxford with their intentions.

Situational Awareness of the Conflicting Aircraft and Action were assessed as **ineffective** because neither pilot had been aware of the other aircraft in the vicinity.

Electronic Warning System Operation and Compliance were assessed as **ineffective** because although it would have been expected that the CWS on the NG5 would have alerted to the DA40, it had not.

See and Avoid were assessed as **ineffective** because both pilots reported being distracted by in-cockpit activities which resulted in an effective non-sighting by the NG5 pilot and a non-sighting by the DA40 pilot.
