AIRPROX REPORT No 2024100

Date: 27 May 2024 Time: 1301Z Position: 5133N 00051W Location: Near Henley-on-Thames

PART A: SUMMARY OF INFORMATION REPORTED TO UKAB

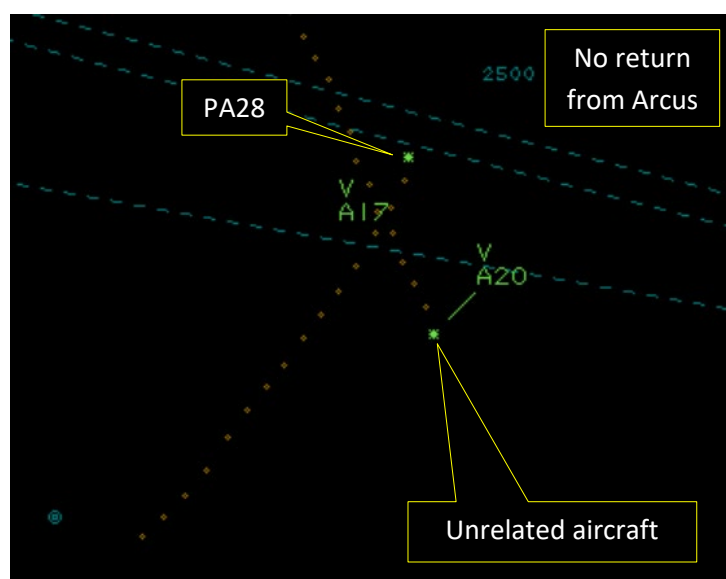
An analysis of the NATS radar replay was undertaken and neither aircraft could be positively identified. However, both aircraft tracks were available via ADS-B and those for the PA28 matched returns on the radar replay (Figure 1).

Figure 1 Time 1301:18 primary radar track to CPA.

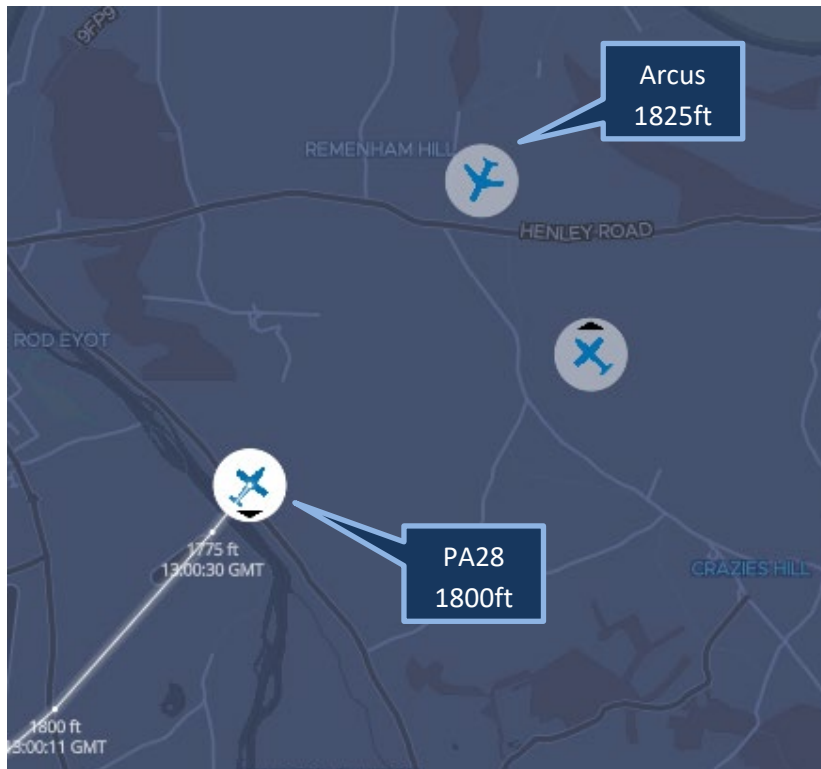
The ADS-B data is based on 1013hPa, with both aircraft positively identified prior to CPA (Figure 2).

Figure 2 -Time 1301:01. Pre-CPA separation 1.1NM and 25ft.

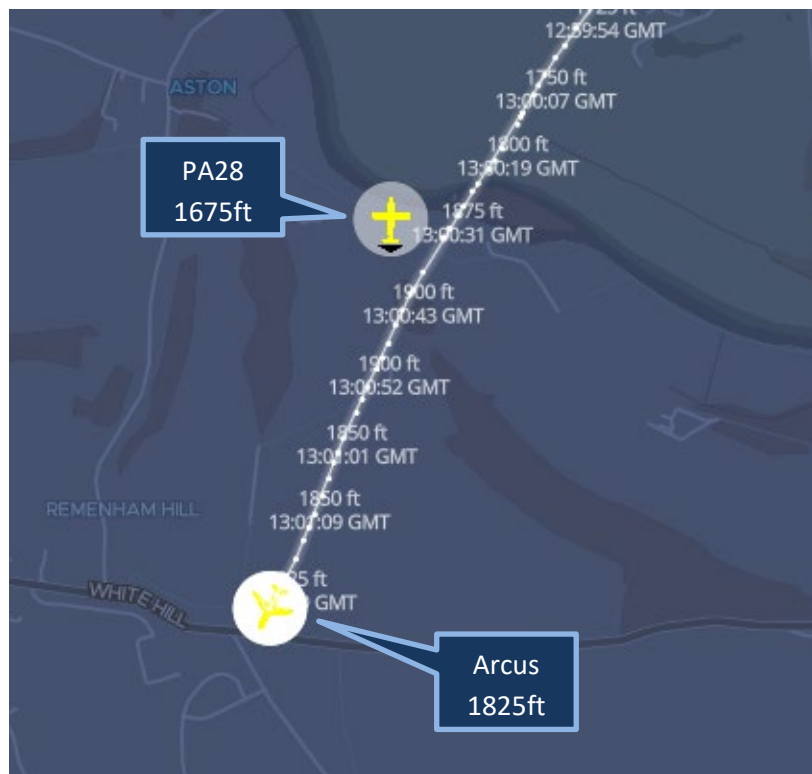
The next combined ADS-B data collection time occurred after CPA, and the Arcus track was clearly defined at approximately 12sec intervals (Figure 3).

Figure 3 – Time. 1301:25. Post CPA separation 0.6NM and 150ft.
