AIRPROX REPORT No 2024105

Date: 31 May 2024 Time: 1534Z Position: 5158N 00013E Location: 5NM NNW of Stansted

PART A: SUMMARY OF INFORMATION REPORTED TO UKAB

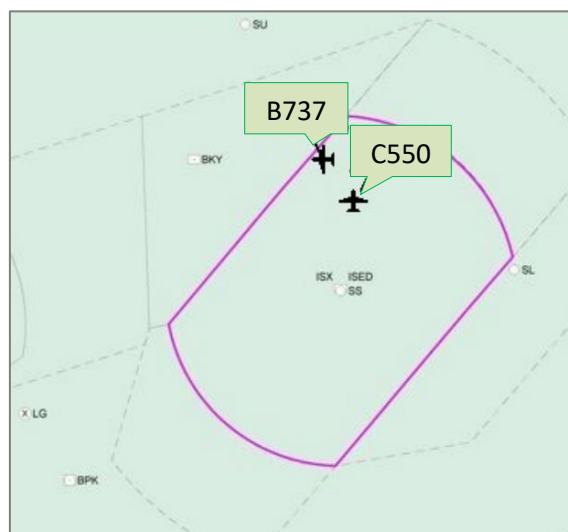
Figure 1 – Stansted Event Map Image.

THE STANSTED RADAR CONTROLLER reports that the [C550] departed Stansted on a NUGBO departure climbing to 5000ft on the standard instrument departure. They were instructed to maintain 5000ft and fly heading 325°. The aircraft was observed climbing to 5300ft under the [B737] which was at 6000ft. Avoiding action was given to [the C550 pilot to turn] onto a heading of 360° and maintain 5000ft.

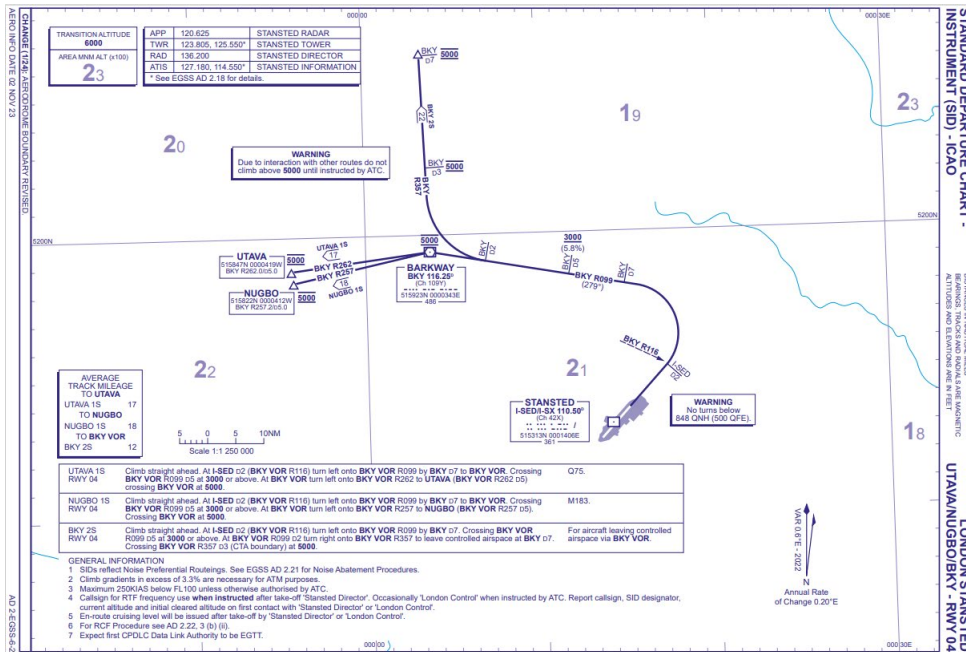
Figure 2 – Stansted NUGBO Standard Instrument Departure RW04

A [C550] departed Stansted on a NUGBO1S SID (Figure 2) climbing to 5000ft. The Stansted Final Director observed [the C550] climb to 5300ft below [the B737] maintaining 6000ft resulting in a loss of separation. The controller issued avoiding action to the pilot of [the C550] and instructed them to maintain 5000ft; [The C550 pilot] had already initiated descent to, and subsequently maintained, 5000ft.

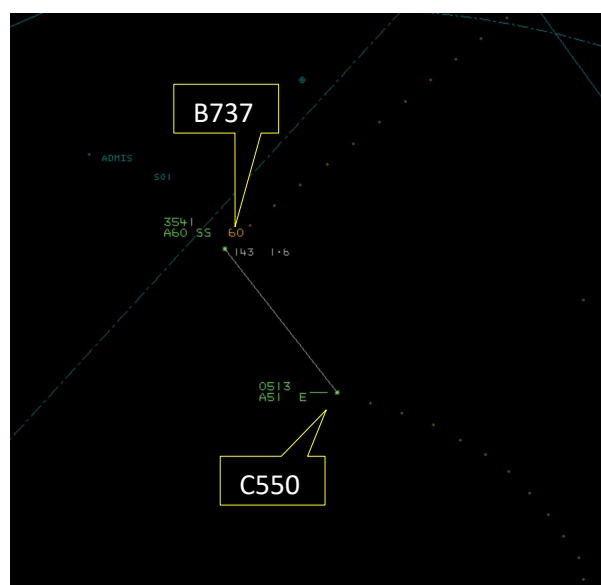
Figure 3 – Time 1533:34 Initial loss of separation.

An analysis of the NATS radar replay was undertaken, where both aircraft were identified using Mode S data and were visible throughout. The initial erosion of separation was recorded at 1533:34 (Figure 3).

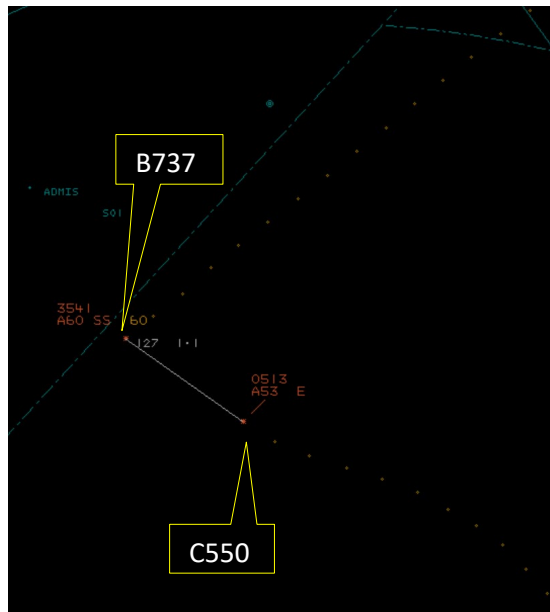
Figure 4 – Time 1533:43 separation at CPA 1.1NM 700ft

CPA was determined as 1533:43 with 1.1NM horizontal and 700ft vertical separation (Figure 4).
