AIRPROX REPORT No 2024107

Date: 02 Jun 2024 Time: ~1113Z Position: 5209N 00128W Location: 1.7NM NW Shenington

PART A: SUMMARY OF INFORMATION REPORTED TO UKAB

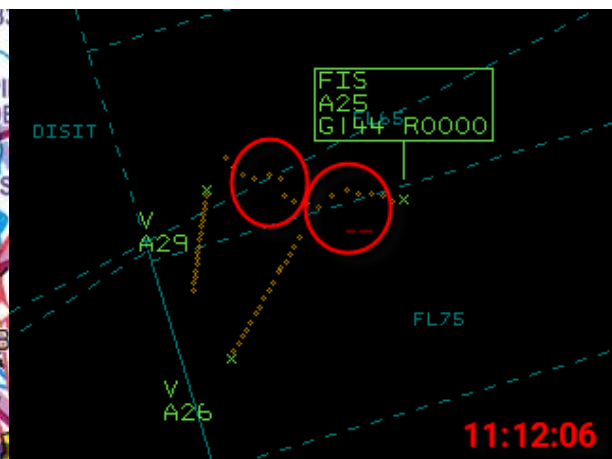
Figure 2

Review of NODE radar displayed [BE18 C/S] make some unusual manoeuvres at 1111:14 and 1111:42 (Figure 2). From the timing of the RT-reported engine failure, it was presumed that these manoeuvres occurred due to this technical issue, as the pilot report stated no form of avoiding action was taken.

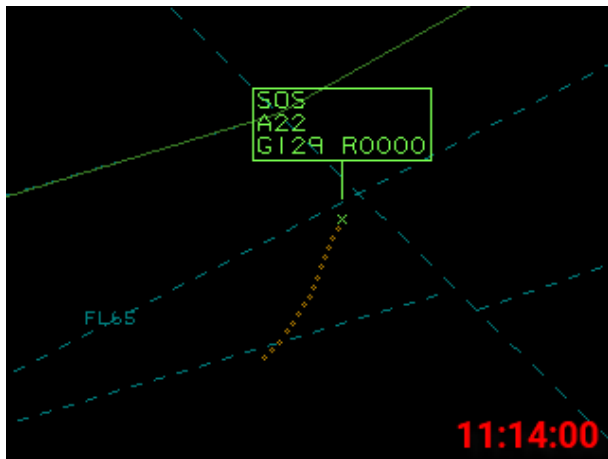
Figure 3

Radar displayed no primary or secondary contacts on NODE radar replay that correlated with the pilot’s reported conflict, therefore a closest point of approach could not be established (Figure 3).

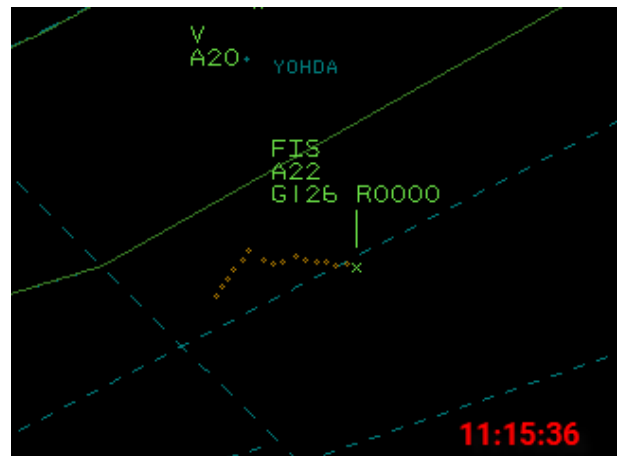
Figure 4

A further significant manoeuvre was observed at 1114:58 (Figure 4), although this may have been a turn to coincide with the pilot’s decision to change direction from Coventry, back to [destination].
