AIRPROX REPORT No 2024108

Date: 25 May 2024 Time: 1130Z Position: 5213N 00138W Location: Wellesbourne ATZ

PART A: SUMMARY OF INFORMATION REPORTED TO UKAB

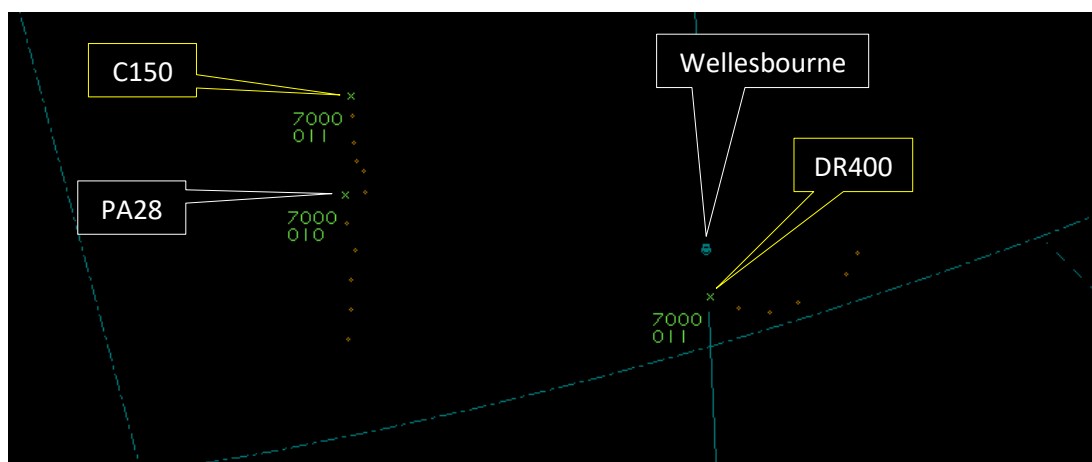
Figure 1 – Aircraft positions at 1128:02

An analysis of the NATS radar replay was undertaken and both aircraft could be positively identified from Mode S data (Figure 1).

The aircraft were depicted on the radar replay at Flight Levels. A suitable correction was applied to determine their altitudes. The diagram was constructed and the separation at CPA determined by reference to the radar data.

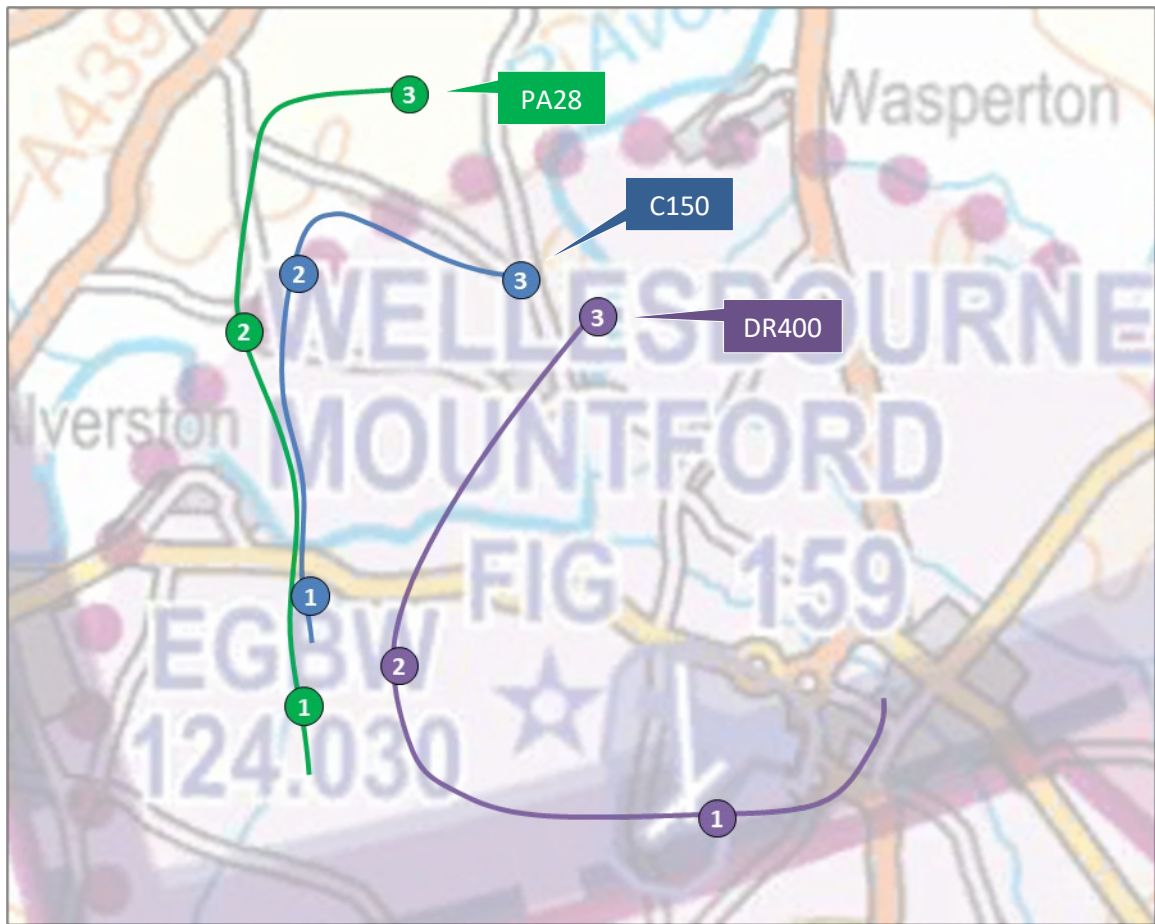
Figure 2 - Circuit patterns

The coloured dots depict the aircraft positions at 1128:02 (1), 1128:50 (2) and 1129:38 (3)

The Board first discussed the actions of the pilot of the C150. Members noted that they had extended their downwind leg and had turned onto base leg at a position just outside the ATZ. A diagram for the circuit at Wellesbourne (as provided on the Wellesbourne Airfield website) was reviewed by members. It was noted that the standard circuit pattern for the runway that had been in use on this particular occasion, is wholly contained within the ATZ. However, it was acknowledged that such a diagram is only representative of a typical circuit pattern. The reason that the pilot of the C150 had extended their downwind leg was not clear to members, but they agreed that it would have been prudent for the C150 pilot to have relayed their intention on the Wellesbourne frequency for the benefit of the other pilots in the circuit and for the Wellesbourne AFISO (**CF3**). Members agreed that the same had been applicable to the pilot of the PA28 who had further extended their downwind leg for increased separation from the C150 ahead of them. Members were in agreement that the pilot of the C150 had had generic situational awareness of the presence of the DR400 (**CF7**) and noted there had been no need to have taken avoiding action when they had subsequently visually acquired the DR400 on the base leg. However, members appreciated that to have sighted the DR400 turning ahead of them on base leg had caused them some concern (**CF10**).

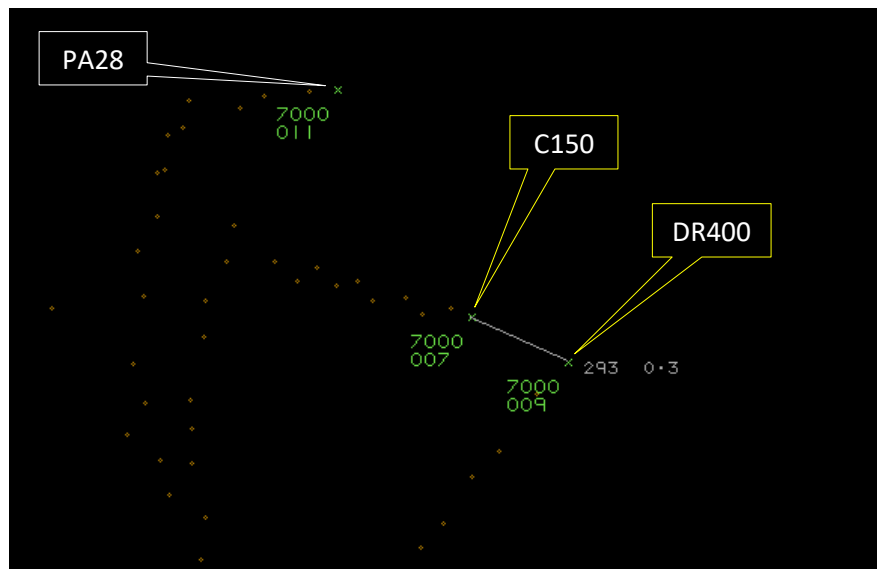
Figure 3 – CPA at 1129:38

The DR400 and C150 pilots shared an equal responsibility for collision avoidance and not to operate in such proximity to other aircraft as to create a collision hazard.² An aircraft operated on or in the vicinity of an aerodrome shall conform with or avoid the pattern of traffic formed by other aircraft in operation.³
