AIRPROX REPORT No 2024120

Date: 16 Jun 2024 Time: 1514Z Position: 5156N 00104W Location: 3NM NE Bicester

PART A: SUMMARY OF INFORMATION REPORTED TO UKAB

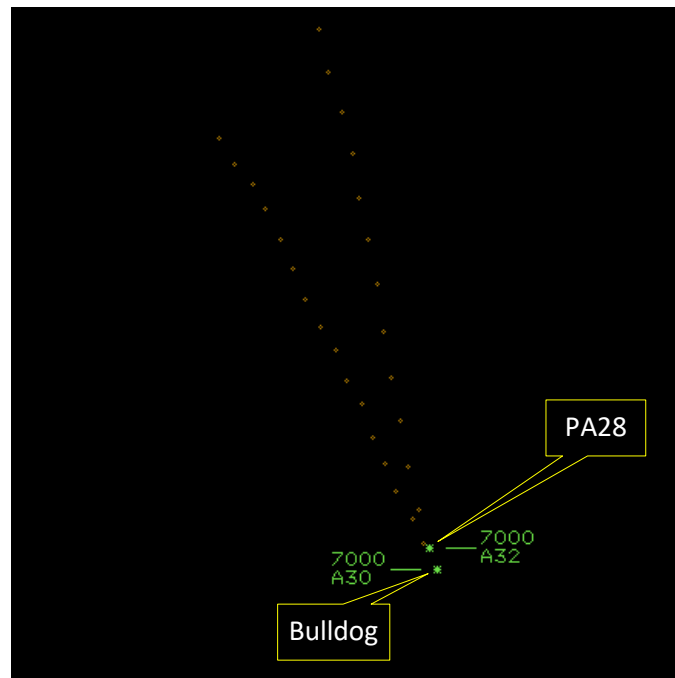
Figure 1 – 1513:50 (2sec before CPA)

An analysis of the NATS radar replay was undertaken and both aircraft could be positively identified from Mode S data. CPA was assessed to have occurred between the radar sweeps at 1513:50 and 1513:54 (Figures 1 and 2).
