AIRPROX REPORT No 2024131

Date: 19 Jun 2024 Time: 1507Z Position: 5129N 00021E Location: Little Thurrock

PART A: SUMMARY OF INFORMATION REPORTED TO UKAB

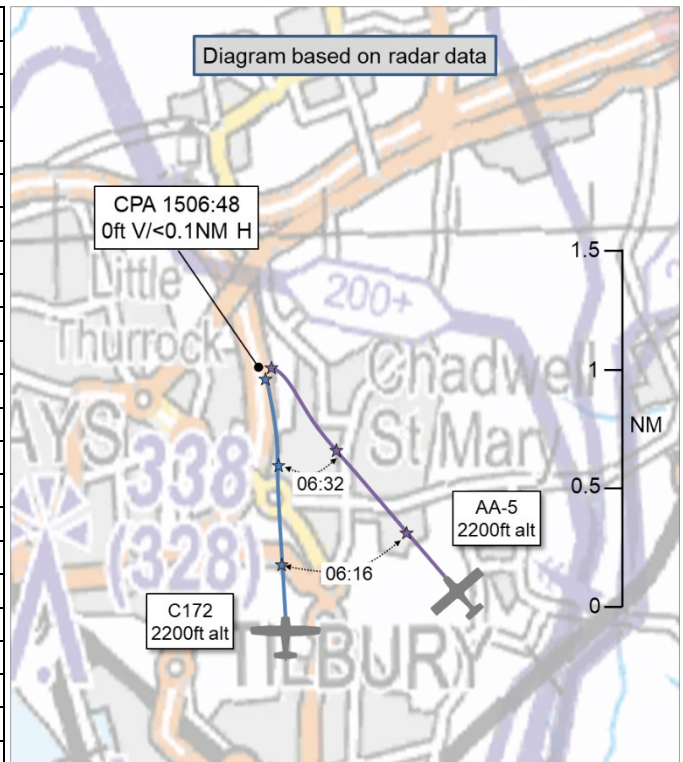
Recorded	Aircraft 1	Aircraft 2
Aircraft	C172	AA-5
Operator	Civ FW	Civ FW
Airspace	London FIR	London FIR
Class	G	G
Rules	VFR	VFR
Service	Basic	Basic
Provider	Southend Radar	Southend Radar
Altitude/FL	2200ft	2200ft
Transponder	A, C, S	A, C, S
Reported		
Colours	White/Blue	Red
Lighting	Bcn, strobes, ldg.	Beacon, nav
Conditions	VMC	VMC
Visibility	>10km	>10km
Altitude/FL	2200ft	2100ft
Altimeter	QNH (1022hPa)	QNH
Heading	355°	330°
Speed	105kt	110kt
ACAS/TAS	Not fitted	PilotAware
Alert	None	Information
Separation at CPA		
Reported	100ft V/50m H	200ft V/0m H
Recorded	0ft V/<0.1NM H

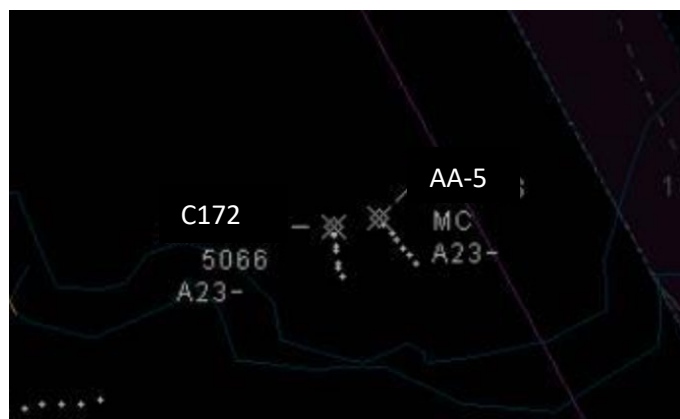
Figure 1 – Southend Radar at 1506:14

At time 1506:14, according to the recorded surveillance data, [the AA-5] was approximately 1NM to the east of [the C172], on a converging track. Mode C on both aircraft indicated 2300ft (Figure 1).

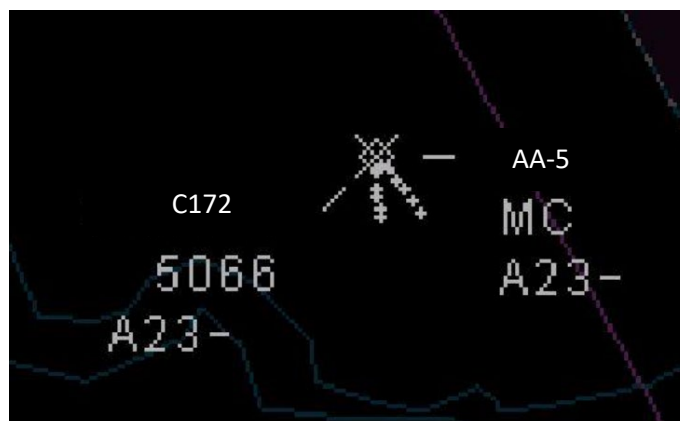
Figure 2 Southend Radar 1506:45 (CPA)

At time 1506:45 CPA occurred when the radar contacts merged, and the Mode C on both aircraft indicated 2300ft (Figure 2),

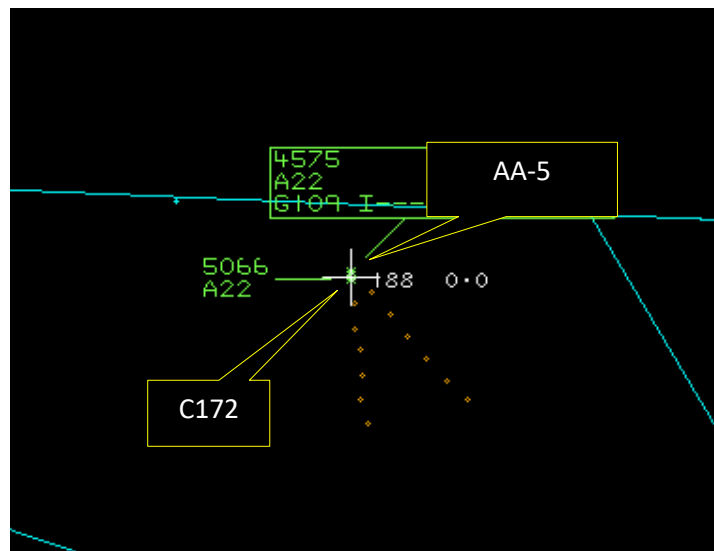
Figure 3 Time 1506:48 CPA separation 0ft and $< 0.1\text{NM}$

An analysis of the NATS radar replay was undertaken, and both aircraft were visible throughout and identified using Mode S data. CPA was seen as the aircraft paths crossed at 1506:48 with 0ft vertical and 0.0NM horizontal separation indicated, depicted in the diagram on page 1 and Figure 3 below as less than 0.1NM due to known radar resolution limitations.
