AIRPROX REPORT No 2024134

Date: 21 Jun 2024 Time: 1337Z Position: 5204N 00041W Location: 2.5NM W of Cranfield

PART A: SUMMARY OF INFORMATION REPORTED TO UKAB

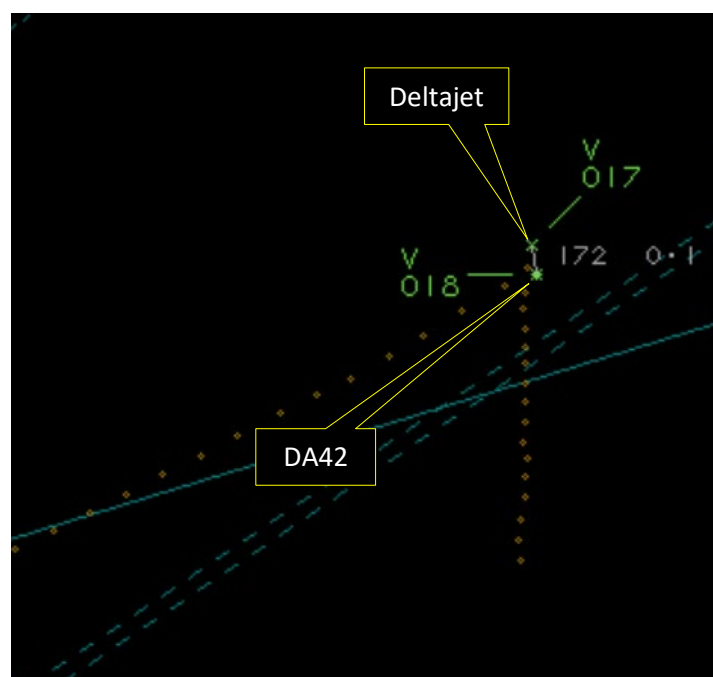
An analysis of the NATS radar replay was undertaken and both aircraft were identified throughout using Mode S data. The DA42 was seen maintaining an east-northeast heading, in a slow descent toward the CPA, and the Deltajet was heading north. The CPA occurred at 1337:15 with the Deltajet passing the 12 o'clock of the DA42 at a distance of 0.1NM and 100ft vertical separation (Figure 1).

Figure 1- Time 1337:15 CPA separation 0.1NM and 100ft
