AIRPROX REPORT No 2024144

Date: 25 Jun 2024 Time: 1220Z Position: 5150N 00106W Location: 3.5NM SSE Bicester

PART A: SUMMARY OF INFORMATION REPORTED TO UKAB

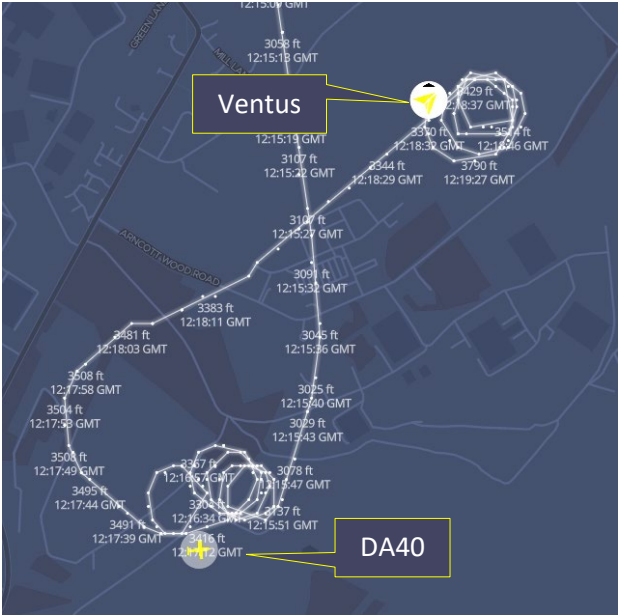
Figure 1 - Time 1220:02 CPA separation was 40ft and 0.6NM

The Ventus had been thermalling from 1218:30 and continued through to 1221:30 in clockwise orbits. The ADS-B data matches the radar replay and the Ventus pilot's GPS data. The CPA was assessed to have been at 1220:02 with the ADS-B data displaying a separation of 40ft vertically and 0.6NM horizontally, the DA40 at 3975ft and the Ventus at 4015ft (Figure 1).

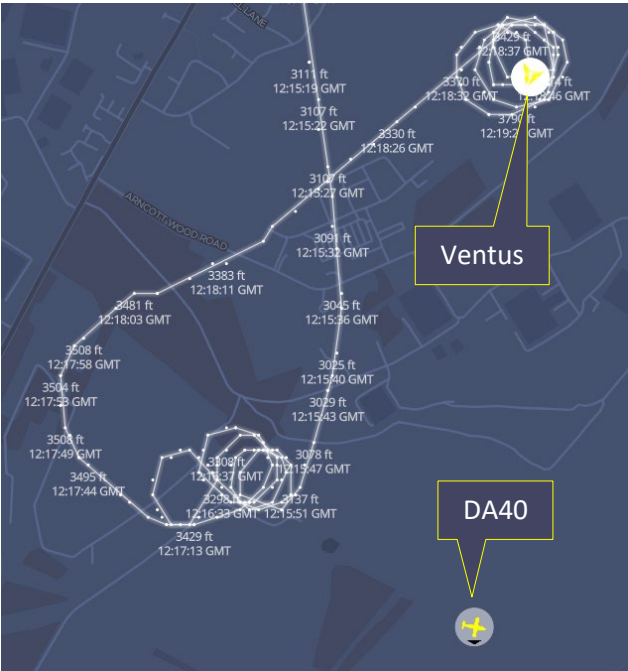
Figure 2 - Time 1220:10 aircraft positions 4sec after CPA

At 1220:10, 8sec after CPA, the DA40 was seen to have continued on track to WCO while the Ventus continued to orbit.
