AIRPROX REPORT No 2024151

Date: 26 Jun 2024 Time: 1536Z Position: 5119N 00052W Location: Blackbushe

PART A: SUMMARY OF INFORMATION REPORTED TO UKAB

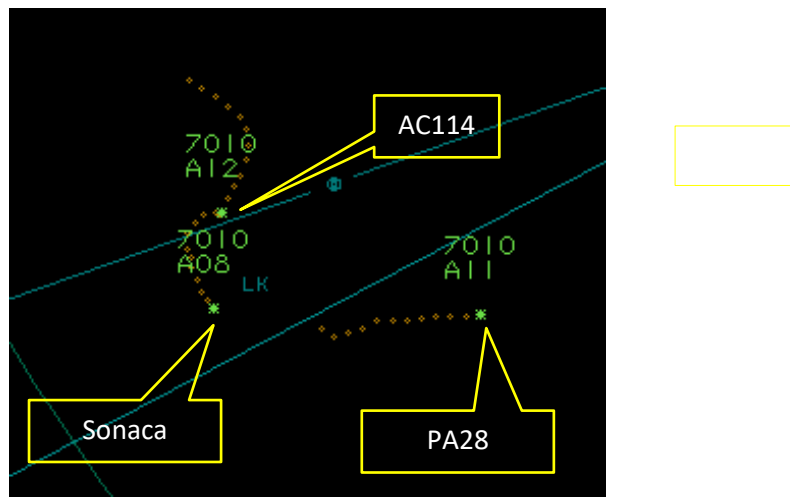
A review of the NATS radar replay and R/T transcripts was made, and it was noted that the exact time of CPA could not be established from the radar replay. The screenshot below displays the AC114 very slightly north of the climb-out lane at time 1535:56, crossing from north-to-south, indicating altitude 1200ft QNH. The AC114 pilot had initially been following a track that would take them much closer to the airfield, however, they made a wide right turn when they were still to the north of the climb-out lane, appearing to be positioning themselves to integrate into the circuit pattern already formed by the PA28 and Sonaca that were ahead of them (Figure 1).

Figure 1 Time 1535:56 AC114 integrating in circuit.

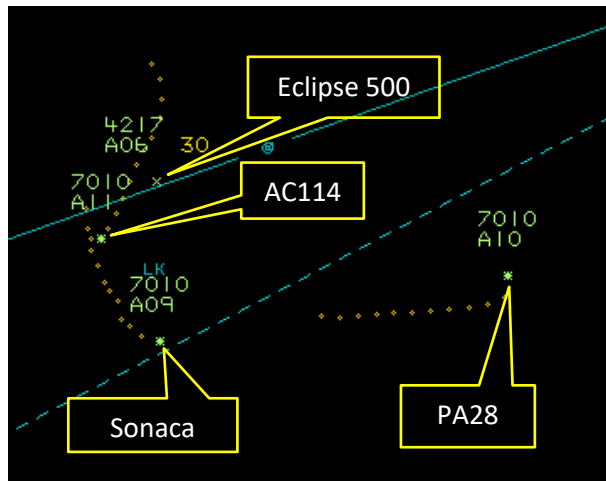
Blackbushe reported that the Eclipse 500 was airborne at 1536:01, however the aircraft did not display on the radar replay until 1536:11, when they were indicating altitude 600ft QNH. It seems likely that the AC114 was passing through the climb-out lane when the Eclipse 500 was lifting from the runway (Figure 2).

Figure 2 – Time 1536:11 with the Eclipse 500 displaying

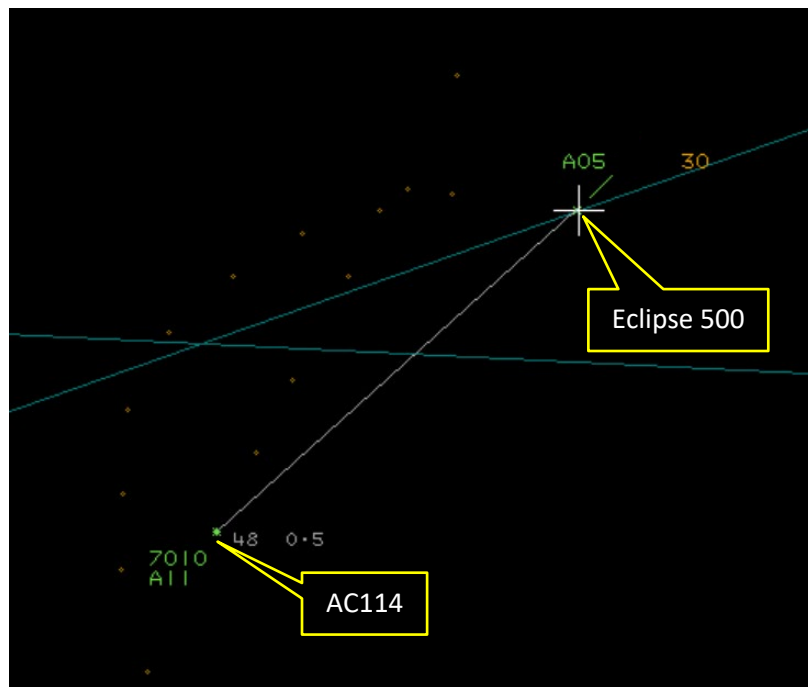
An analysis of the NATS radar reply was undertaken and both aircraft were positively identified using Mode S data. The Eclipse 500 first appeared at 1536:10 at 500ft and the AC114 was seen on the crosswind leg at 1100ft, as the Eclipse 500 was taking off (Figure 3).

Figure 3 – Time 1536:10 First appearance of the Eclipse 500, separation 0.5NM and 600ft.

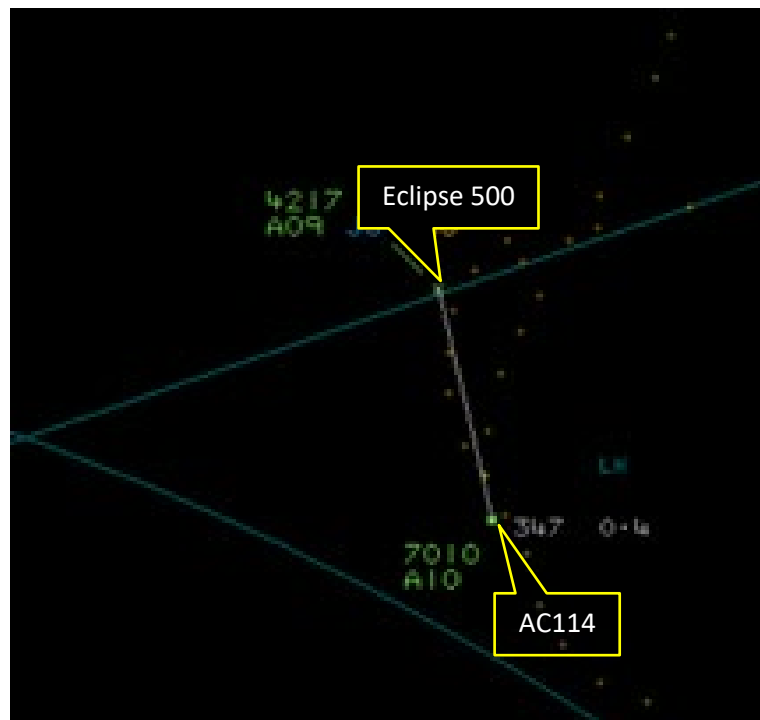
Figure 4 - Time 1536:26 CPA separation 0.4NM and 100ft

CPA was seen to have occurred at 1536:26 with a separation of 0.4NM and 100ft (Figure 2)
