AIRPROX REPORT No 2024158

Date: 22 Jun 2024 Time: 0839Z Position: 5208N 00057E Location: Wattisham ATZ

PART A: SUMMARY OF INFORMATION REPORTED TO UKAB

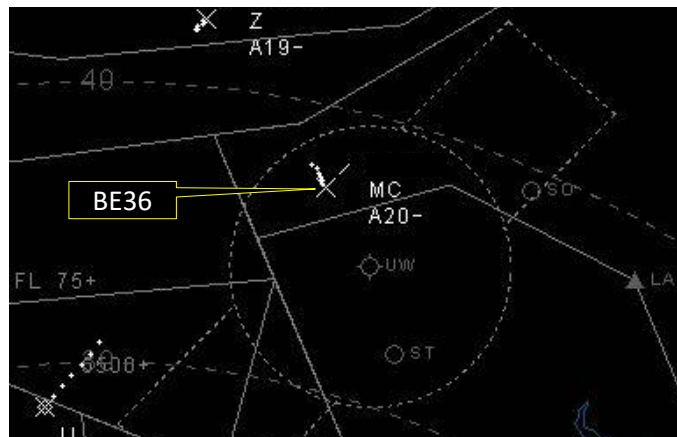
Figure 1 – Southend Radar at 0838:00

At time 0838:00, according to the recorded surveillance data, [the BE36] was approximately 3.5NM to the north-northwest of Wattisham. At that time, the aircraft's Mode C indicated level at altitude 2000ft (Figure 1).

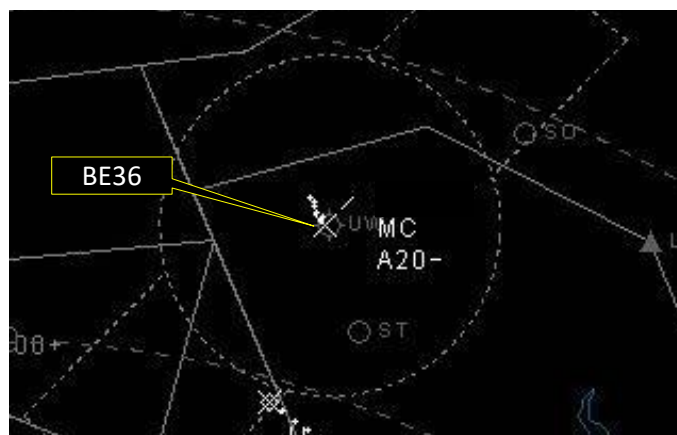
Figure 2 – Southend Radar at 0839:18

At time 0839:18 (Figure 2), according to the recorded surveillance data, [the BE36] was overhead Wattisham.

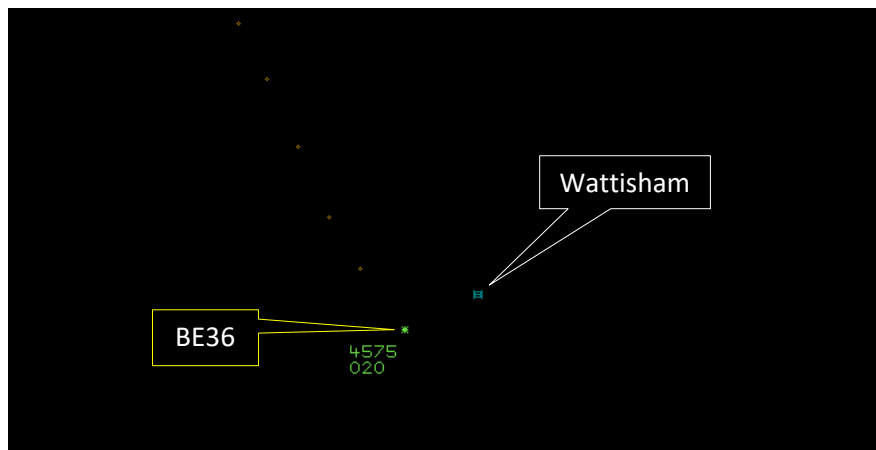
Figure 3 - 0839:18 (1sec after CPA)

An analysis of the NATS radar replay was undertaken and the BE36 could be positively identified from Mode S data (Figure 3). The BE36 was depicted on the radar replay as having flown at Flight Levels. A suitable correction was applied to determine its altitude which has been shown as an approximation in the diagram. The ASK21 was not observed on the radar replay before CPA. However, a primary-only return was observed on radar after CPA which, by reference to GPS data for the flight of the ASK21 as obtained by the UKAB Secretariat, broadly correlated to the position of the ASK21 (Figure 4). The altitude of the ASK21 had changed rapidly during the moments leading to CPA and has therefore been shown as estimated values.

CPA was determined to have occurred between the radar sweeps at 0838:14 and 0838:18. The diagram was constructed and the separation at CPA determined by combining the data sources.

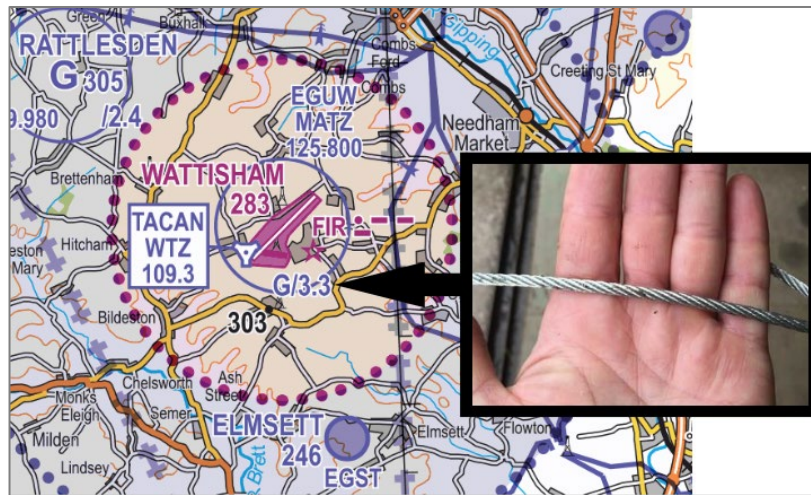
Figure 5

UK glider launch sites are listed in UK AIP ENR 5.5 and labelled on the CAA 1:500,000 and 1:250,000 charts with a "G" symbol, as shown in figure 5. A greater density of gliders may be expected nearby at any time during daylight hours, and at any altitude up to cloudbase. Where winch launching is used, the maximum winch launch altitude is listed in the AIP and marked on the chart; this is 3300ft AMSL at Wattisham, as indicated by the black arrow in the figure.
