AIRPROX REPORT No 2024159

Date: 05 Jul 2024 Time: 1524Z Position: 5215N 00018W Location: NE Cambridge Airport

PART A: SUMMARY OF INFORMATION REPORTED TO UKAB

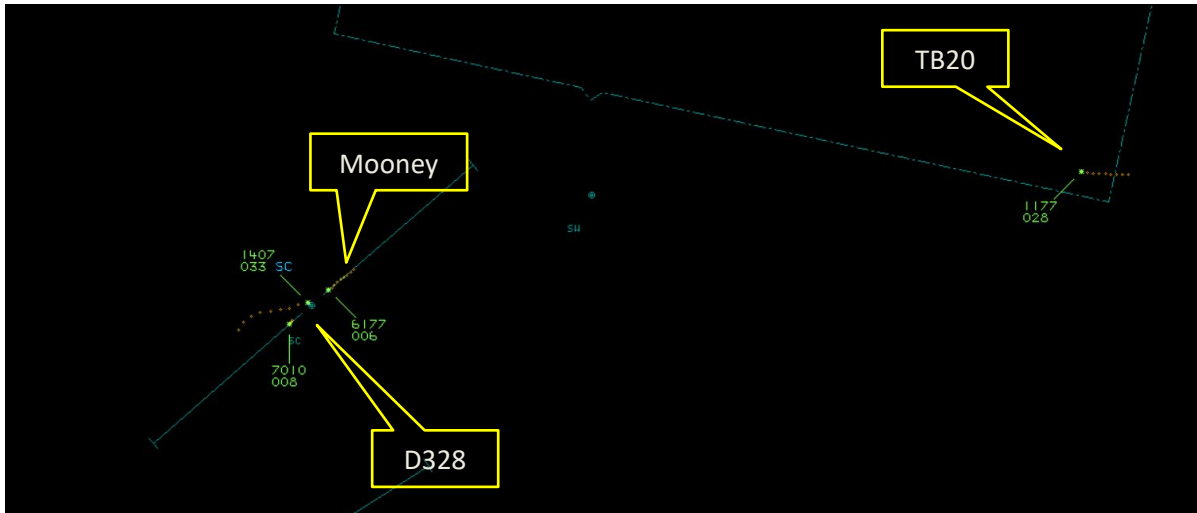
Figure 1 –1517:10

The pilot of the TB20 made their initial call to Cambridge Approach at 1517:25 advising: *“just routeing through the northern edge, through your instrument approach at 2600ft on 1005. I’m approximately 15, 20 miles to your east”* (Figure 1).

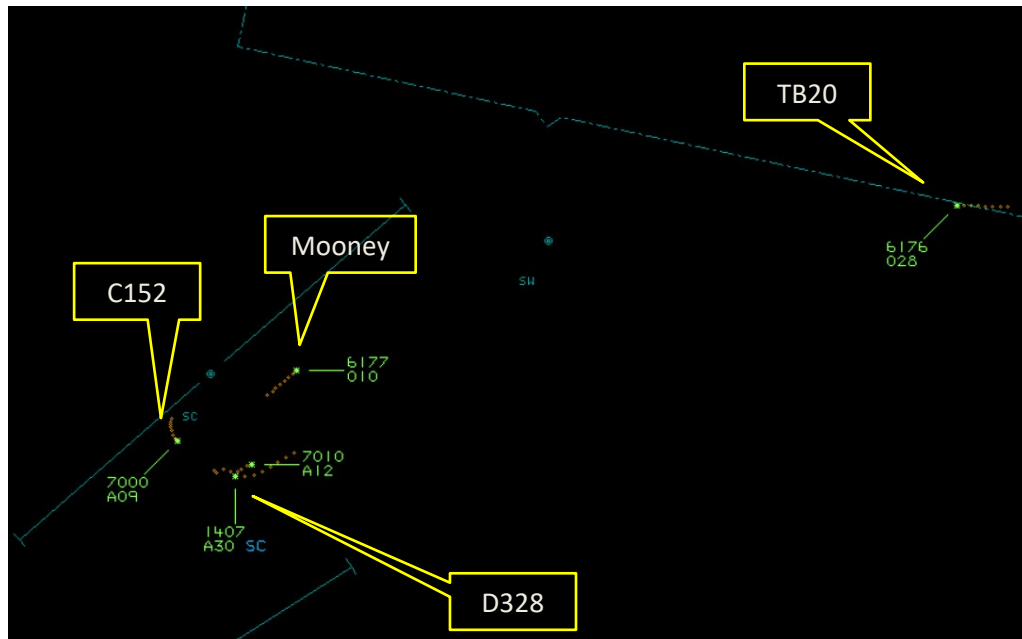
Figure 2 – 1519:12

The Tower controller rang again at 1518:42 to advise that the Mooney had entered the visual circuit, and a discussion took place between the controllers as to whether the Mooney was now VFR. The Mooney pilot had previously elected to go-around due to an aircraft departing ahead of them. Although this had not been formally communicated to the Approach controller (and OJTI), both were aware of it as the Tower frequency was monitored in the ACR as a matter of routine at Cambridge. It was decided by the OJTI that they would continue to treat the Mooney as IFR and so the D328 pilot, although not immediately cleared for the approach, was advised at 1519:12: *“next time over the CAM you can expect to go outbound for the approach and again, maintain 3000ft ‘til advised”* which was read back by the pilot (Figure 2).

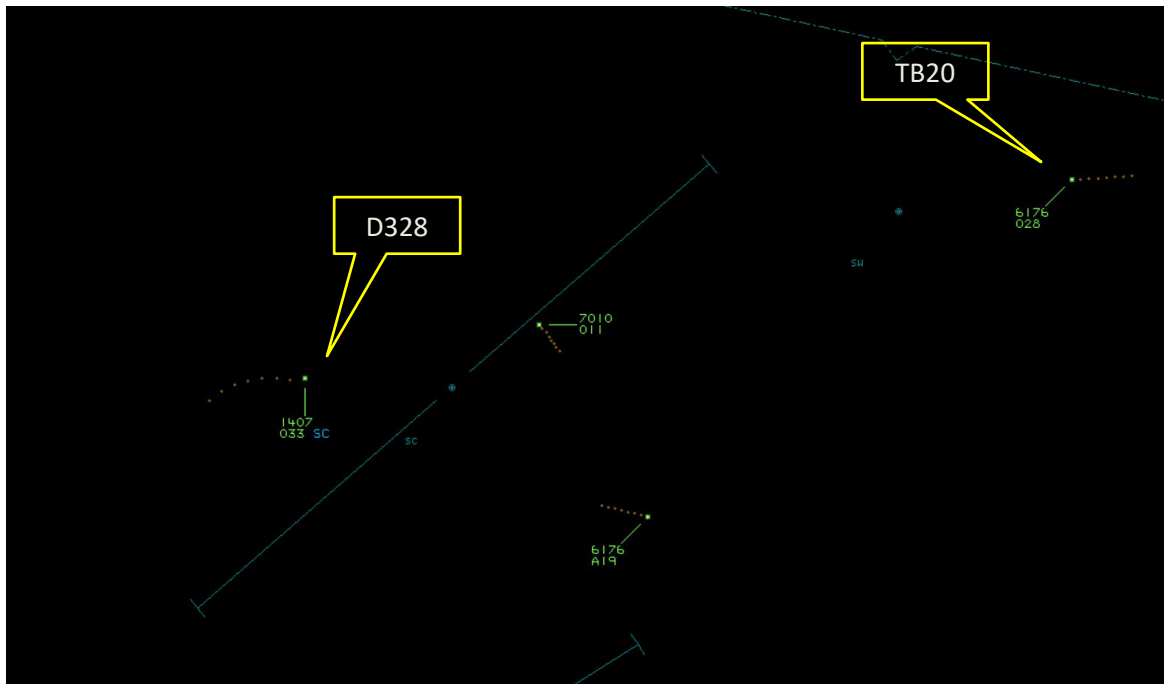
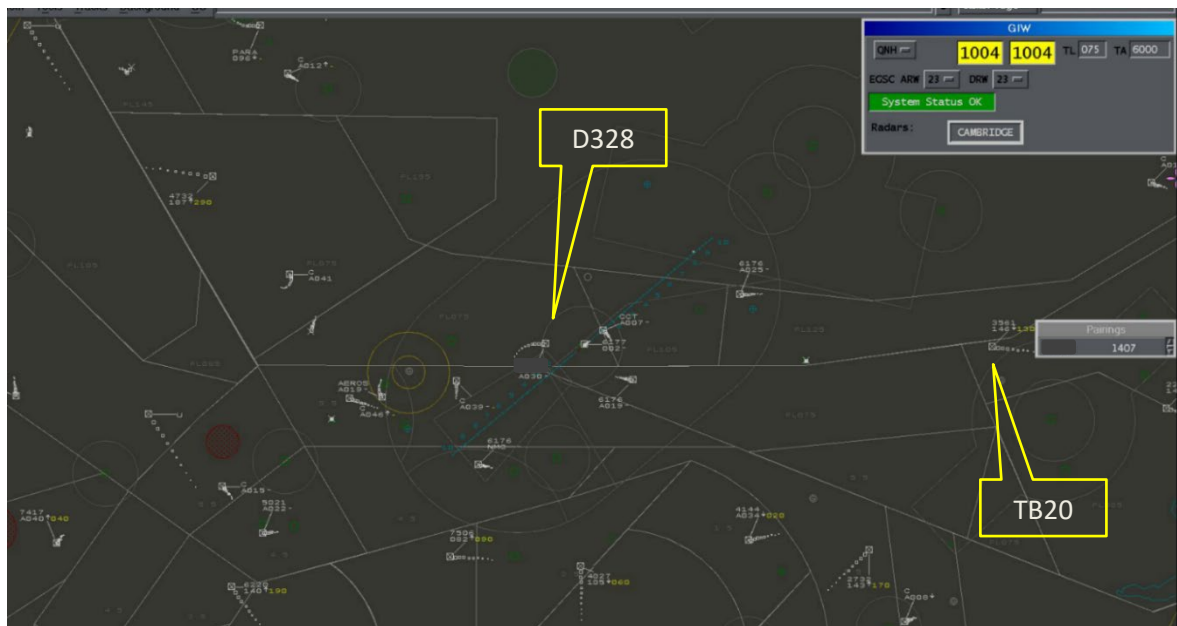
At 1521:55 the Approach controller cleared the D328 pilot for the ILS approach and requested they report the CAM outbound which was acknowledged by the pilot (Figures 3 and 4).

Figure 3 – 1521:55

Figure 4 – 1521:55 (Cambridge Radar Display)

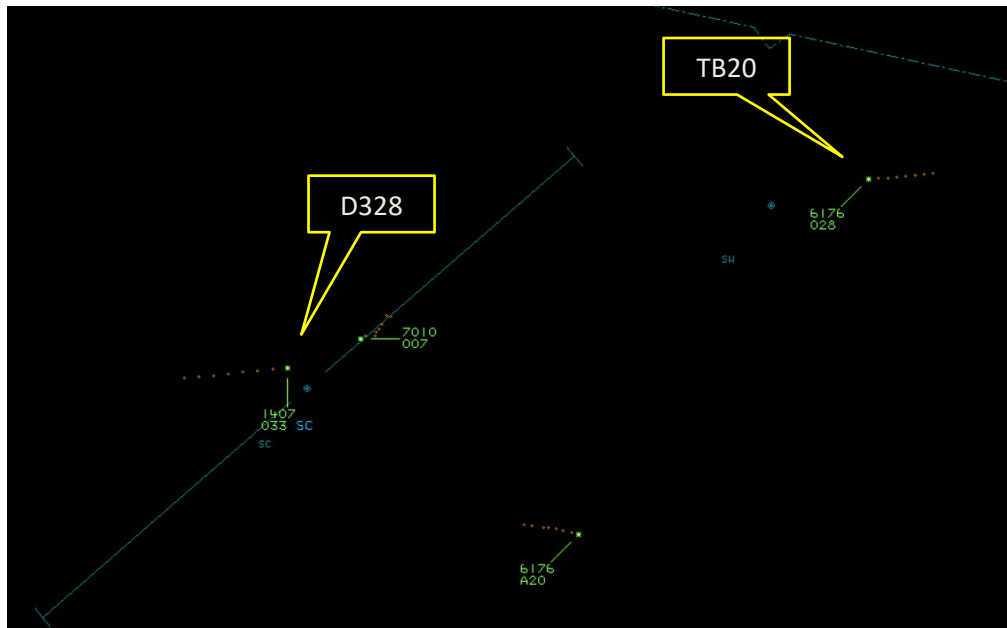
Figure 5 – 1522:31

At 1522:20 the controller issued a warning to the pilot of the PUP about glider activity at Gransden Lodge, and then at 1522:31 requested a position check from the pilot of the TB20 – reported as 8 miles east. Note: The TB20 was actually to the north-east, not east of Cambridge (Figure 5).

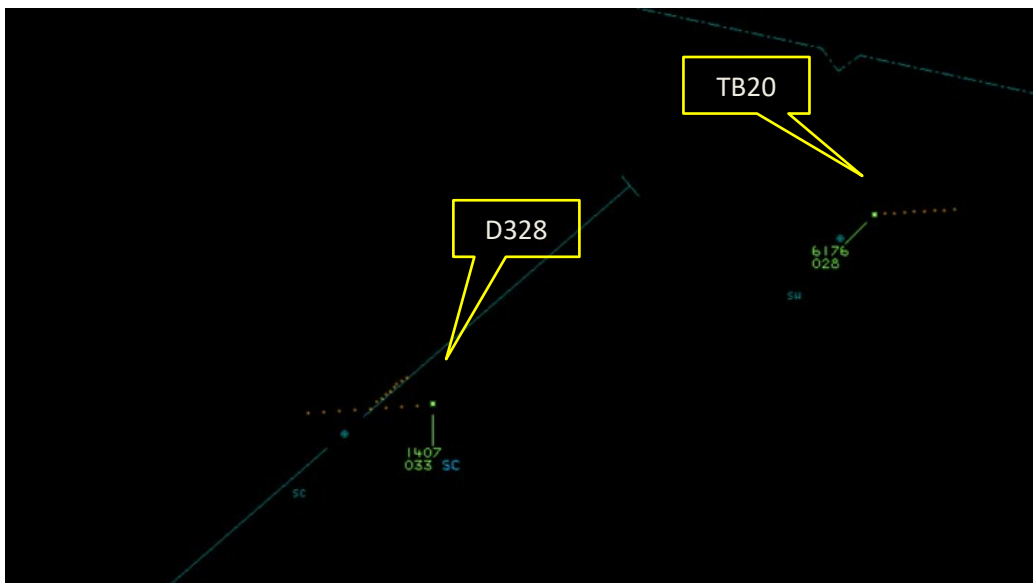
Figure 6 – 1522:55

At 1522:41 the controller advised the pilot of the D328: *“traffic is a TB20, 8 miles to the east of Cambridge transiting towards west-northwest. Last known 2600ft”*, to which the D328 pilot responded: *“that’s copied, are we cleared descent – we are beacon outbound now?”*. The controller confirmed at 1522:55: *“affirm – descend in the procedure”* (Figure 6).

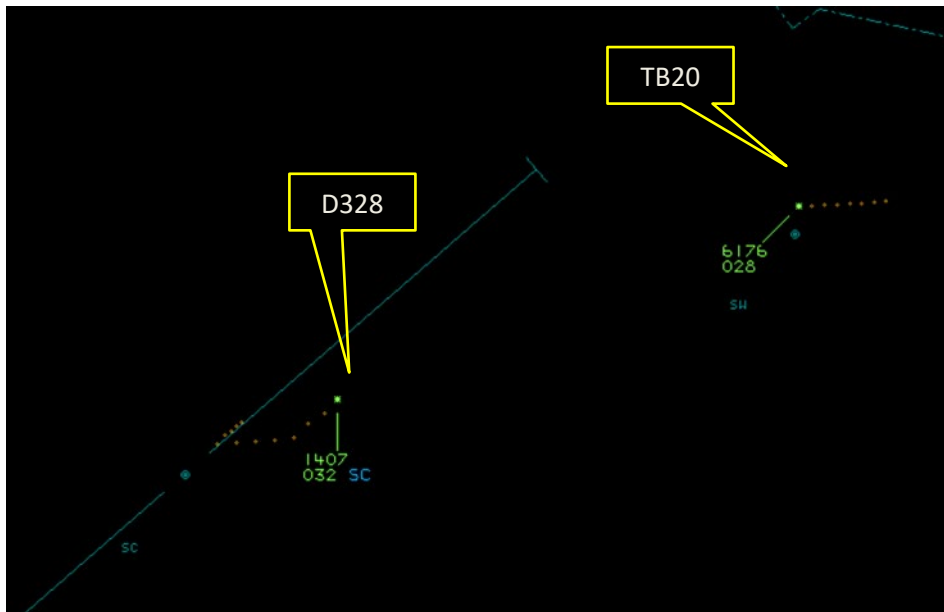
Figure 7 – 1523:11

At 1523:11 the Approach controller requested a report passing 2500ft in the descent from the D328 pilot, which the pilot acknowledged (Figure 7).

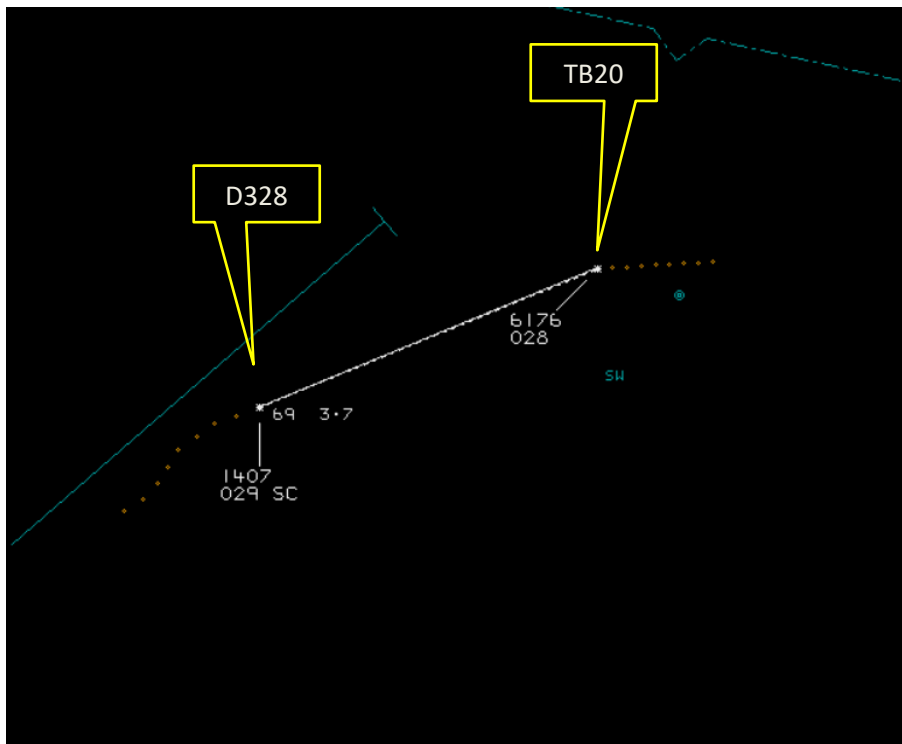
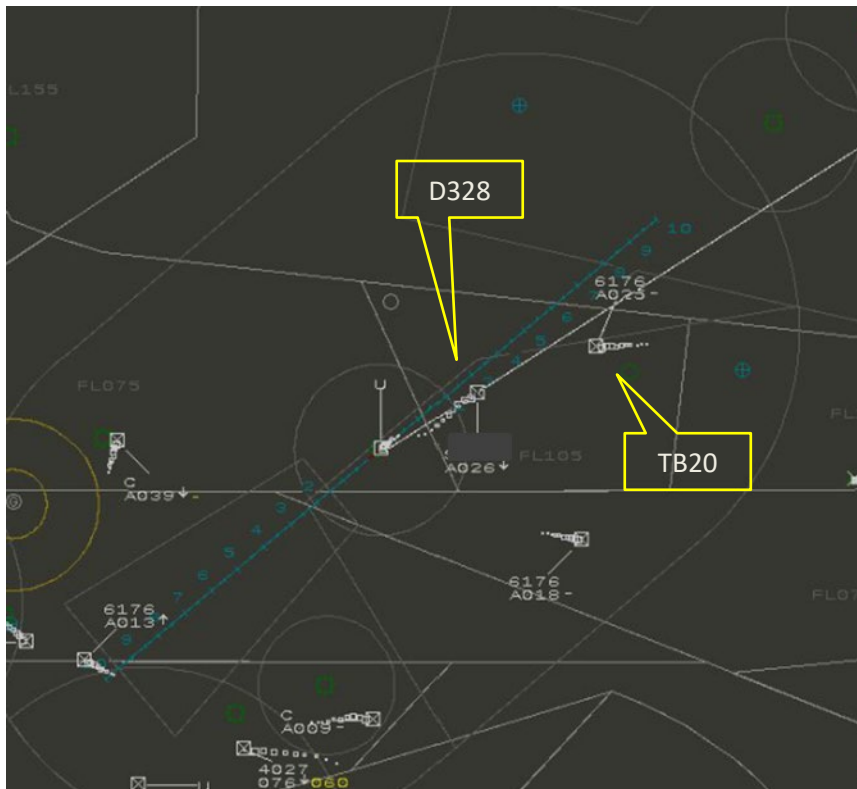
At 1523:33 the controller passed further Traffic Information to the TB20 on the D328: *“traffic is the D328 – outbound from the CAM descending through your level. Report if you get him in sight”* (Figures 8 and 9).

Figure 8 – 1523:33

Figure 9 – 1523:33 (Cambridge Radar display)

Note: the extended line emanating from the D328 is not a predictive track tool, it is the DF/QTE bearing activated by individual aircraft transmissions.

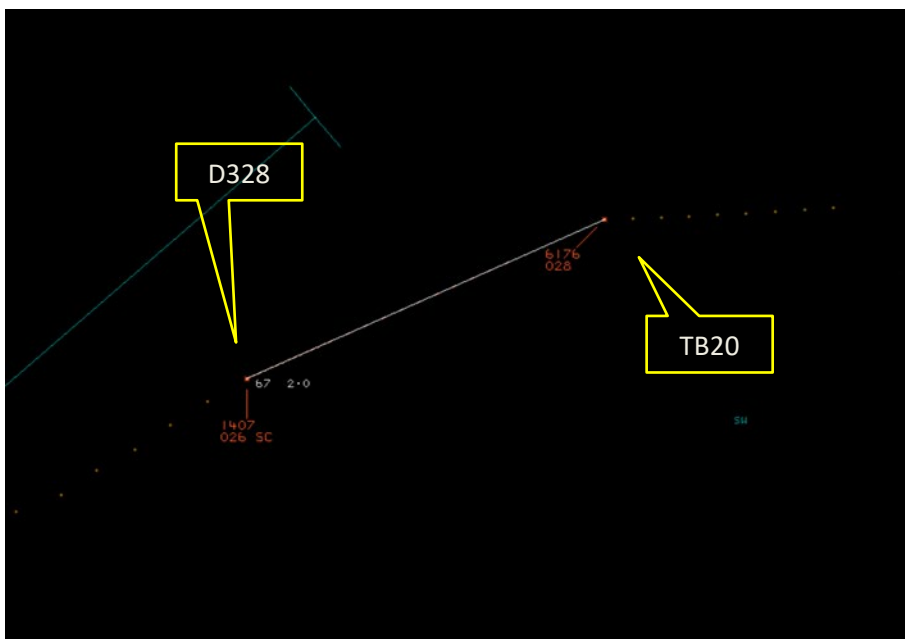
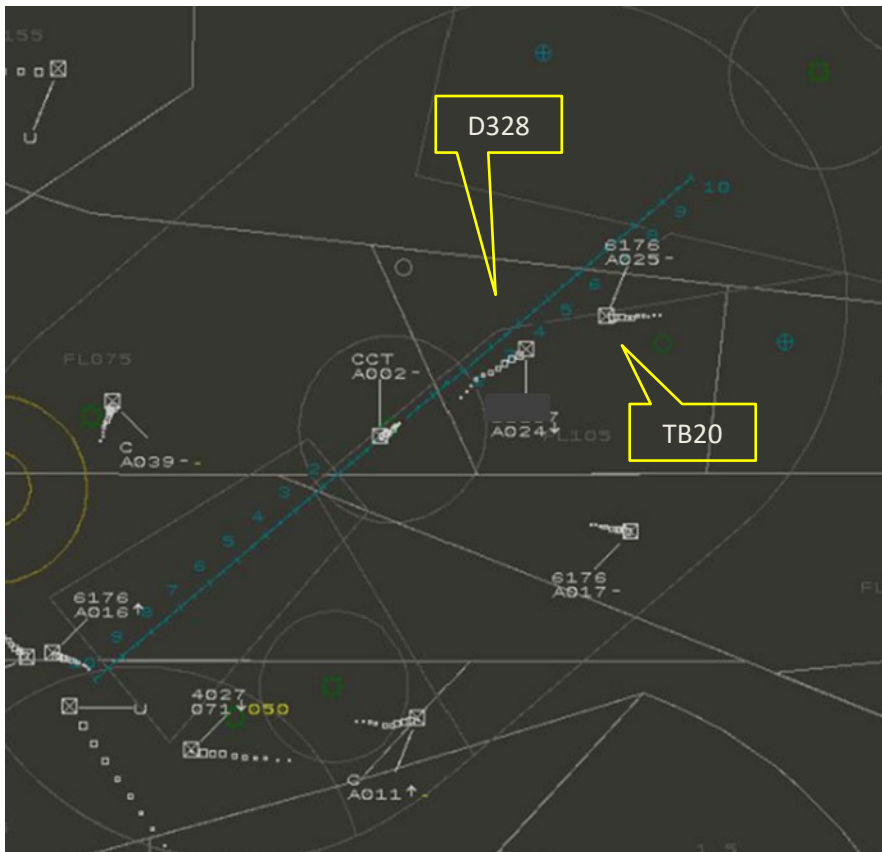
At 1523:51 the OJTI transmitted “(D328 callsign) – non-radar, but I do believe that previously called traffic is now 12 o’clock at 1 mile, crossing right-left, indicating similar level” (Figures 10 and 11).

Figure 10 – 1523:51

Figure 11 – 1523:51 (Cambridge Radar display)

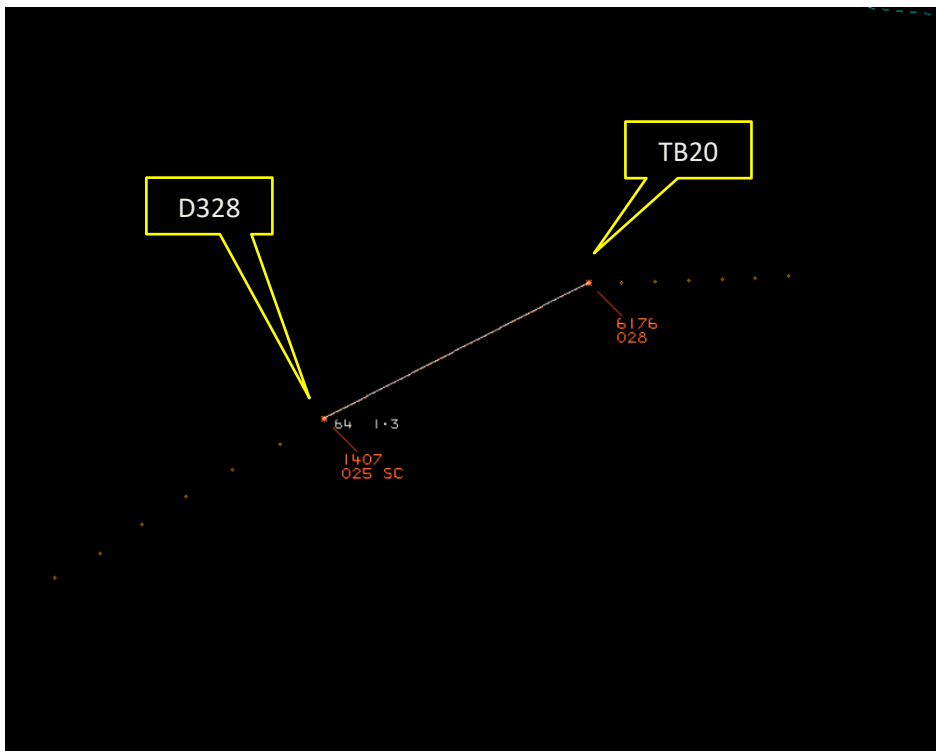
Figure 12 - 1524:00

The D328 pilot replied: “er we have TCAS RA (callsign) – he’s just in front of us” (Figure 12).

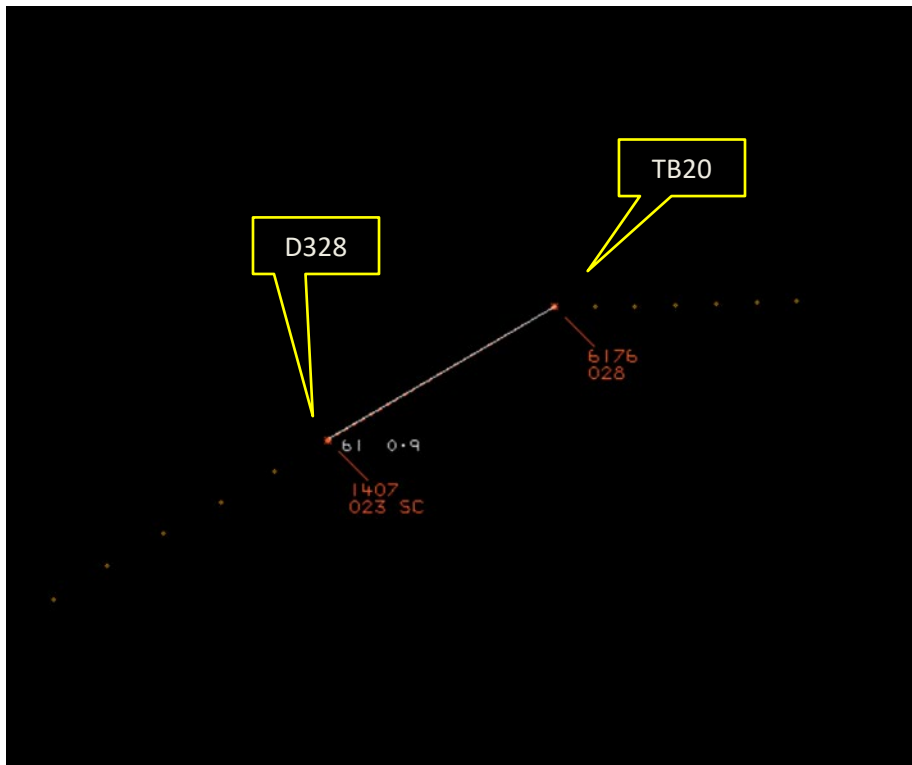
Figure 13 – 1524:05

At 1524:05 the TB20 pilot confirmed: “I’m visual with traffic – he’s below me”.

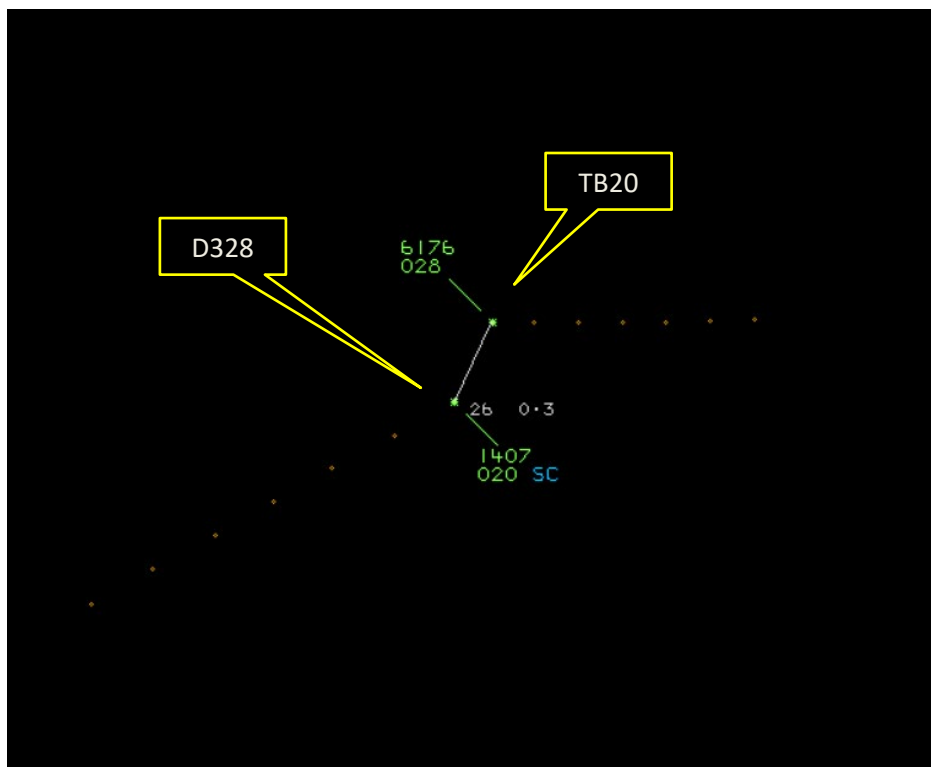
Figure 14 – 1524:12 CPA

CPA (Closest Point of Approach) occurred at 1524:12 with the aircraft separated by 800ft vertically and 0.3NM laterally (Figure 14).

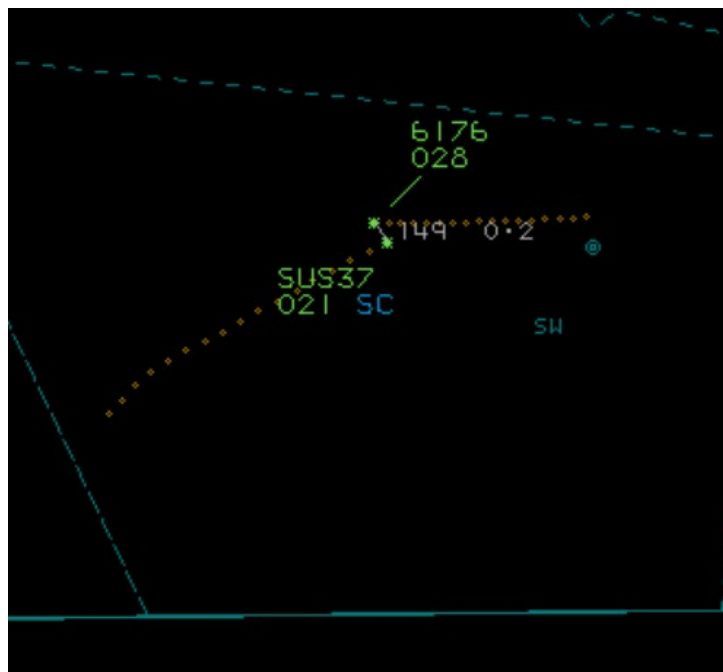
Figure 15 - 1524:18

An analysis of the NATS radar was undertaken and allowing the radar to continue to 1524:18 gave a radar CPA of 700ft vertical and 0.2NM horizontal separation.
